INFRASTRUCTURE ASSESSMENT REPORT FOR SUVA-NAUSORI SCHOOLS

FINAL REPORT

PREPARED FOR: MINISTRY OF EDUCATION
January 2025

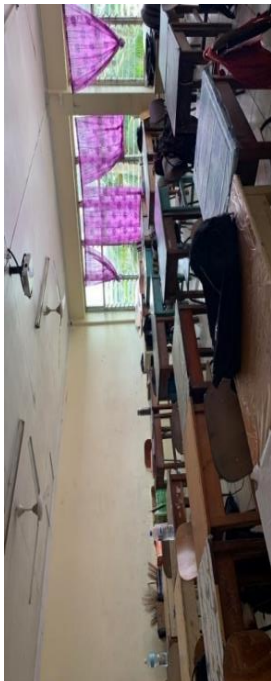
Gospel High School	Overcrowding: 11/19 classrooms (58%) overcrowded. WASH facilities: Boys - 14 cubicles ; 19 Girls cubicles.	23 total classrooms are to be present utilizing Recommended sizing (1.5m ²) requirement. WASH Facilities: Boys – (7 cubicles) Girls – (15cubicles)	4 extra classrooms are needed since current 19 classrooms are not sufficient to support the total roll.

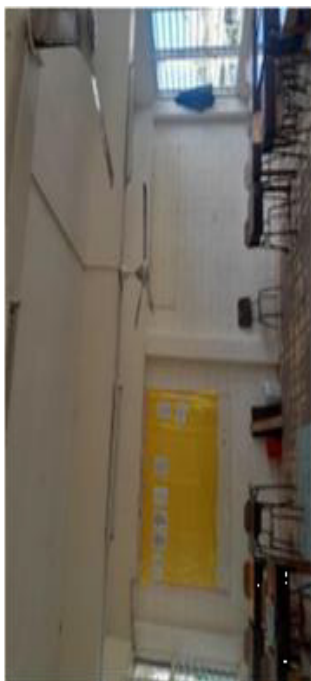
Deenbhandoo Memorial School	Overcrowding: 4/13 classrooms (30.8%) overcrowded. WASH facilities: Boys - 4 cubicles ; 4 Girls cubicles.	17 total classrooms are to be present utilizing Recommended sizing (1.5m ²) requirement. WASH Facilities: Boys – (6 cubicles) Girls – (9 cubicles)	4 extra classrooms are needed since current 13 classrooms are not sufficient to support the total roll. WASH Facilities: Boys : 2 cubicles required. Girls: 5 cubicles required

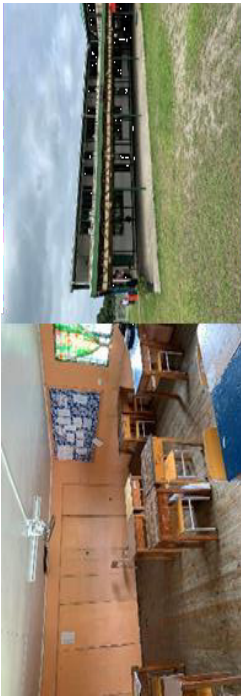
John Wesley Primary School	The school has 16/16 overcrowded classrooms, limited disability features, and rusted cladding.	RECOMMENDED SIZING (1.5M2)1990 standards for structural safety, additional classrooms, proper washroom ratios, and accessibility are required.	The school needs 8 extra classrooms, six additional washroom cubicles for girls, cyclone upgrades, and ramps.

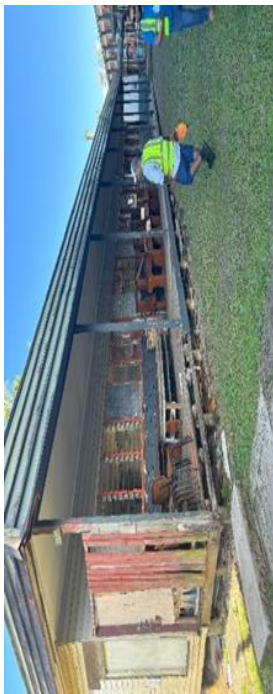
Nabua Primary School	Structure - the timber structures used as classrooms were in poor condition and displayed weak structural integrity like damaged timber walls and floors with the floor framing deteriorating.	<ul style="list-style-type: none"> - Structural Integrity – Columns, slabs, beams, rafters, purlins sizes to follow FNBC1990. - General upkeep –routine checkup as per MOE policies with major defects requiring immediate intervention.' 	Structures need to be renovated and require timely maintenance and repair works of all structures.

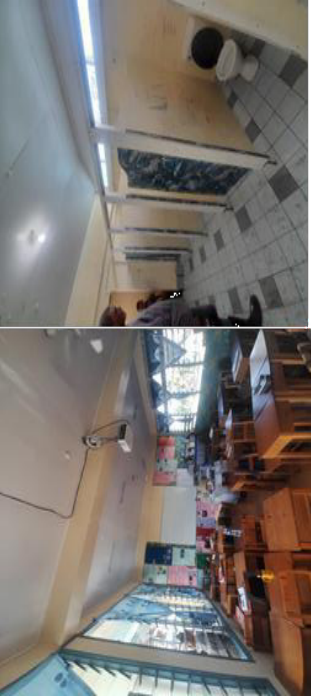
Suva Methodist Primary School	Overcrowding – 15/21 (71.4%) of classrooms were overcrowded, Disability Accessibility - 100% not accessible to disabled people. Disaster Resilience - 90% not resilient.	Overcrowding - 23 classrooms are required to meet Recommended sizing (1.5m2); Disability Accessibility - Ramps, signs, accessible toilets and wider doorways are required to meet compliance. Disaster Resilience - Structural Integrity such as columns, slabs, beams, rafters and purlin sizes to follow FNBC 1990.	Overcrowding - 2 classrooms are needed based on Recommended sizing (1.5m2); Disability Accessibility - not compliant with FDFP Disability audit tool; Disaster Resilience - the architectural fractures and structural cracks visible are required maintenance.

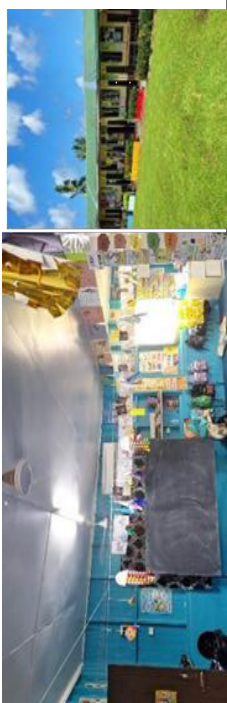
Yat Sen Secondary School	Structural integrity and disaster resilience - 15%	Structural does not comply to FNBC 1990 as there is a severely deteriorated structural member (B1 beam) that may compromise the structural integrity of the building	Immediate Structural analysis required for structural element (beam at B2)

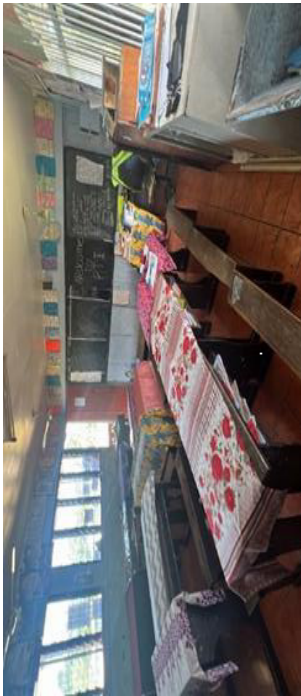
Ratu Sukuna Memorial School	Existing infrastructure in bad condition and No Fire compliance	Upgrade Infrastructure to minimum standards. Fire Safety Compliance	Engage Engineer for structural assessment and rehabilitation. Upgrade all fire fighting equipment and obtain NFA Compliance

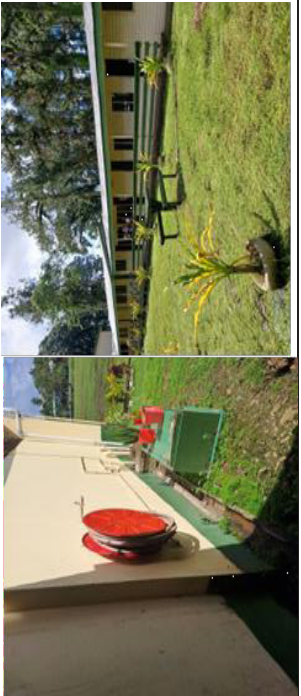
St John Bosco	Overcrowding – 10/21 (47.6%) of classrooms were overcrowded, Disaster Resilience - 90% not resilient.	Overcrowding - 26 classrooms are required to meet Recommended sizing (1.5m ²); Disaster Resilience - roof cladding and roofing nails are rusted and there weren't any permanent mesh shutters on the windows. For cyclone certification these will need to be amended	Overcrowding - 5 classrooms are needed based on Recommended sizing (1.5m ²); Disaster Resilience - rusting of roof cladding, roofing nails and permanent cyclone mesh shutters contradicts to the cyclone certification requirement requiring replacement.

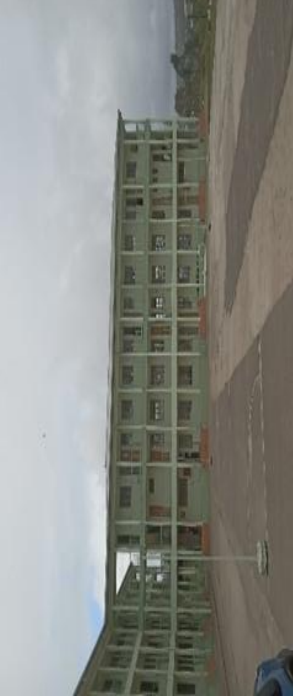
Bishop Kempthorne Memorial	Disability Access and Fire	Upgrade Infrastructure to include disability access. Fire Safety Compliance	construct ramps, provide space, etc, or disability. Upgrade all fire fighting equipment and obtain NFA Compliance

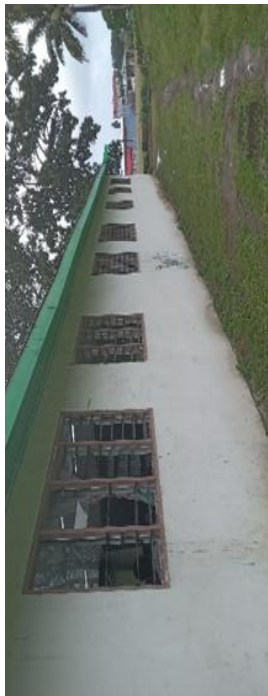
Basden College	Existing infrastructure in bad condition and No Fire compliance	Upgrade Infrastructure to minimum standards. Fire Safety Compliance	Engage Engineer for structural assessment and rehabilitation. Upgrade all fire fighting equipment and obtain NFA Compliance

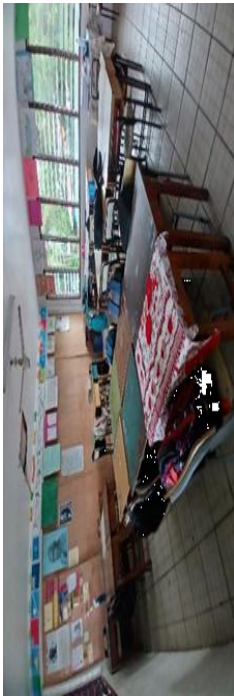
Kalabu Fijian Primary School	Total of 12/16 overcrowded classroom with total of 655 students with average of 42 student in each classroom. B2 Timber structure building doesn't comply with cyclone standard.	total 22 classroom need to meet Recommended sizing (1.5m2). Upgrade work required on B2 to meet cyclone standard.	additional 6 classroom need to meet Recommended sizing (1.5m2) to address overcrowding in school and upgrade works on B2 Timber structure to meet cyclone standards

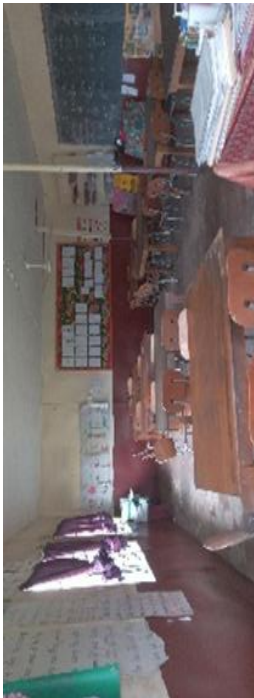
Ahmadiyya Muslim College	<p>Disability Accessibility - 100% not accessible to disabled people.</p> <p>Disaster Resilience - 90% not resilient.</p> <p>Condition of Infrastructure - 80% structural integrity failure.</p>	<p>Disaster Resilience - roof cladding and roofing nails are rusted and there weren't any permanent mesh shutters on the windows. For cyclone certification these will need to be amended,</p> <p>Disability Accessibility - Ramps, signs, accessible toilets and wider doorways are required to meet compliance.</p> <p>Condition of Infrastructure - building structure require more intervention to improve structural integrity and condition.</p>	<p>Disaster Resilience - rusting of roof cladding, roofing nails and permanent cyclone mesh shutters contradicts to the cyclone certification requirement requiring replacement,</p> <p>Disability Accessibility - not compliant with FDFP Disability audit tool.</p> <p>Condition of Infrastructure - building structure require more intervention to improve structural integrity and condition.</p>
