INFRASTRUCTURE ASSESSMENT AUDIT FOR SUVA – NAUSORI URBAN SCHOOLS

DR. RAM LARKHAN MEMORIAL PRIMARY SCHOOL (REG 2384)

SUMMARY REPORT

SITE INSPECTION REPORT

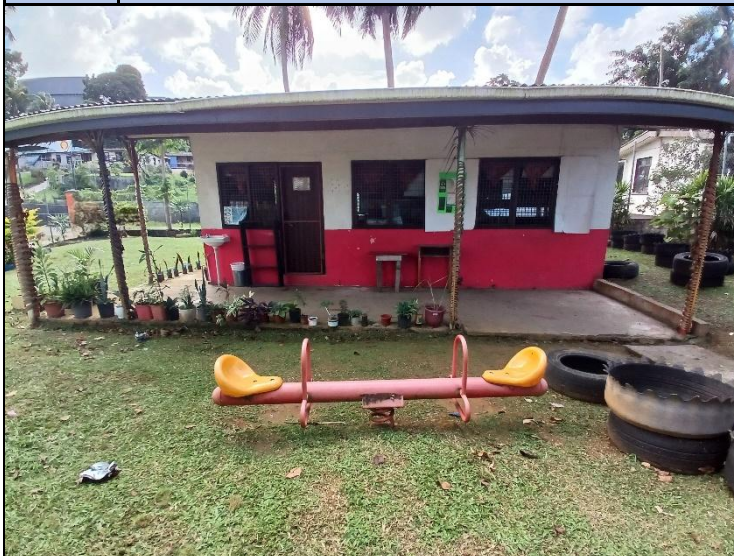
PHOTOGRAPH No. 1: FRONT

12	Services – communication (internet)		✓			None	
13	Drainage		✓			Open 'V' drains for Stormwater Discharge	
<u>Comments</u>							
Visual defects							
➤ Surface cracks are visible along the walk-way floor slabs							
➤ Guttering & Downpipe not fixed properly on brackets

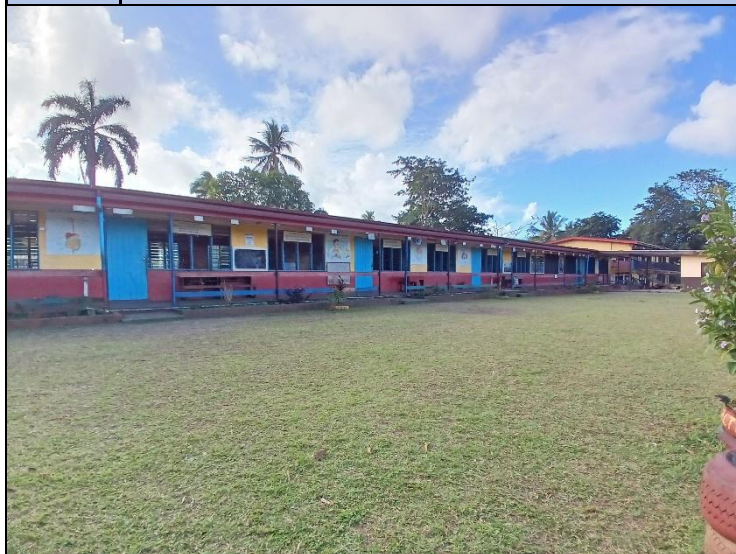
PHOTOGRAPH No. 1: FRONT

10	Available taps for general use		✓			4- Taps	Student – tap ratio = 40: 1
11	Services – electricity			✓		EFL	
12	Services – communication (internet)		✓			Wireless and LAN connection	
13	Drainage		✓			Open drains for Stormwater Discharge/ Sump for Hand Basin Water to discharge	
Comments							
Visual defects							
➤ Surface cracks are visible along the walk-way floor slabs							
➤ Guttering & Downpipe not fixed properly on brackets							
➤ Rotten Fascia Board							
➤ Bi-Folding Timber Partition on Classroom has loose fitting and causing falling off from its fittings.

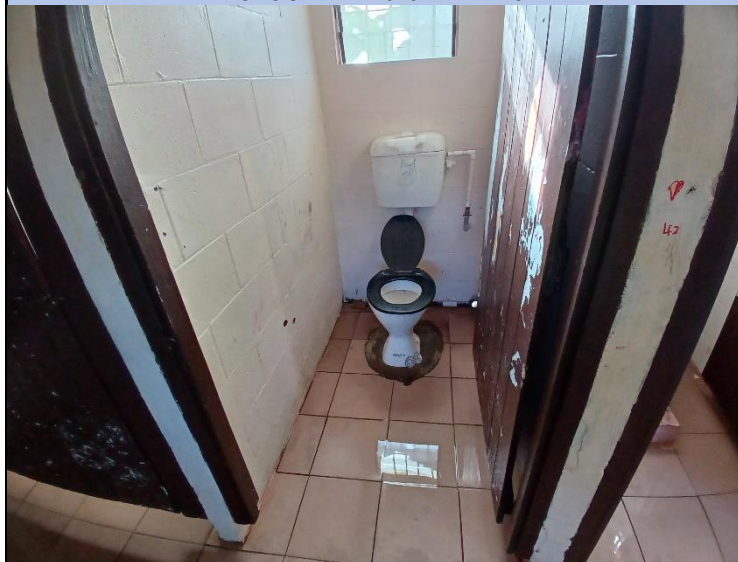
PHOTOGRAPH NO 7 - TOILETS

- The toilets are required to be maintained and clean on a regular basis.
- The shower area is required to be maintained and clean on a regular basis.
- There was only 1 small menstrual sanitary bin provided in the girls' toilet.

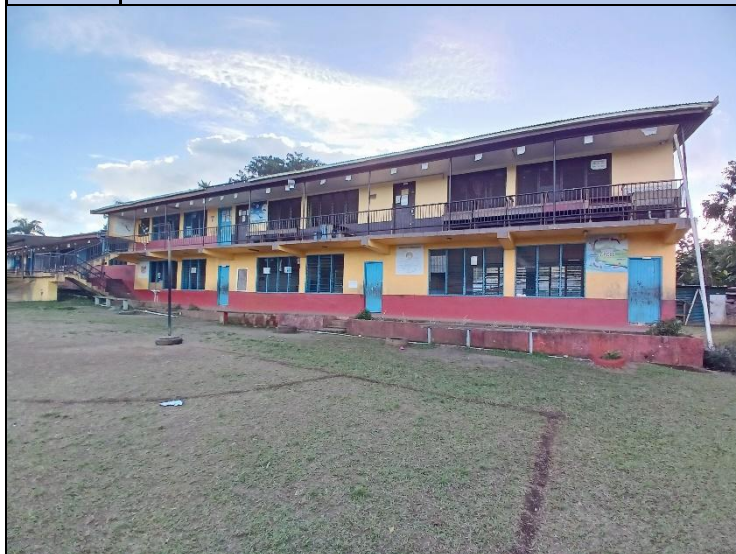
PHOTOGRAPH No. 1: FRONT

11	Services – electricity			✓		EFL	
12	Services – communication (internet)		✓			Wireless and LAN connection	
13	Drainage		✓			Open drains for Stormwater Discharge/ Sump for Hand Basin Water to discharge	
<u>Comments</u>							
Visual defects							
➤ Surface cracks are visible along the walk-way floor slabs							
➤ Guttering & Downpipe not fixed properly on brackets							
➤ Rotten Fascia Board							
➤ Handrails installed along the stairs display signs of corrosion.
