INFRASTRUCTURE ASSESSMENT AUDIT FOR SUVA – NAUSORI URBAN SCHOOLS

DRAIBA PRIMARY SCHOOL (REG 2324)

SUMMARY REPORT

INFRASTRUCTURE ASSESSMENT FOR SUVA DRAIBA PRIMARY SCHOOL (2324)
SITE INSPECTION REPORT

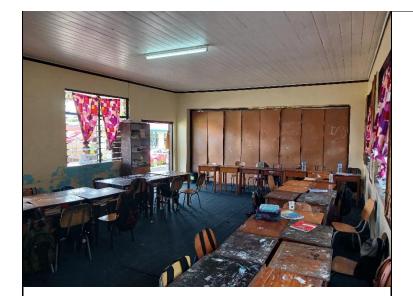
PHOTOGRAPH No. 5: INTERIOR

• There were no toilet bays for the building.

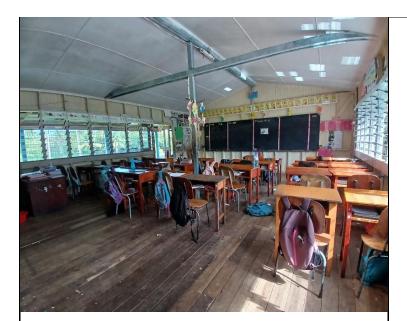
PHOTOGRAPH No. 5: INTERIOR	PHOTOGRAPH No. 6: ROOF SPACE		
There were no toilet bays for the building.	No taps available		
PHOTOGRAPH NO 7 - TOILETS	PHOTOGRAPH NO 8 - TAPS

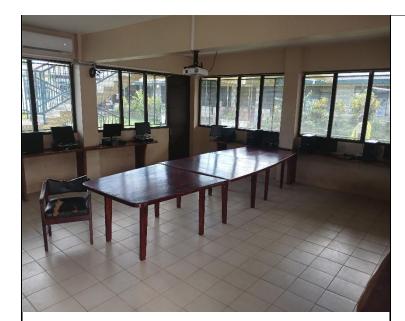
PHOTOGRAPH No. 5: INTERIOR	PHOTOGRAPH No. 6: ROOF SPACE
There were no toilet bays for the building.	No taps available
PHOTOGRAPH NO 7 - TOILETS	PHOTOGRAPH NO 8 - TAPS

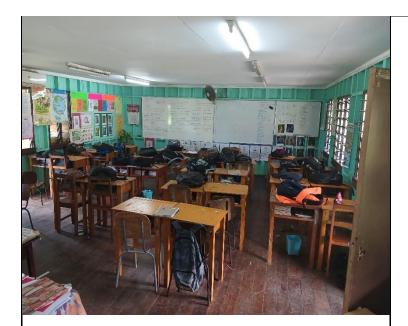
PHOTOGRAPH No. 5: INTERIOR	PHOTOGRAPH No. 6: ROOF SPACE
There were no toilet bays for the building.	No taps available.
PHOTOGRAPH NO 7 - TOILETS	PHOTOGRAPH NO 8 - TAPS

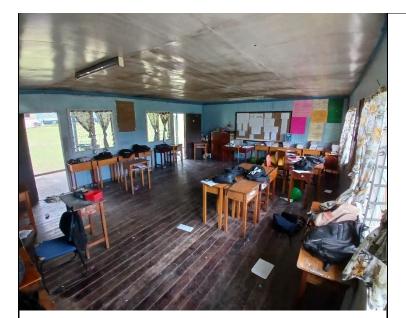
PHOTOGRAPH No. 5: INTERIOR

• There were no toilet bays for the building.
