INFRASTRUCTURE ASSESSMENT AUDIT FOR SUVA – NAUSORI URBAN SCHOOLS

GOSPEL PRIMARY SCHOOL (REG 2354)

SUMMARY REPORT

INFRASTRUCTURE REPORT

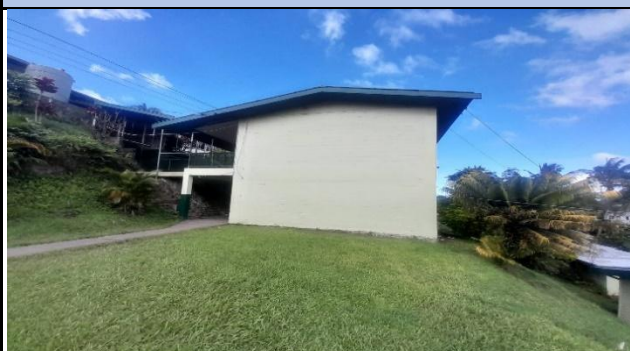
PHOTOGRAPH No. 4: RIGHT SIDE (LA1)

- Visual defects: Mild rust present on corrugated roof cladding and will require application of weather shielding paint.
- Other observations: No female WASH facilities. The girls will have to use the WASH facilities at Girls Toilet Upper Primary. Recommend new female ablution block at Land Available (LA 1).

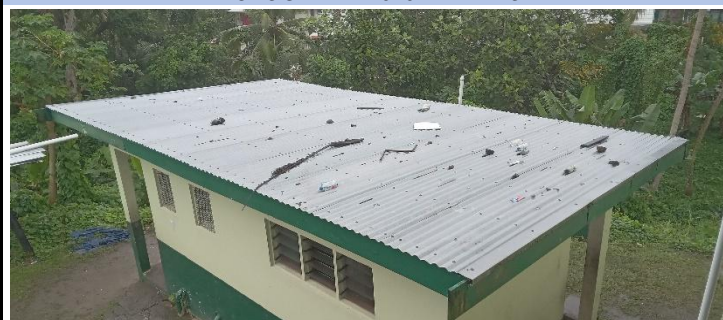
PHOTOGRAPH NO 7 – MALE TOILET BLOCK (WC1)

9	Students to WASH ratio	Toilet taps: 4		Male (106 Students)	26:1	Female	N/A
Comments <ul style="list-style-type: none">A standalone toilet block (WC1) built in the year 2001 for male students and teachers only. Constructed out of concrete block walls on ground concrete floor slab with a lean-to timber roof structure and corrugated roof cladding.Loose PVC gutters. Regular maintenance required.Refer to drone imagery on page 7 for location of building, toilets, walkway, etc.

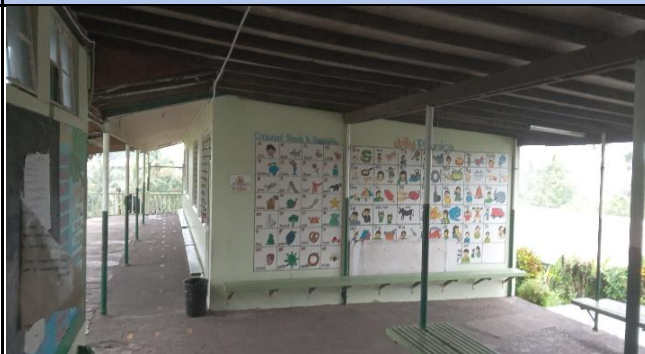
PHOTOGRAPH No. 4: RIGHT SIDE (FOYER F1)

- Concrete staircase (WW3) leading to the Upper Primary classroom buildings is not in accordance to the building code standard and NBC. Recommend upgrading the existing concrete staircase to existing foyer (F1).

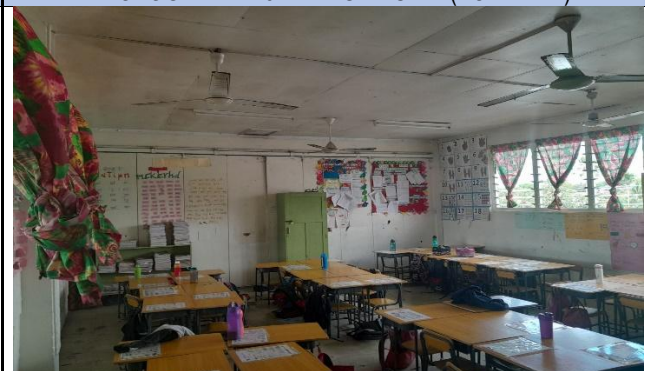
PHOTOGRAPH No. 6: ROOF SPACE

- Dimensions of each classroom Length(m) = 8.1, Width(m)= 6.5, Height(m) = 2.5
- Visual defects: Mild rust present on corrugated roof cladding and will require application of weather shielding paint.

- Some missing ceiling board in the classrooms and corridor to be replaced with new ones.
- Other observations: The girls use the WASH facilities at Girls Toilet Upper Primary (WC3)
