INFRASTRUCTURE ASSESSMENT AUDIT FOR SUVA – NAUSORI URBAN SCHOOLS

HOLY TRINITY ANGLICAN SCHOOL (REG 2332)

SUMMARY REPORT

SITE INSPECTION REPORT

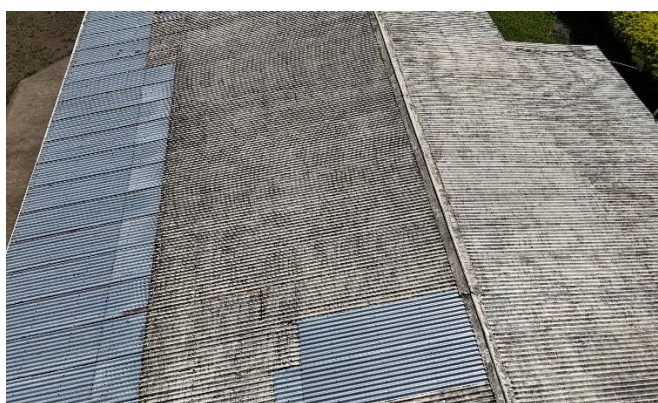
PHOTOGRAPH No. 8: ROOF CLADDING PHOTOGRAPH

Figure 8: B1 ROOF CLADDING.

- Removing and replacing existing roof cladding and screws with new.
- Wire brush and recoat column base and bolts. Should it be extensively corroded, it is required to remove and replace the existing base and bolts.
- Washbasins in the toilets at B1 are to be fixed.
- Should the timber flooring and wall frame consist of damaged timber and corroded steel fixtures, it is recommended to remove and replace with new.
- Remove and replace damaged gutters and fascia boards.
- Remove existing paint and recoat with new on the handrails.
- Fix all damaged cubicle door locks and doors that cannot be closed.
- Patch up and fix damaged partition cubicle walls in all the toilets.
- Remove and replace damaged toilet pans.

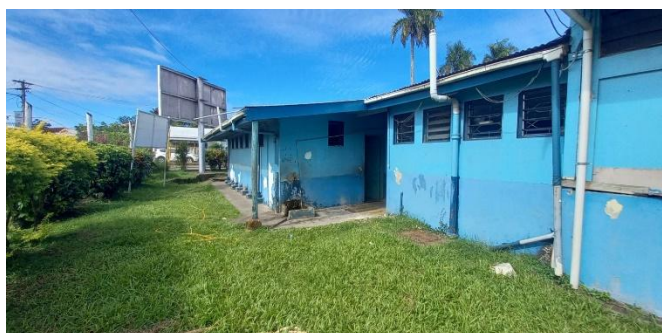
PHOTOGRAPH No. 9: ENTRANCE TO THE STUDENT MALE TOILET

5	Toilet Bays – accessible			✓			Toilets are not accessible.
6	Entry to toilet building		✓		Timber		The entrances to the toilets are unsafe. The entrance to the male's toilet is at the back of the building, out of view from the school, while the female's toilet entrance is situated next to the office toilet, also out of sight.
7	Exit to toilet building		✓		Timber		Additionally, the toilets are visible to the public, with the school gate just a few meters away. This lack of visibility makes it difficult for the school to monitor who enters, particularly in these areas that are not easily seen.
8	Menstrual Hygiene facilities		✓			1	Only 1 bin provided at the female toilet.

Figure 9: B1 ENTRANCE TO MALES TOILET.

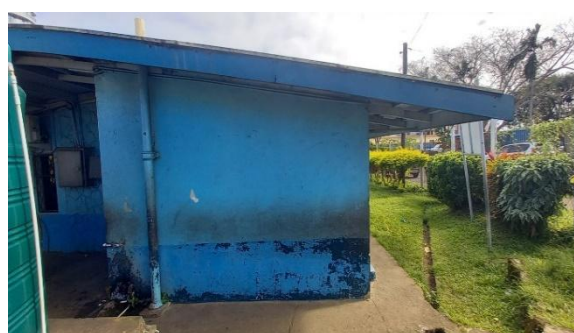
PHOTOGRAPH No. 10: ENTRANCE TO THE STUDENT FEMALE TOILET

Figure 10: B1 ENTRANCE TO THE FEMALE TOILET.

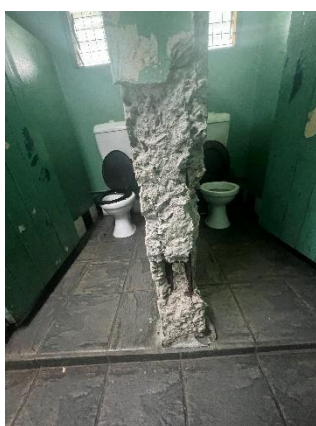
PHOTOGRAPH No. 11: B1 STUDENT MALE TOILET

3	Toilet Partition between boys and girls.		✓		Concrete		There are damages at the male's toilet.
4	Shower bay		✓		Concrete	1	1 shower per toilet, however is not working.

Figure 13: B1 STUDENT MALE TOILET.

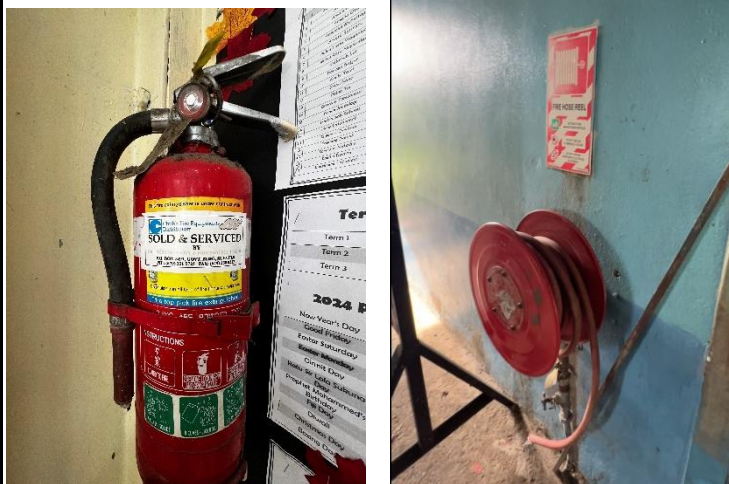
PHOTOGRAPH No. 15: B1 FIRE EXTINGUISHER AND FIRE HOSE REEL.

- Ventilation is adequate in all rooms.
- Missing louvre blades.
- There is only 1 way entrance per room.
- Fire extinguishers present in each room that is outdated.
- There is a fire reel hose at the end of the building. No fire hydrant in the school.
- There is no car park allocated within the school premises. All cars are parked outside along the road.
- The canteen present in Building 1 consists of a fire extinguisher and cooling blanket.

Figure 17: B1 FIRE EXTINGUISHER AND FIRE HOSE REEL.

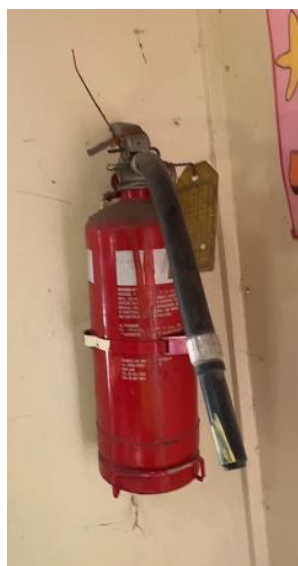
PHOTOGRAPH No. 7: FIRE EXTINGUISHER

- The sick bay is also included in the classroom with a bed provided.
- The ventilation was good in the building, however, there were missing louvre blades.
- There was a fire extinguisher present in the classroom but was outdated.
- There are gaps in the floor sheeting and damage to the window timber seal.

Figure 25: B2 FIRE EXTINGUISHER

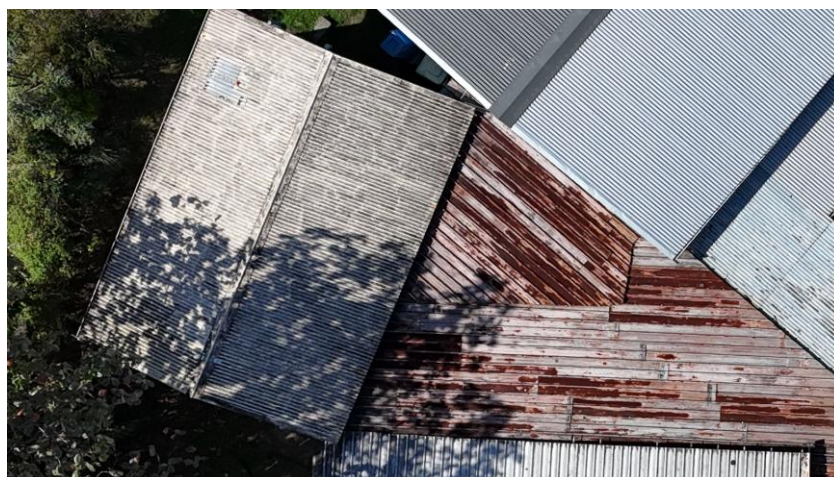
PHOTOGRAPH No. 11: B2 ROOF CLADDING

Building Index		B2 : Ground Floor (GF): 1x Classroom and the Sick Bay.				Year built: TBC	
Type:	Single Story Timber Building					No. of Levels: 1	
Dimensions		Length (m): 6.74	Width (m): 4.75 (excluding walkways)			Height (m): 2.4	
Existing State of Building							
REF. No.	Building Component	Good ⁵	Fair ⁶	Poor ⁷	Structure Type ⁸	Comments	
1	Roof Lining		✓		Steel	CGI consisted of rust as well as the roof screws.	
2	Roof Structure	Concealed Upon Inspection				The gable roof was concealed upon inspection.	
3	Walls		✓		Timber	The timber wall frame was concealed upon inspection.	
4	Columns	N/A				There were no columns in the structure. However, the walkway consisted of steel posts that were corroded.	
5	Beams	Not Accessible.			Timber	Timber wall plates or beams could not be inspected.	
6	Floor		✓		Timber	The flooring was timber with timber bearers and joists. Only a portion of the timber flooring was inspected, however the steel fixtures require attention as it was rusted upon inspection.

Figure 29: B2 ROOF CLADDING

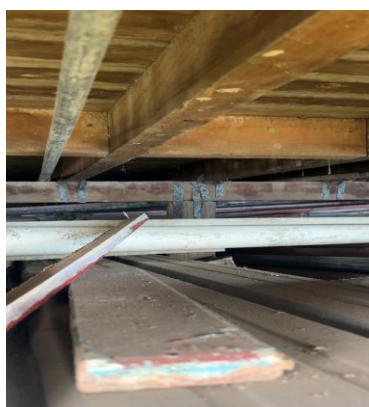
PHOTOGRAPH No. 7: FLOORING

Figure 36: B3 FLOORING

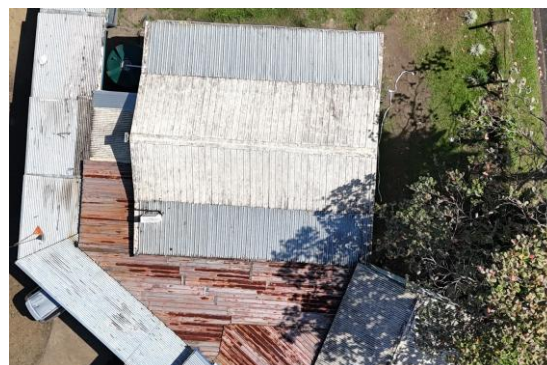
PHOTOGRAPH No. 8: ROOF CLADDING

Figure 37: B3 ROOF CLADDING

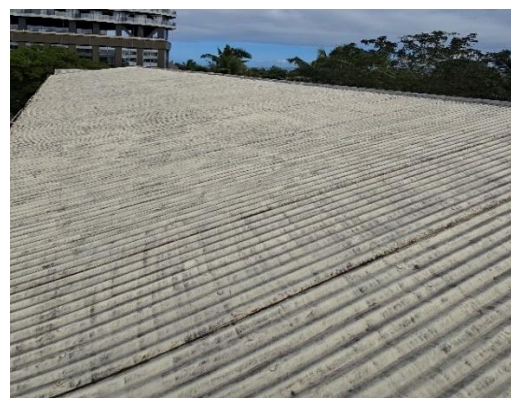
PHOTOGRAPH No. 8: ROOF CLADDING

Figure 47: B4 ROOF CLADDING
