INFRASTRUCTURE ASSESSMENT AUDIT FOR SUVA – NAUSORI URBAN SCHOOLS

JOHN WESLEY SCHOOL (REG 2369) SUMMARY REPORT

JOHN WESLEY SCHOOL (REG 2369) SITE INSPECTION REPORT

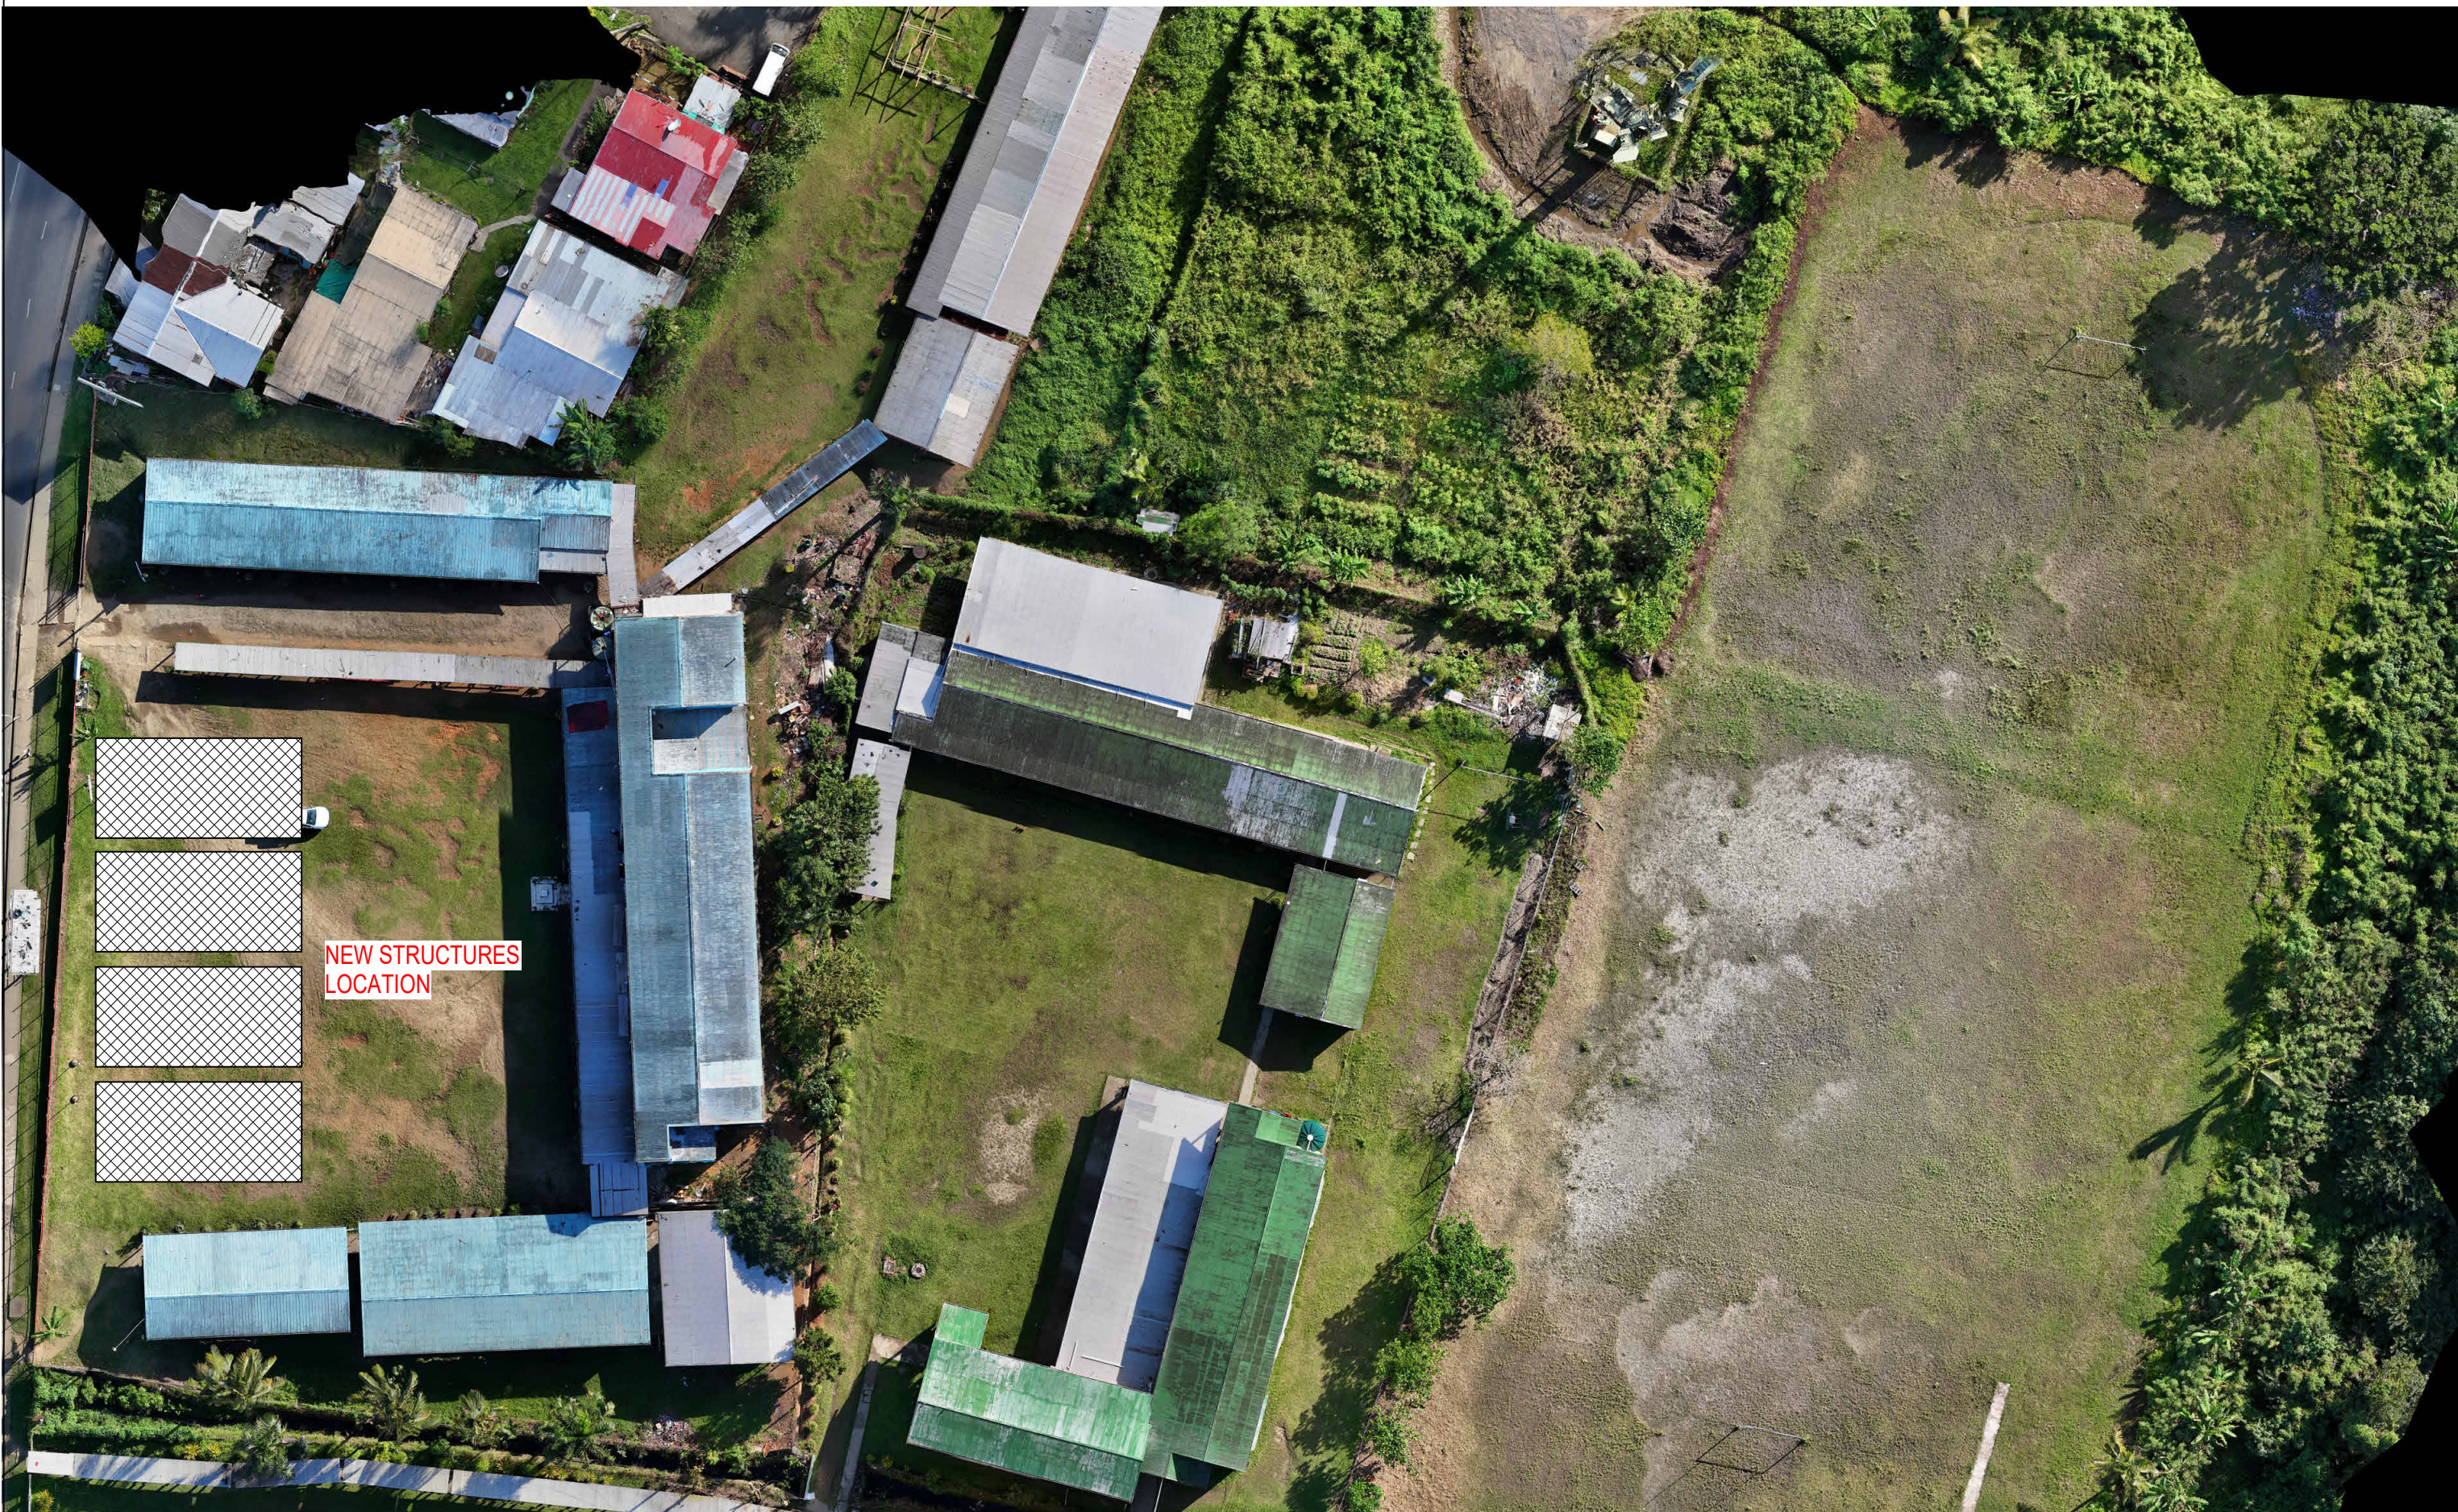
Appendix C – Land Available for Expansion

- **Land Availability:** There is sufficient land for additional blocks behind building B-D & along the roadside, the front car parking area.
- **NFA Compliance:** Compliant with NFA basic guidelines but does not have NFA certification.
