INFRASTRUCTURE ASSESSMENT AUDIT FOR SUVA – NAUSORI URBAN SCHOOLS

KALABU PRIMARY SCHOOL (1812)

SUMMARY REPORT

SITE INSPECTION REPORT

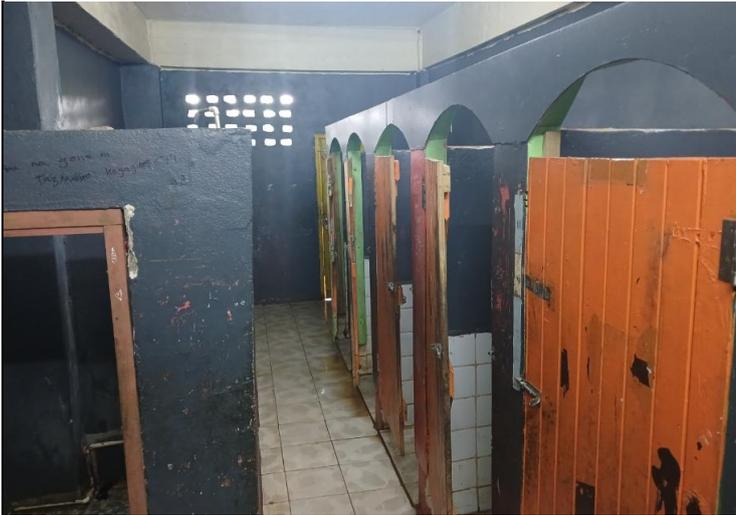
PHOTOGRAPH NO 7 - TOILETS

- The cubicle doors were damaged.
- Some toilet seat pans were missing.
- Rust was found on the door hinges and steel connectors of the PVC pipe outlets in the toilet system.
- The floor and walls had damaged and missing tiles.

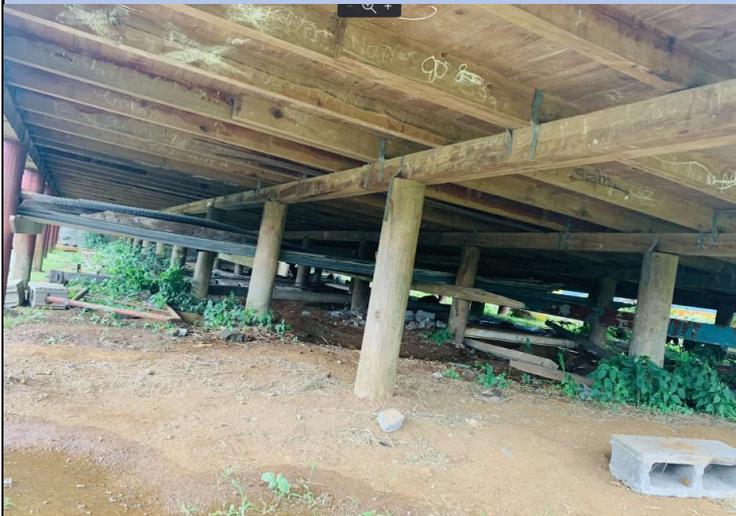
PHOTOGRAPH NO 7 – Timber Floor

| Building Index | | Block B | | | | | |
|---|---|---|---|---|---|---|---|
| 6 | Floor | | | ✓ | Timber | Deteriorating timber floor damaged at sections | |
| 8 | Walkway(s) | | ✓ | | Timber | Bend when walking indicating damaged missing floor joist and bearers, | |
