INFRASTRUCTURE ASSESSMENT AUDIT FOR SUVA – NAUSORI URBAN SCHOOL

NASINU GOSPEL PRIMARY SCHOOL (2398)

SUMMARY REPORT

NASINU GOSPEL PRIMARY SCHOOL (2398) SITE INSPECTION REPORT

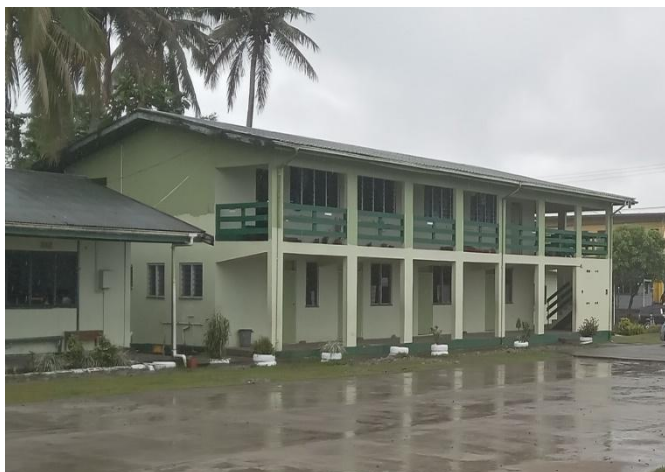
01. FRONT VIEW & STAIRS TO LEVEL 1 AT CANTEEN END.

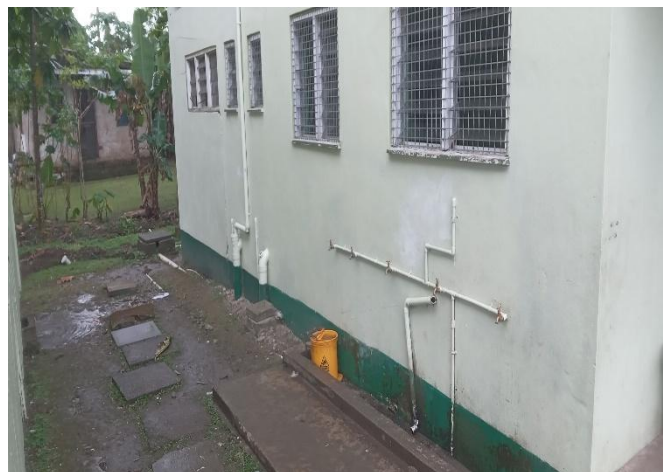
02. GENERAL USE TAPS ON THE SIDE WALL.

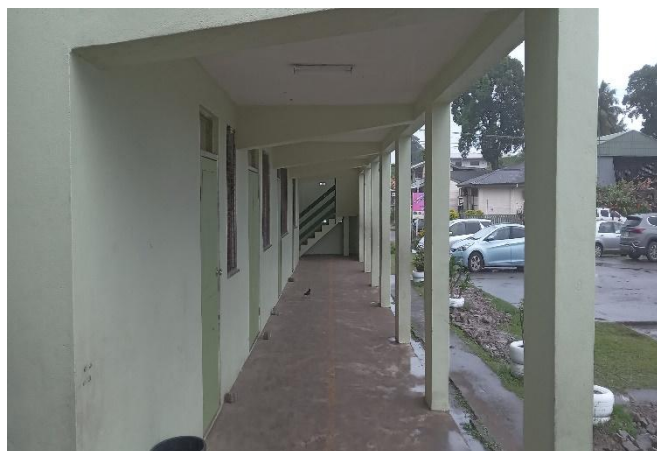
03. RIGID CONCRETE BEAMS & COLUMNS STRUCTURE.

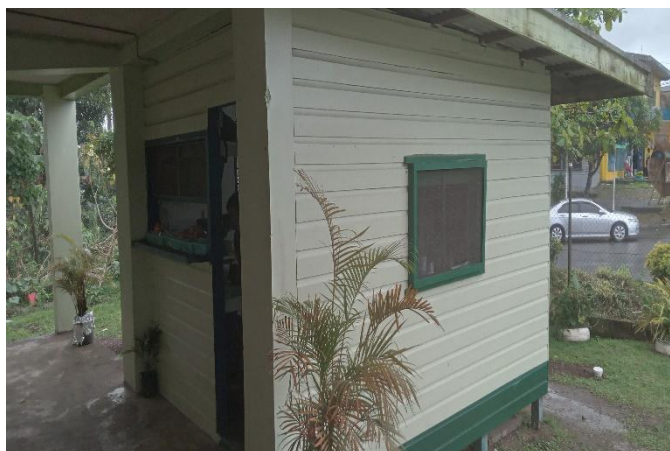
04. ATTACHED CANTEEN – TIMBER STRUCTURE.

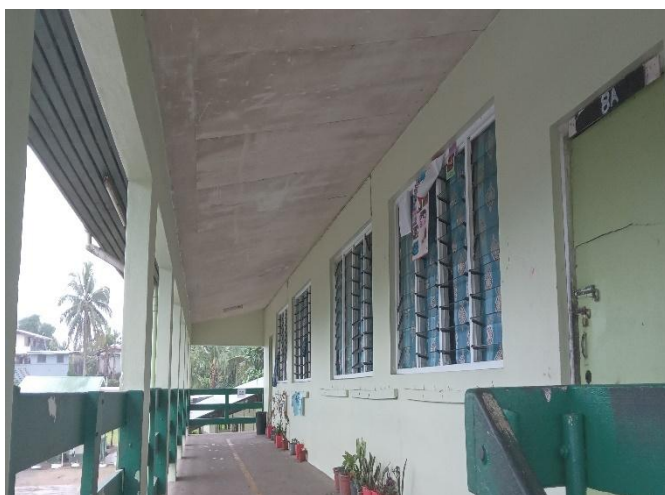
05. LEVEL 1 CORRIDOR WITH TIMBER RAILING.

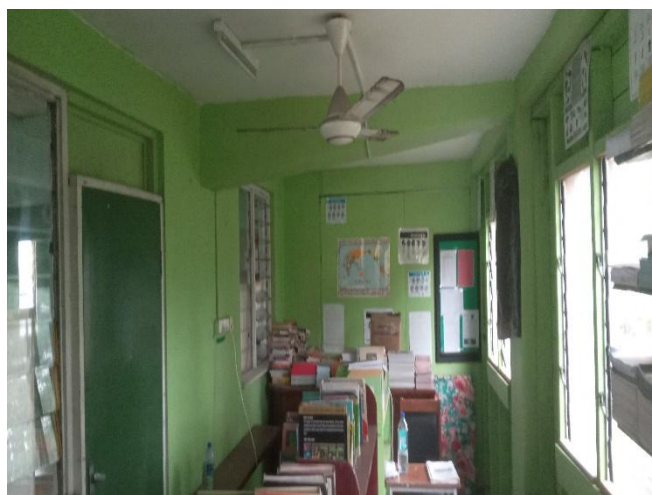
06. CONGESTED LIBRARY – TIMBER ENCLOSURE.

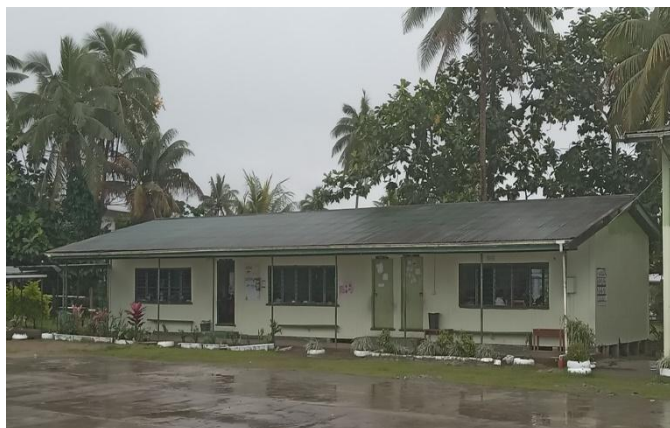
01. FRONT VIEW WITH EXIT ONTO HARDCOURT.

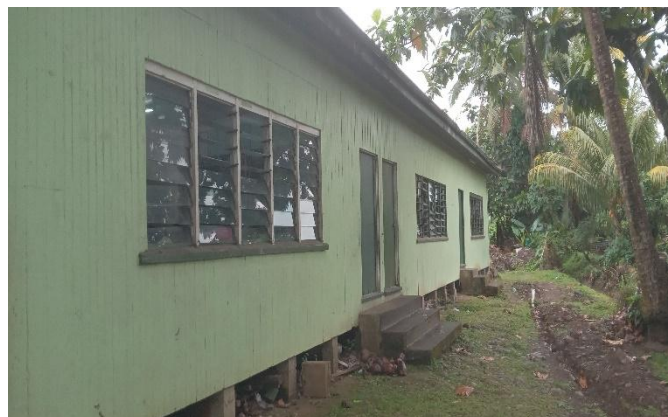
02. BACK VIEW WITH TREES ALONG BOUNDARY.

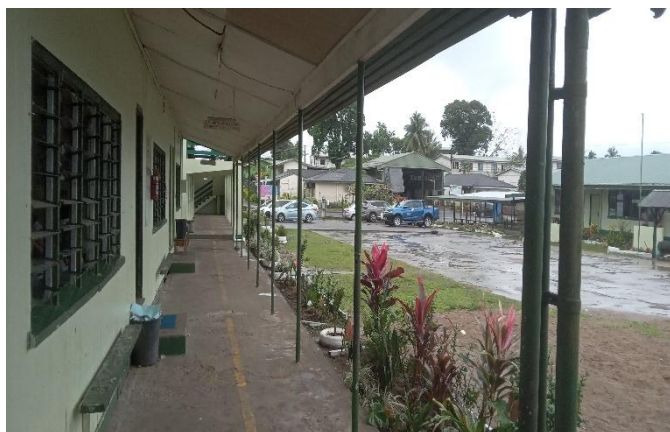
03. CORRIDOR WITH STEP UP INTO CLASSROOMS.

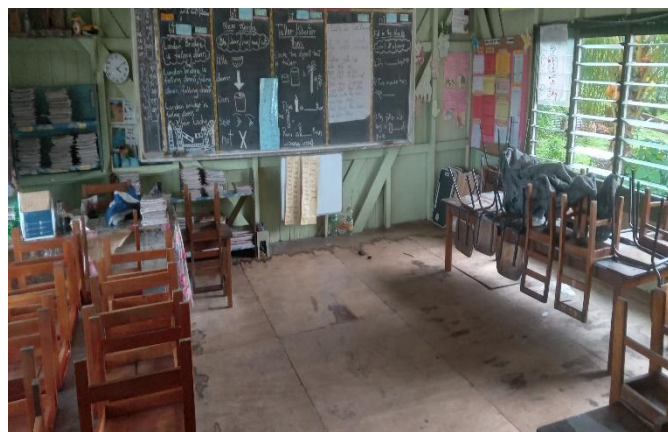
04. CLASSROOM FLOORING TYPICAL.

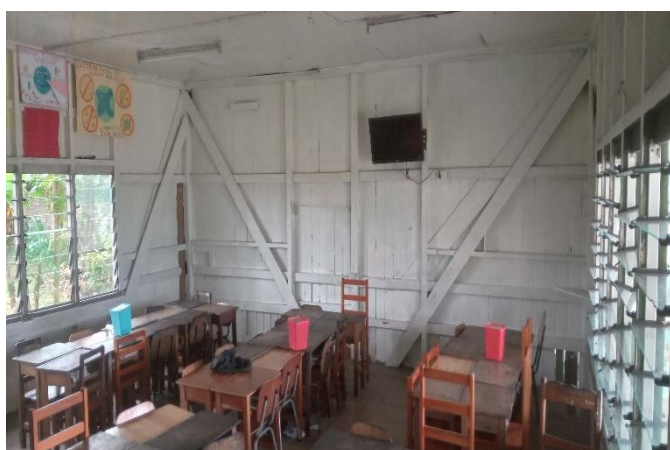
05. END & SIDE WALL TIMBER FRAME.

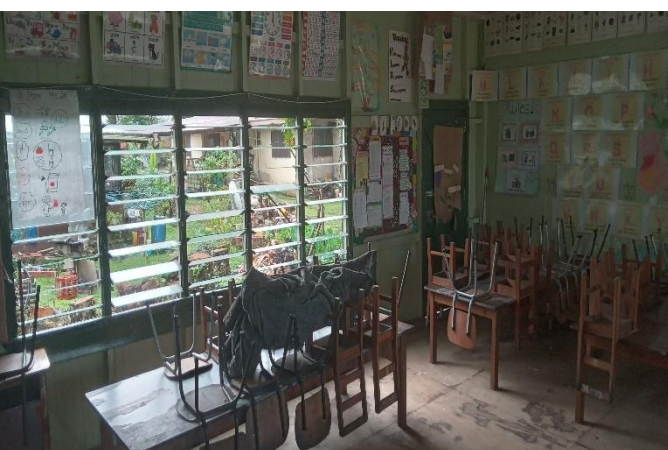
06. LOURVE GLASS WINODWS & SOLID DOORS.

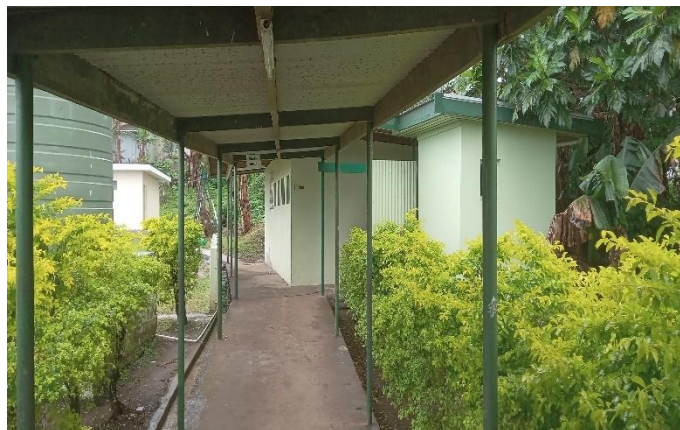
01. SHELTERED WALKWAY TO TOILET BLOCK.

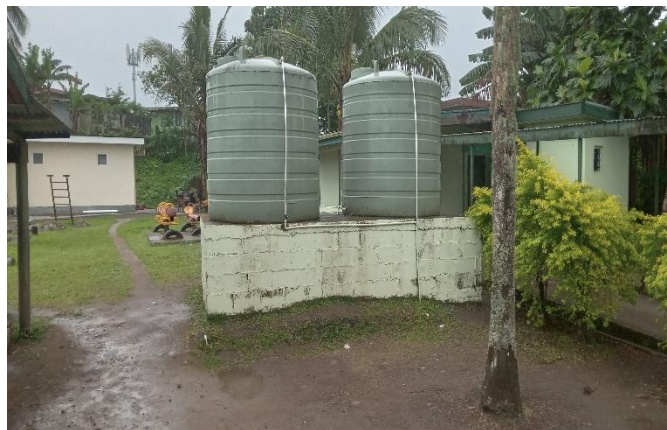
02. BACKUP SUPPLY TO HAND WASH POINT.

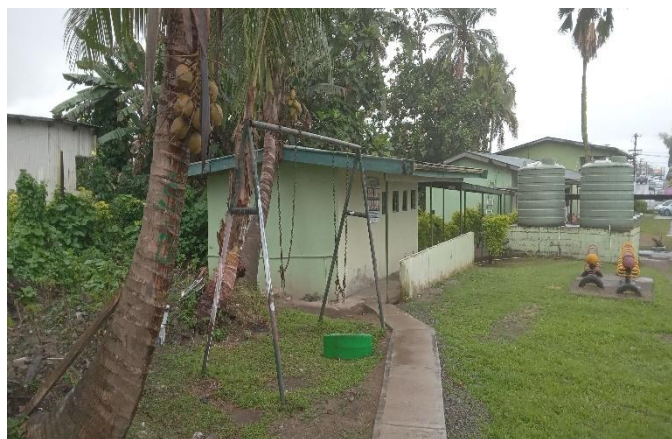
03. RAMP FROM ECE BLOCK TO TOILET BLOCK.

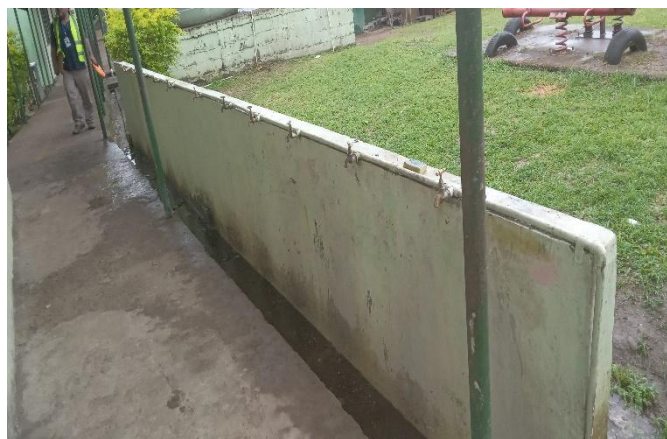
04. TAPS ALONG TOILET BLOCK CORRIDOR.

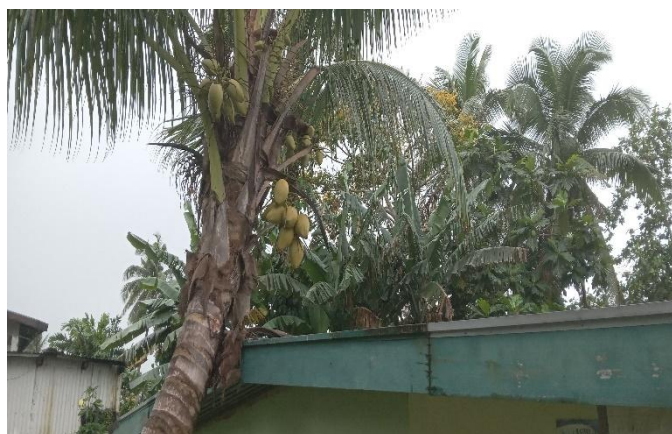
05. TREE OVER ROOF.

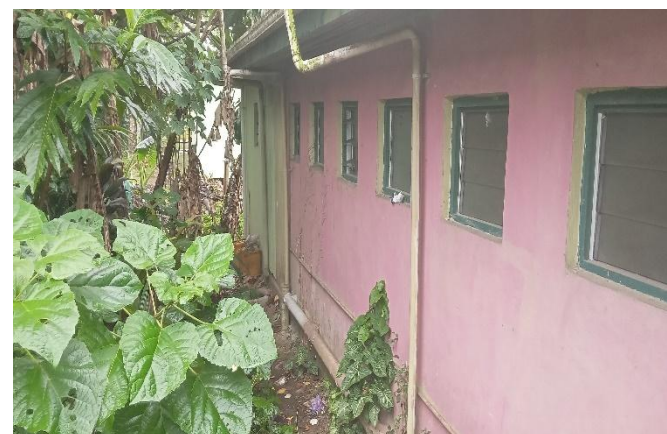
06. BACK VIEW, WINDOW FOR EACH CUBICLE.

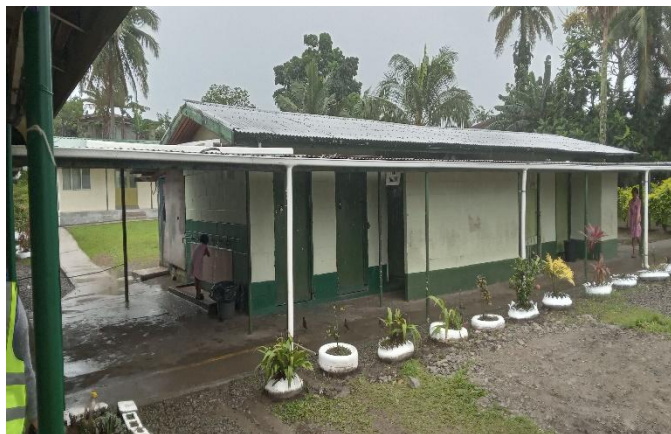
01. FRONT VIEW, SHELTERED WALKWAY TO TOILET.

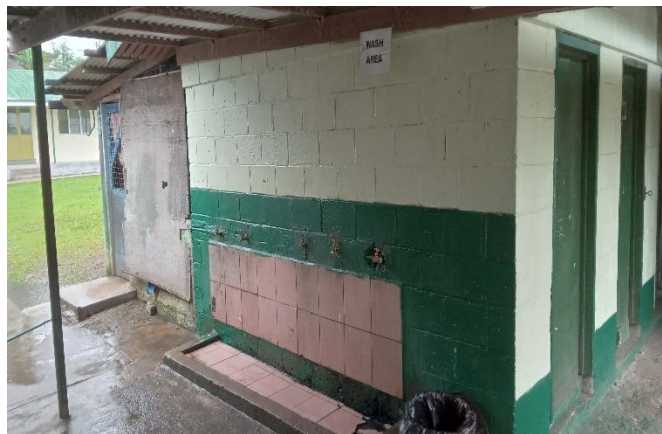
02. GENERAL USE TAPS ON THE SIDE WALL.

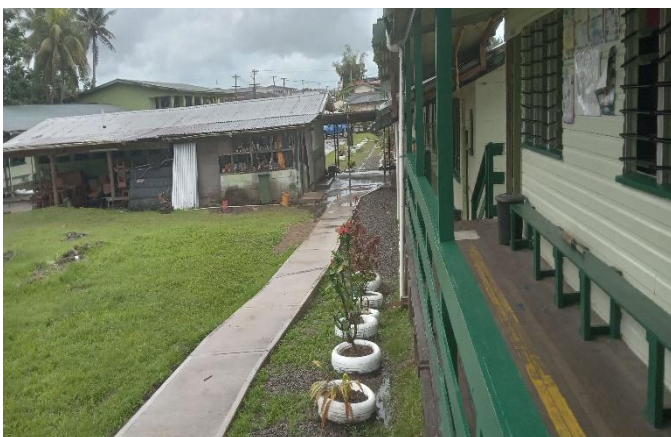
03. RAMP FROM ECE BLOCK TO TOILET.

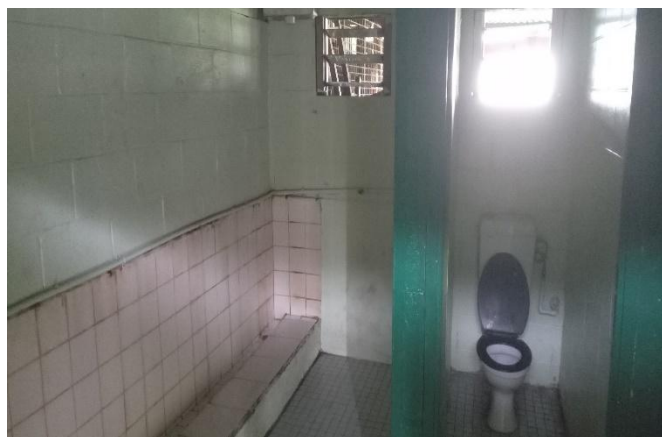
- There is no ceiling for Boys toilet with exposed electrical wiring.
- There is one broken water closet for Boys toilet that will need to be replaced.

04. URINAL AND WATER CLOSET TYPICAL.

- Block 04 main roof and timber fascia to receive new paint and gutters to be cleaned.
- Block 04 broken toilet to be replaced.
- Block 04 ceiling to be provided. All wiring for light fixtures to be concealed.

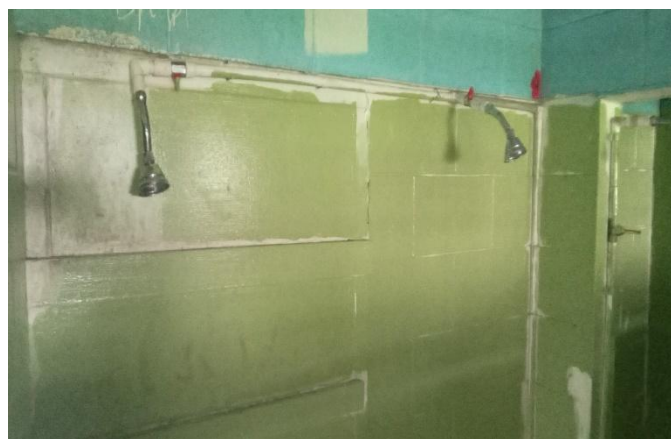
05. OPEN SHOWERS.

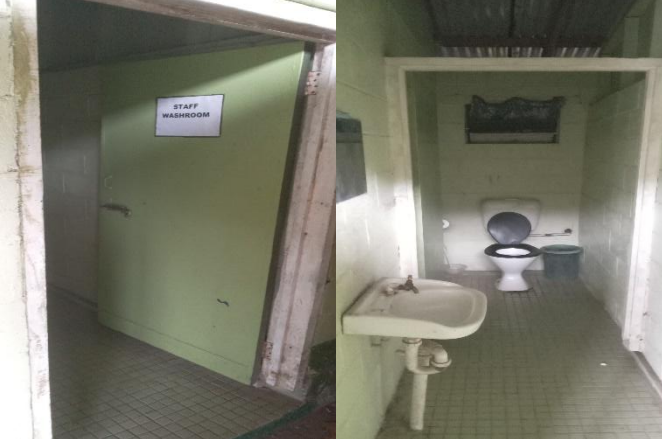
06. STAFF TOILET LAYOUT.

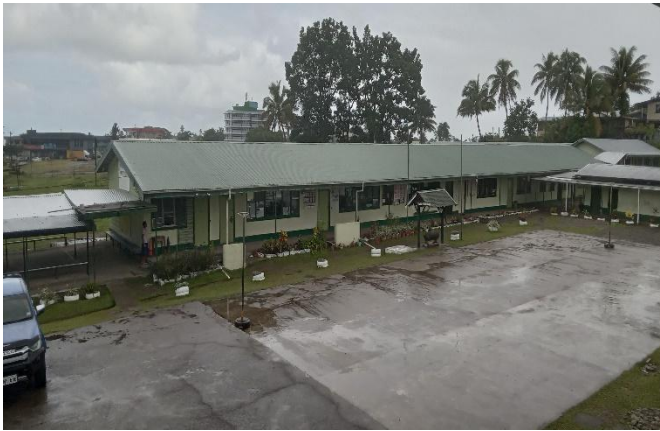
01. FRONT VIEW WITH SHELTERED WALKWAY.

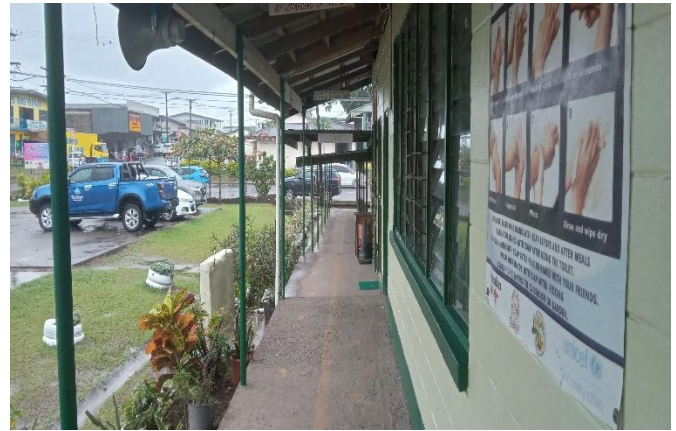
02. CORRIDOR WITH NO CEILING.

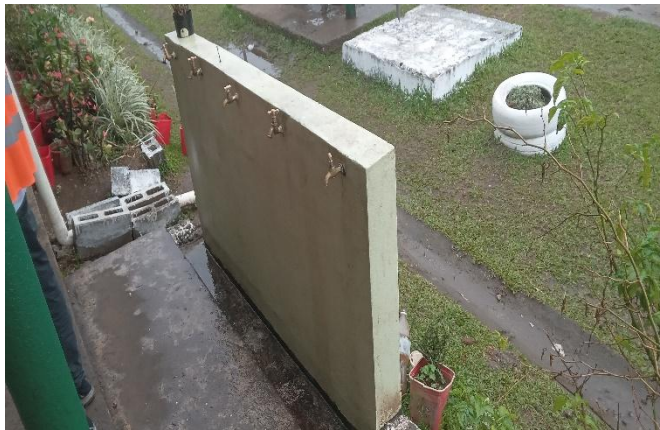
03. GENERAL USE TAPS ALONG CORRIDOR.

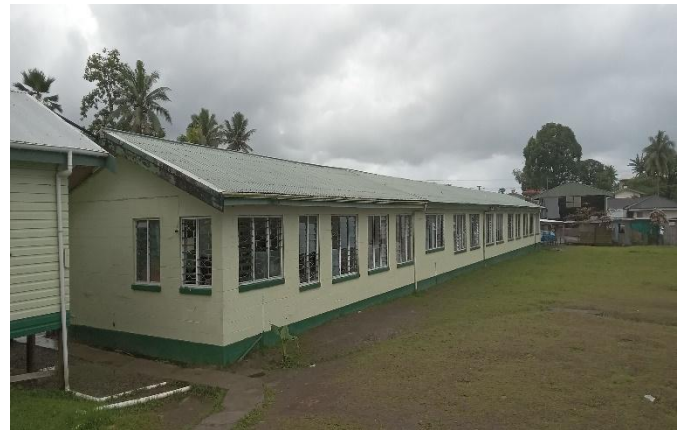
04. BACK VIEW WITH WINDOWS TO EVERY ROOM..

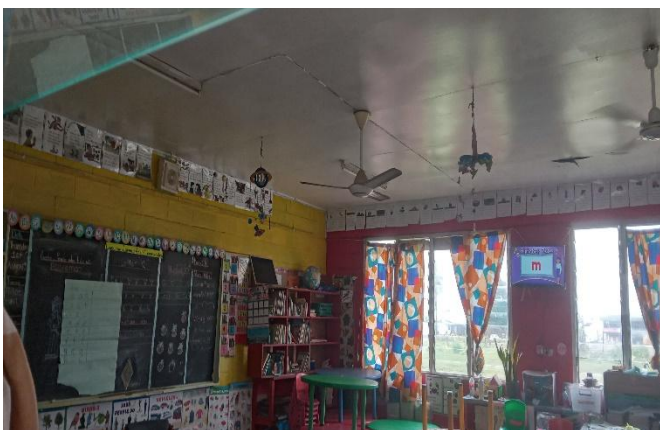
05. KINDI ROOM WITH CEILING FANS, PA SOUND, LIGHTS & WIRING.

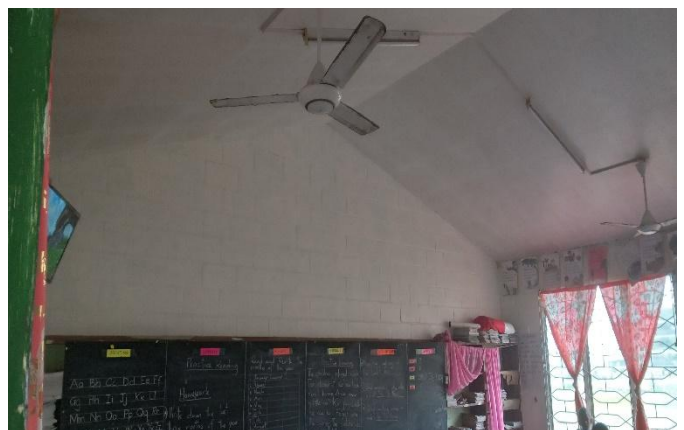
06. YEAR 201 WITH PARTITION BLOCK WALL.

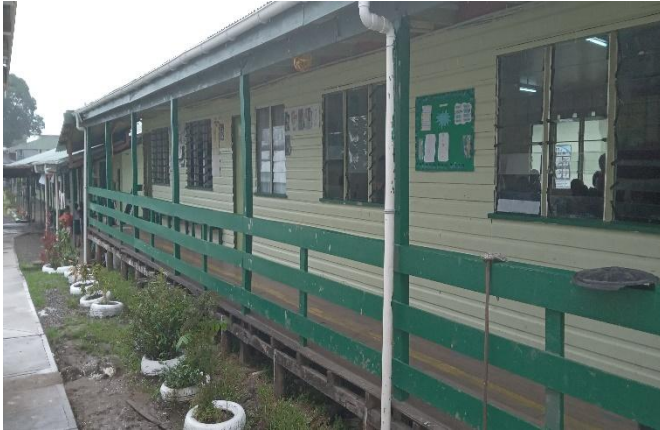
01. FRONT VIEW WITH STORM DOWN PIPES.

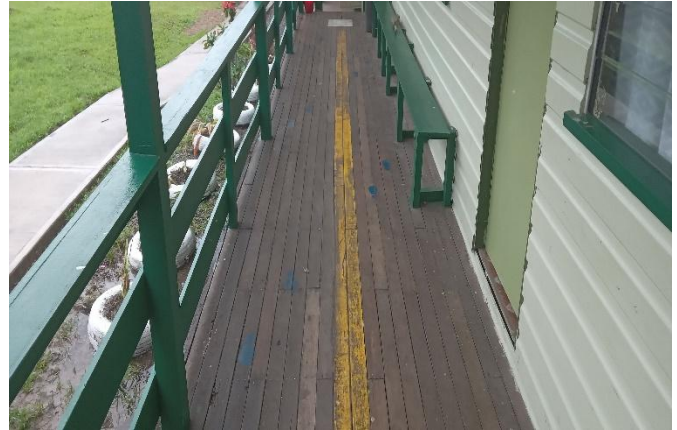
02. CORRIDOR WITH RAILING.

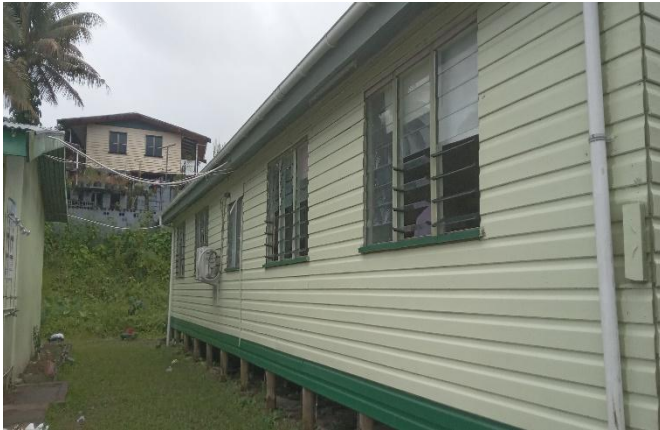
03. BACK VIEW WITH WINDOWS TO EACH ROOM.

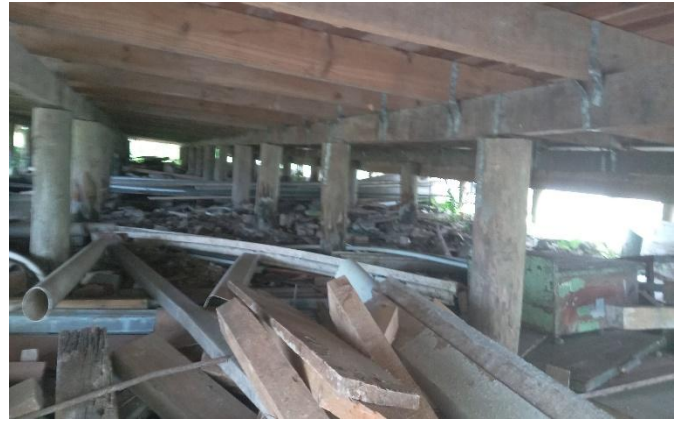
04. TIMBER SUB FLOOR FRAMING & TIE DOWNS.

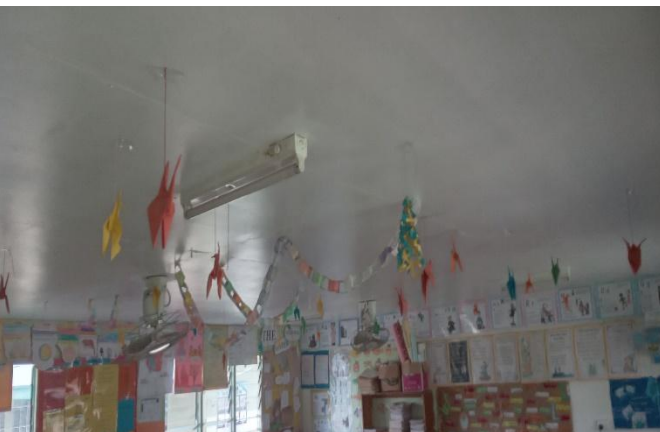
05. YEAR 401 FLAT CEILING, FANS & LIGHT FIXTURES.

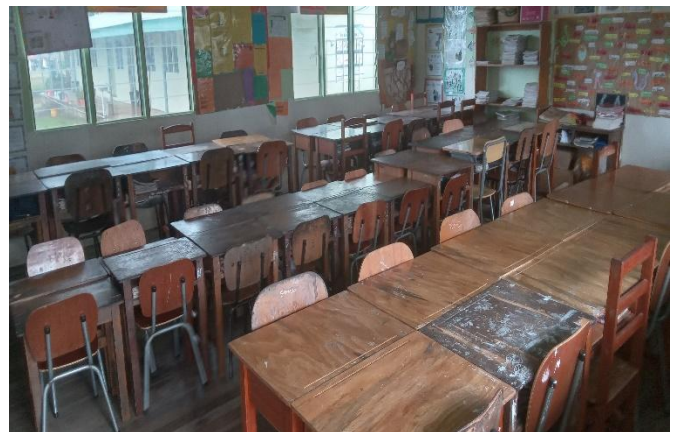
06. TYPICAL ARRANGEMENT DESKS & CHAIRS.

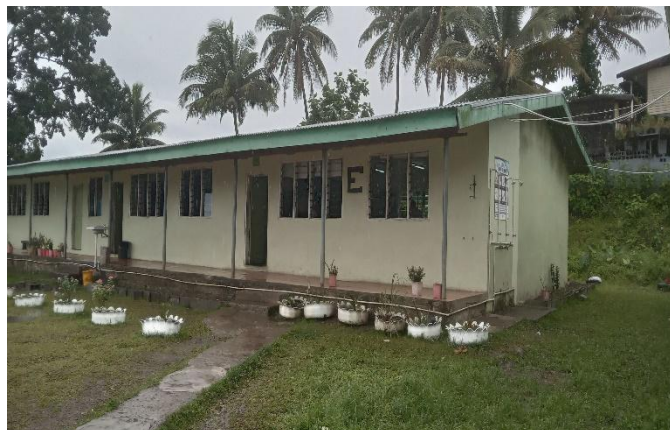
01. FRONT VIEW WITH SHOWER HEADS ON THE SIDE.

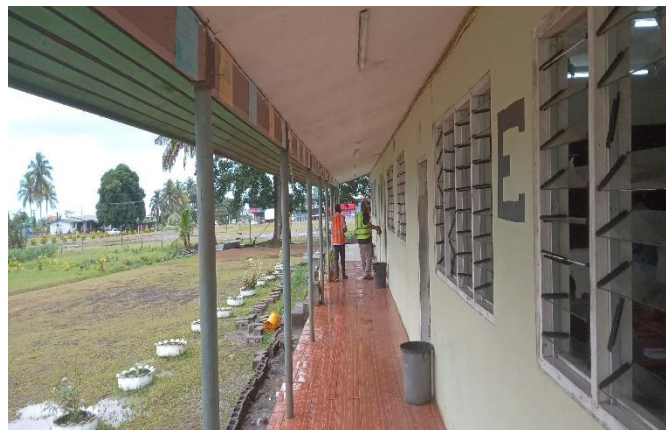
02. TILED CORRIDOR WITH LIGHT FIXTURES.

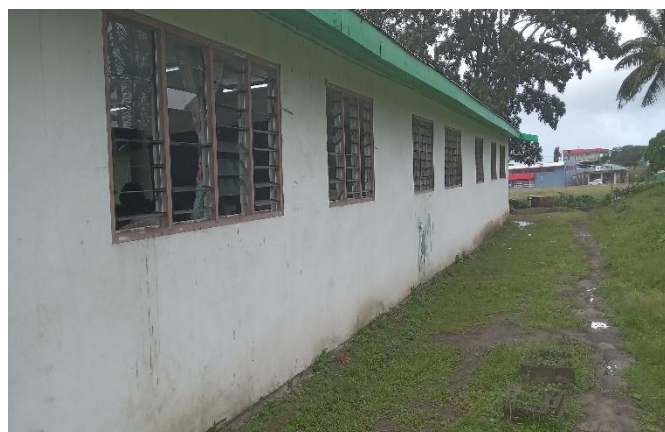
03. BACK VIEW WITH MISSING STORM DRAIN SYSTEM.

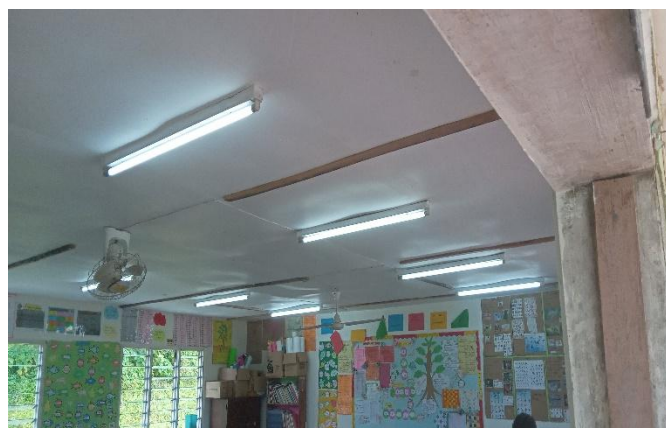
04. TYPICAL LIGHTING & FAN PROVISION FOR EACH ROOM.

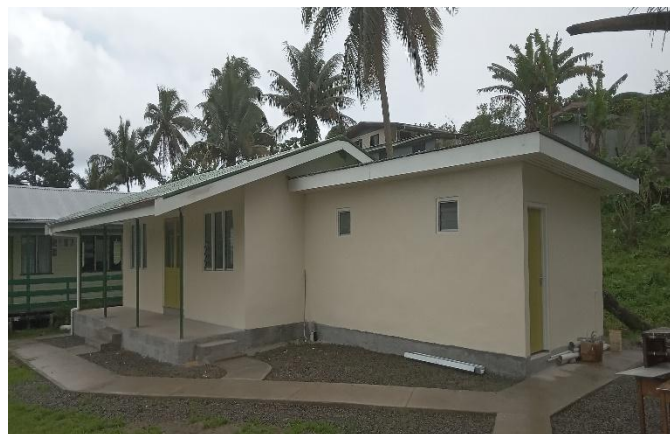
01. NEW ECE BLOCK WITH WASHROOM.

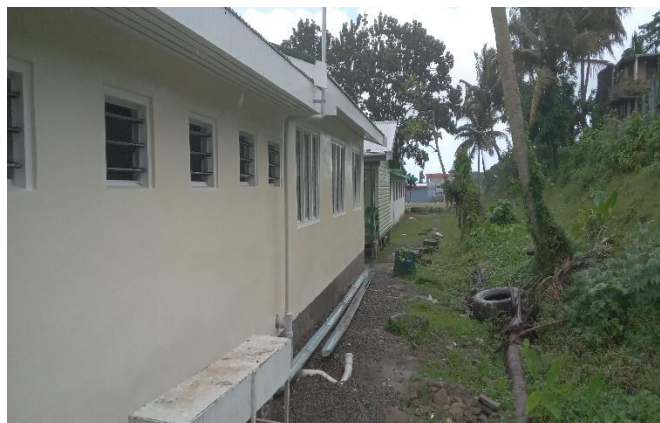
02. ROOF WORKS IN PROGRESS.

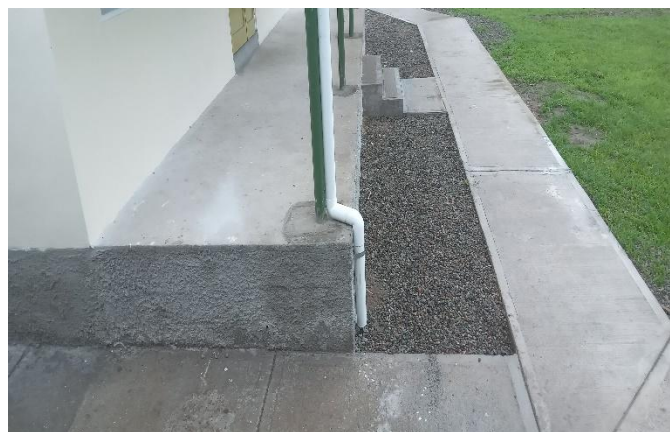
03. DRAINAGE WORKS INCOMPLETE.

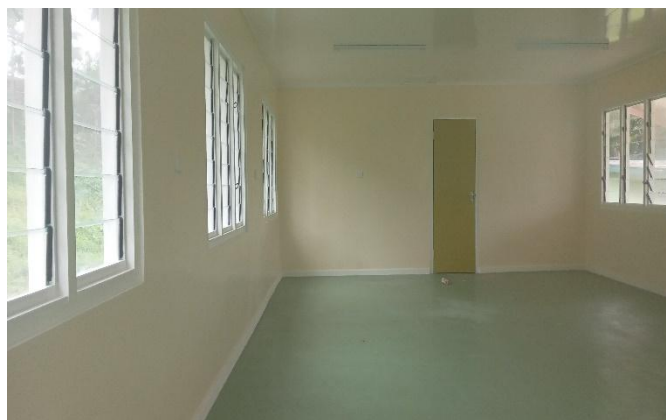
04. PAINTED ROOM FLOOR, NEW LIGHT FIXTURES.

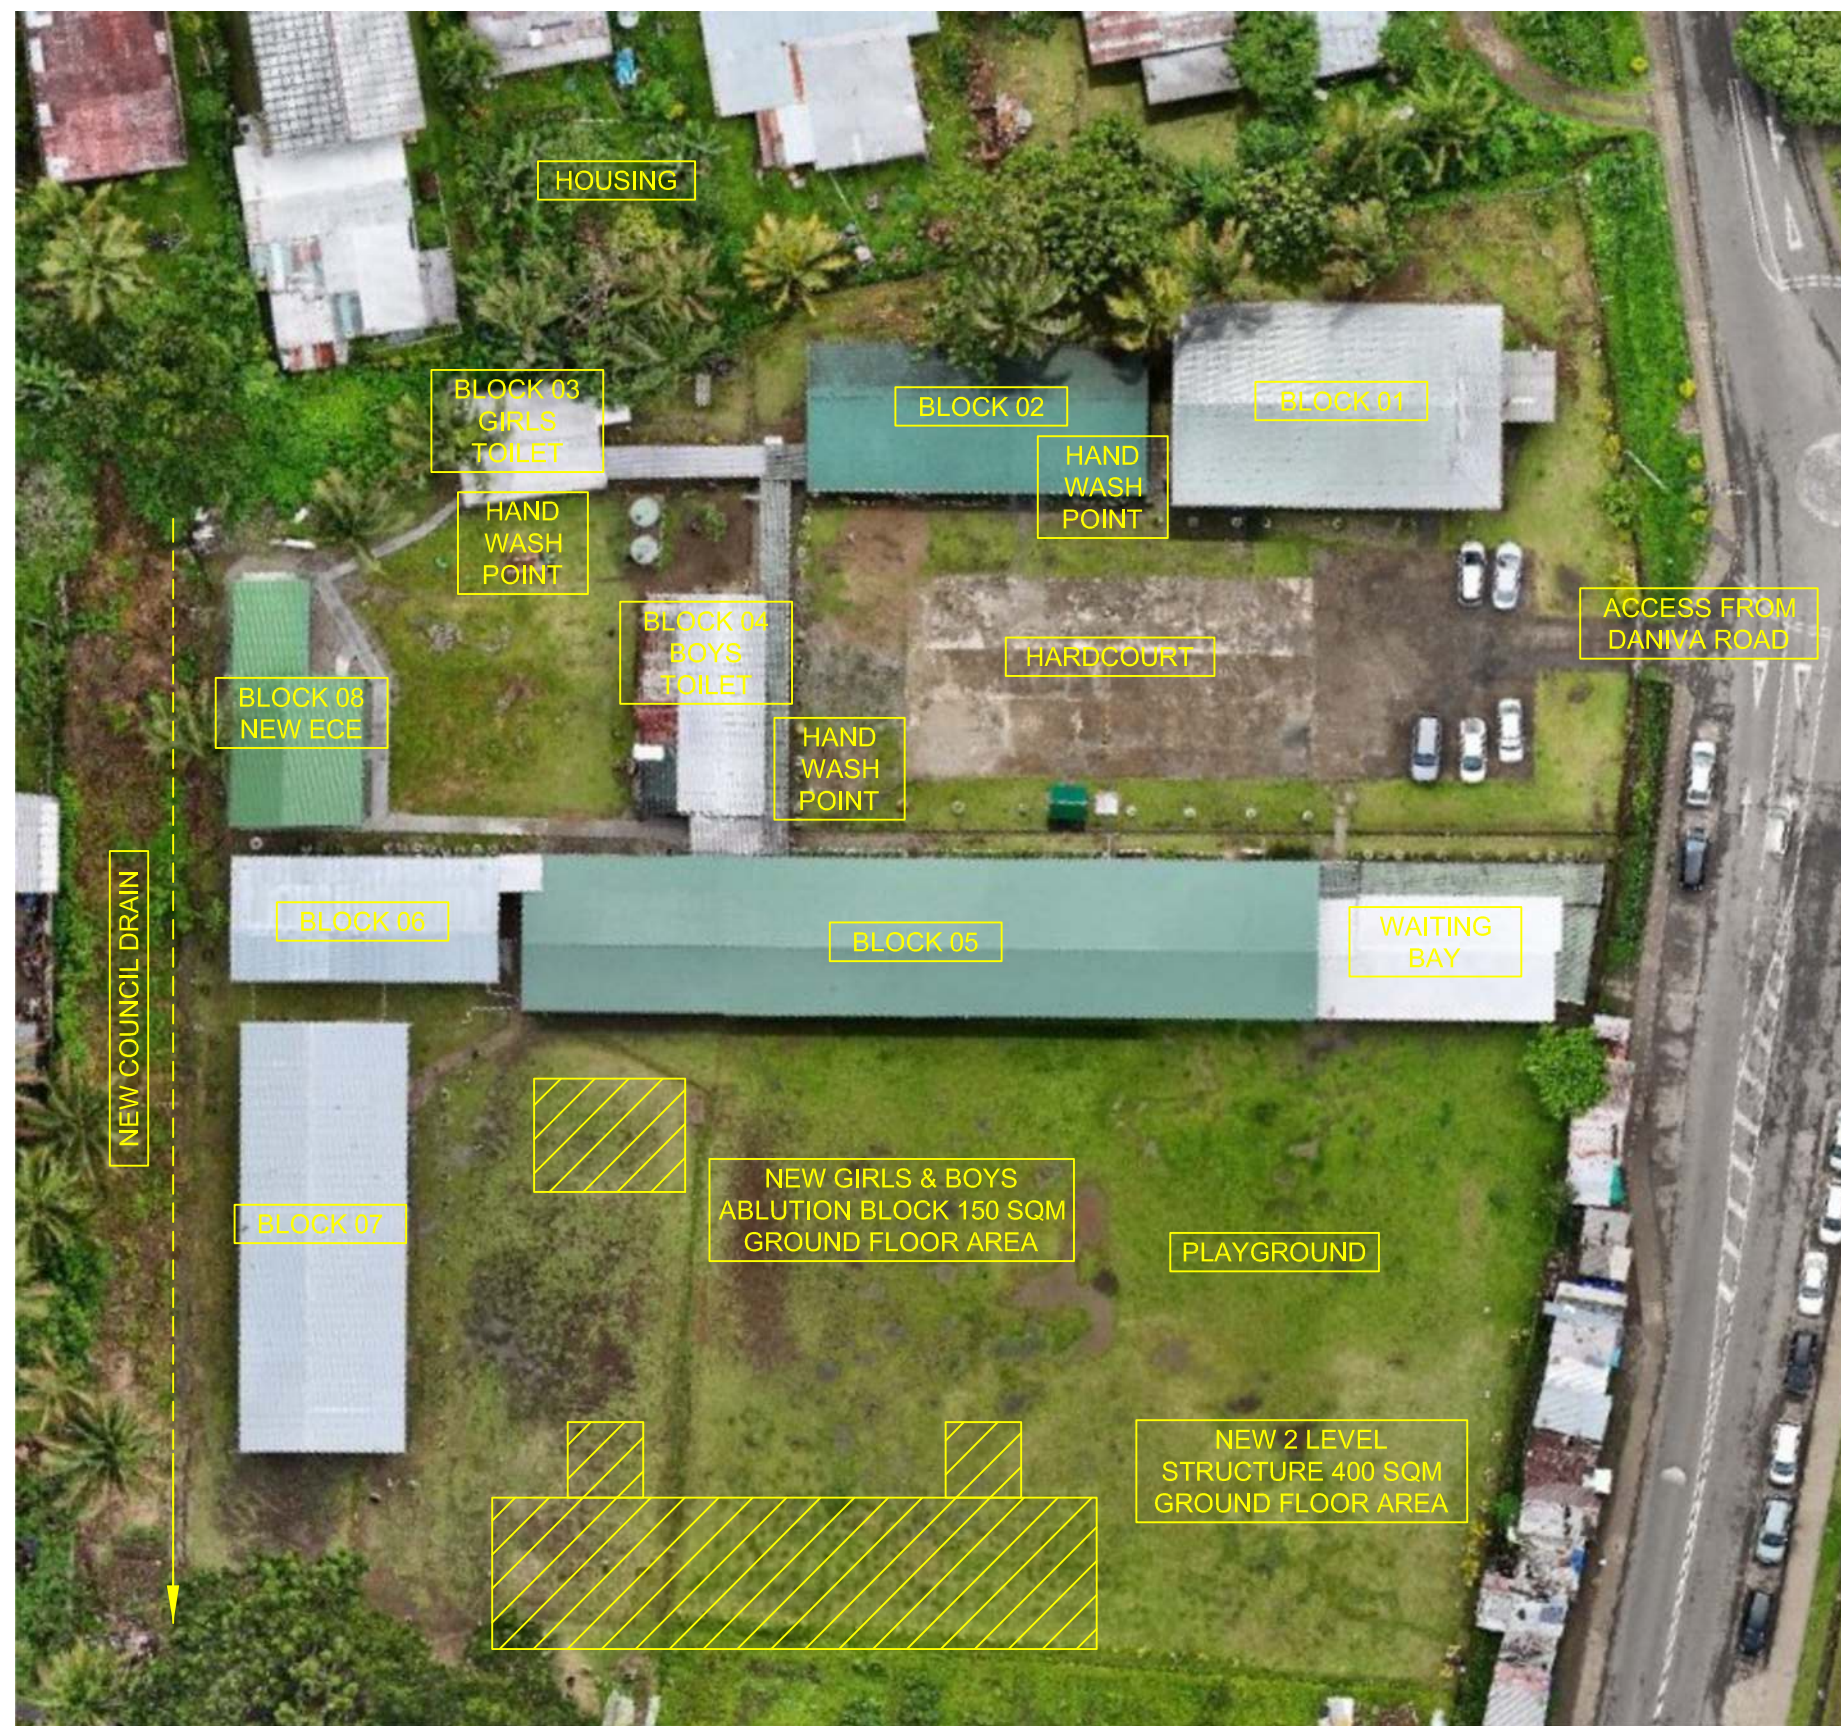
Appendix C – Land Available for Expansion

BLOCK 02 TIMBER STRUCTURE MAY BE REQUIRED TO BE DEMOLISHED AS THE SUB FLOOR STRUCTURE HAS STARTED TO FAIL.

NEW TWO LEVEL STRUCTURE TO CONSIST OF 4no 10m BY 8m CLASSROOM FOR TOP FLOOR AND 4no. 10m BY 8m CLASSROOM FOR GROUND FLOOR. TWO STAIRCASE.

NEW ABLUTION BLOCK TO HAVE 14no. WATER CLOSETS, 4no. SHOWER CUBICLES, 4no. TAPS, WASH TUB FOR GIRLS TOILET AND BOYS TO HAVE 6no. WATER CLOSETS, 4no. SHOWER CUBICLES, 4no. TAPS, 1no. URINAL.
