INFRASTRUCTURE ASSESSMENT AUDIT FOR SUVA – NAUSORI URBAN SCHOOLS

AOG PRIMARY (2335)

SUMMARY REPORT

ASSEMBLIES OF GOD PRIMARY SCHOOL (REG 2335) SITE INSPECTION REPORT

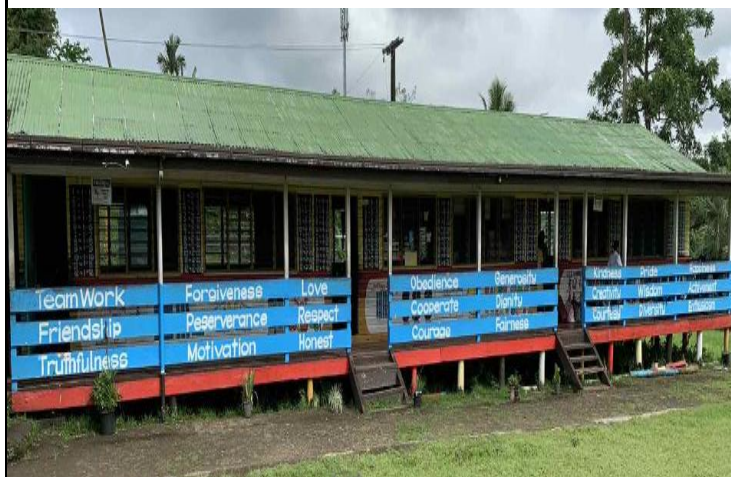
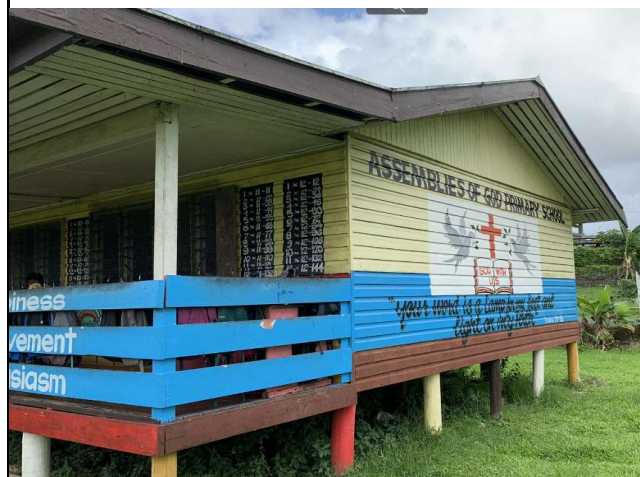
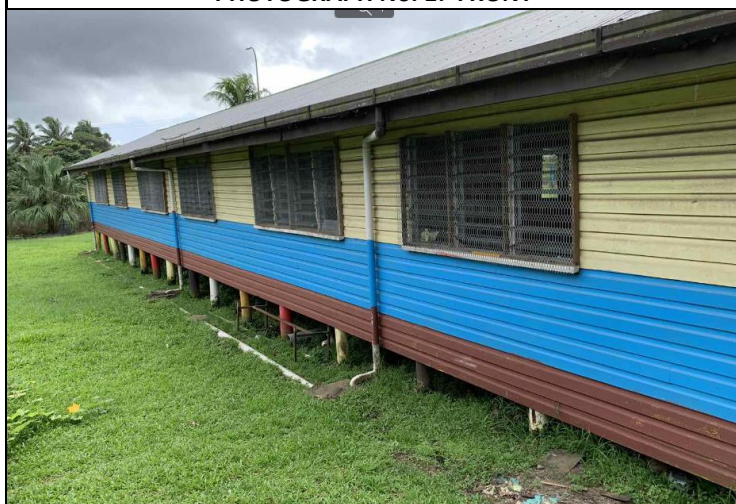
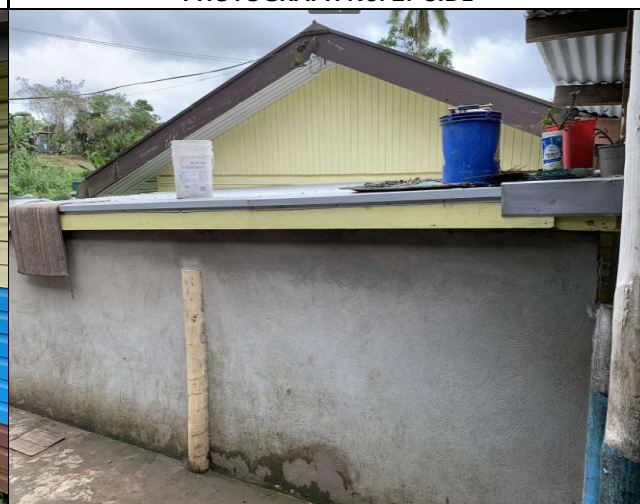
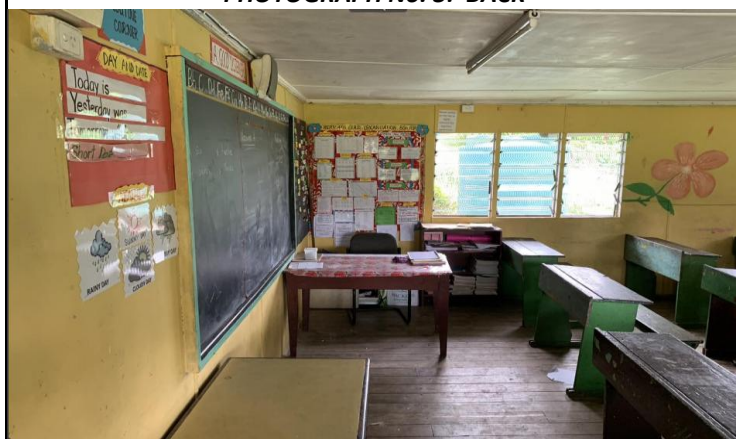
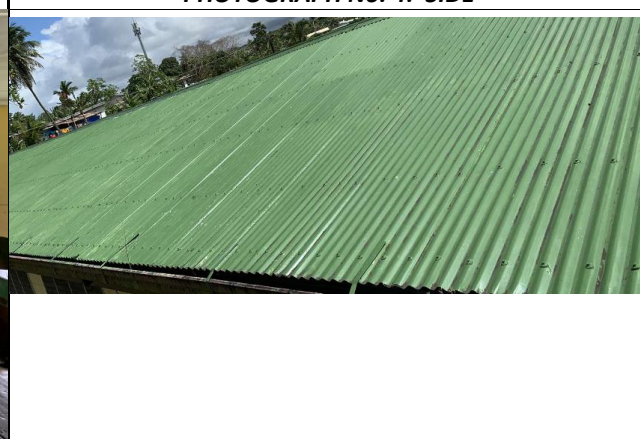
Client:	TETRA TECH INTERNATIONAL DEVELOPMENT (PTY) LTD	School Name:	ASSEMBLIES OF GOD PRIMARY
Project:	INFRASTRUCTURE PLAN FOR SUVA – NAUSORI URBAN SCHOOL.	Building Index:	C

Building Index		Block C			Year built:.....Age:.....		
Type:	Single storey timber building with gable roof. Consists of: ➤ Ground Floor – 3x classrooms 1x Special Room and 1x teacher’s washroom.						No. of Levels:1
Dimensions		Length (m): 25.35		Width (m): 9.54		Height (m): 2.6m	
Existing State of Building							
REF. No.	Building Component	Good ¹	Fair ²	Poor ³	Structure Type ⁴	Comments	
1	Roof Lining			✓	Corrugated Roofing iron	Rusted at some sections.	
2	Roof Structure			✓	Timber	Structure was inaccessible due to absence of manhole	
3	Walls			✓	Timber	Partially damaged on the exterior	
4	Columns			✓	Timber	Damaged timber column	
5	Beams			✓	Timber	Column to column beam deteriorating	
6	Floor			✓	Timber	Deteriorating timber floor damaged at sections	
7	Handrails			✓	Timber	Damaged and paint peeling off have wear and tear and warps.	
8	Walkway(s)		✓		Timber	Bend when walking indicating damaged missing floor joist and bearers,

- **Visual defects**
- Ramp provided for disability student from year 2023/2022.
- Roof corrugated iron rust at some sections.
- Guttering missing, dented and have algae build up.
- Downpipes have algae build up with only half length in dimensions
- Timber walkway panels have wear and tear, wraps/bends when walking indicating damaged/missing floor joist and bearer.
- Electrical light, fans and power switches are missing, damaged and exposed.
- No drainage was observed. Water from guttering flowing down to earth.
- The paints on the walls were peeled off in some sections.
- Window shutters are present in almost all windows in administration section used for safety purpose only. Not compliant to cyclone certification. Some sections showed corrosion.
- Fascia board shows water damage (rotting) at some sections.

- Walkway ceiling plyboard showed tear and water damage.
- Adequate ventilation is in all levels of the building.
- Staff Toilets are nearly maintained with adequate soap, handbasin and bins.

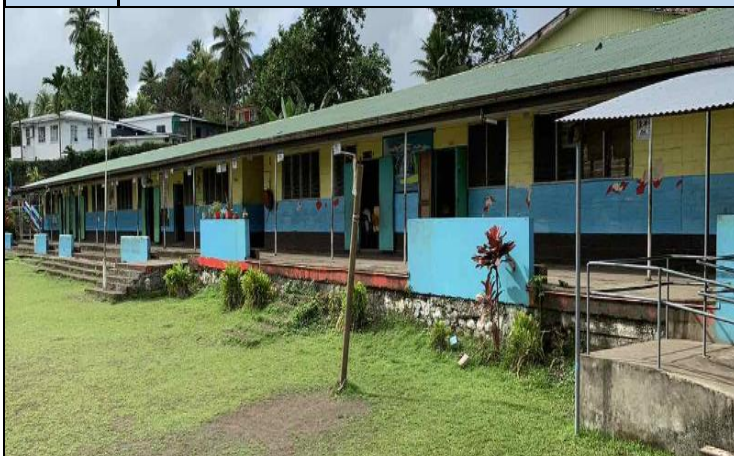
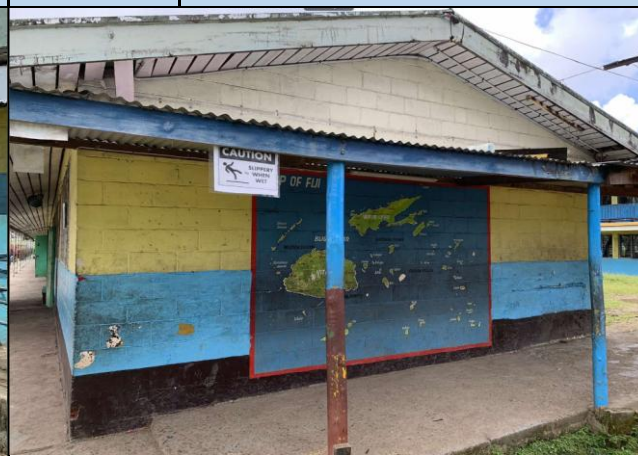
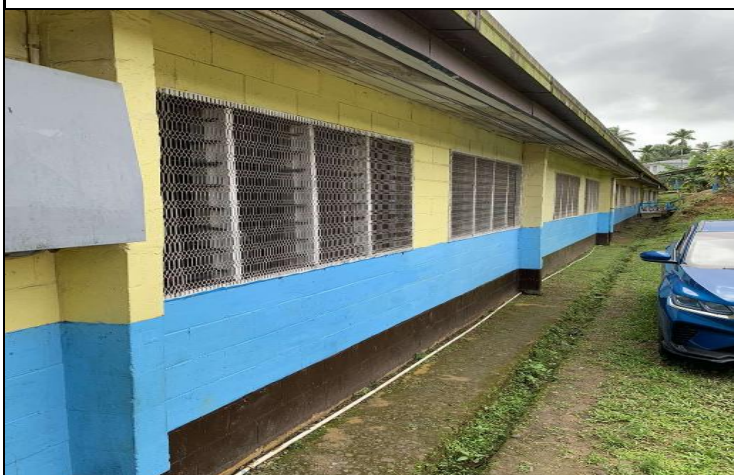
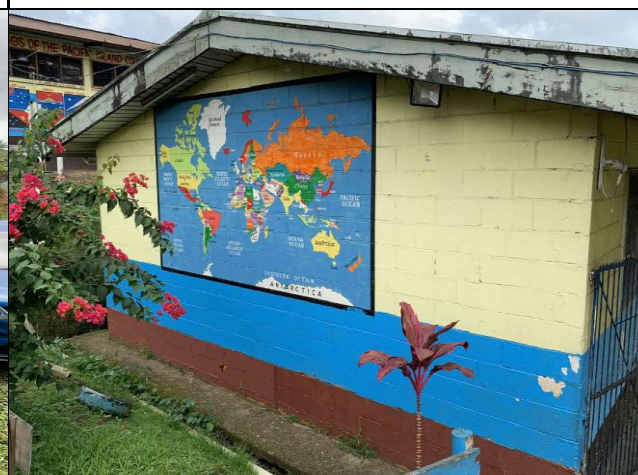
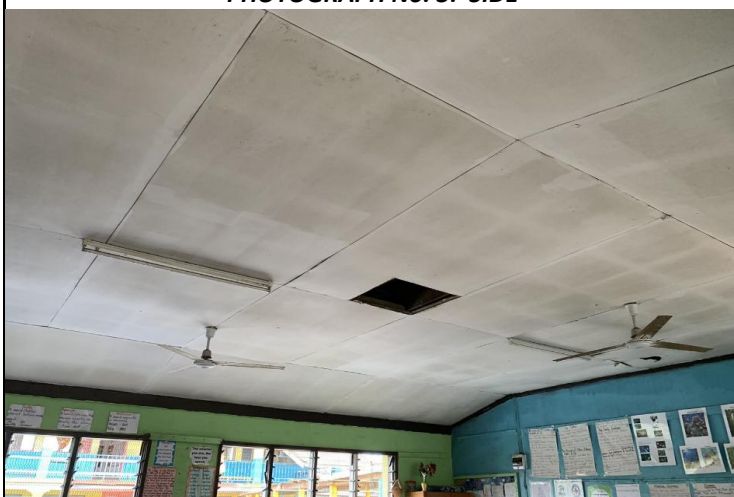
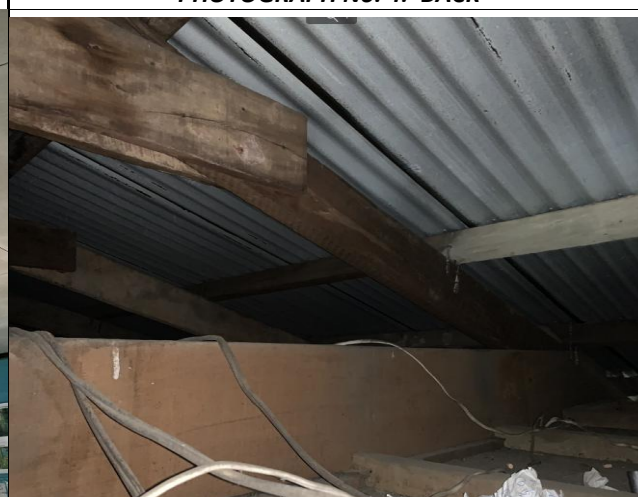
Client:	TETRA TECH INTERNATIONAL DEVELOPMENT (PTY) LTD	School Name:	ASSEMBLIES OF GOD PRIMARY
Project:	INFRASTRUCTURE PLAN FOR SUVA – NAUSORI URBAN SCHOOL.	Building Index:	B

- Fascia board damaged at sections.
- Corrugated roofing iron severely rusted at various sections.
- Valley gutters damaged and covered.
- Eave's batten was broken at some sections. Birds' nests were observed inside the eaves batten at various places.
- Classroom ceilings have holes on the plyboards.
- Internal walls had wooden partitions that displayed damages
- Roof corrugated iron rust at some sections.
- Guttering missing, dented and have algae build up.
- Downpipes have algae build up with only half length in dimensions
- Timber walkway panels have wear and tear, wraps/bends when walking indicating damaged/missing floor joist and bearer.
- Electrical light, fans and power switches are missing, damaged and exposed.

- No drainage was observed. Water from guttering flowing down to earth.
- The paints on the walls were peeled off in some sections.
- Window shutters are present in almost all windows in administration section used for safety purpose only. Not compliant to cyclone certification. Some sections showed corrosion.

- Fascia board shows water damage (rotting) at some sections.
- Absence of roof gutter.
- Electricity, internet and water is sufficient.
- 1x door entry on each side of the class

- Truss was connected with just nail connection without any ties or nail plates. Not fully cyclone compliance.
- 6-inch exterior concrete walls with hairline cracks on the front and side end.

- Rear wall contained visible cracks of about 600mm in length and 150mm maximum crack width on the window lintels.
- Absence of interior columns as the walls supported the weight of the building. Exterior columns on the walkways made up of 2-inch circular hollow section posts fixed to rafter and ceiling joists through anchor bolts and steel U- plates.

- Absence of ceiling joist to wall tie downs. Not cyclone compliant.
- Interior floor fully tiled with exterior walkway surface having hairline cracks at some sections. Approximately 250mm depth on top floor resting on ground.

- Window shutters are present in almost all windows in section used for safety purpose only. Not compliant to cyclone certification. Some sections showed corrosion.

- Shutters outside the classroom badly rusted and of large openings not compliant under cyclone standards.

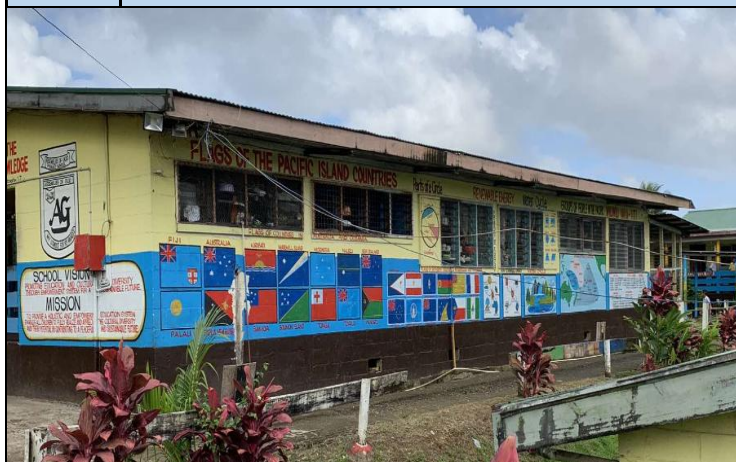
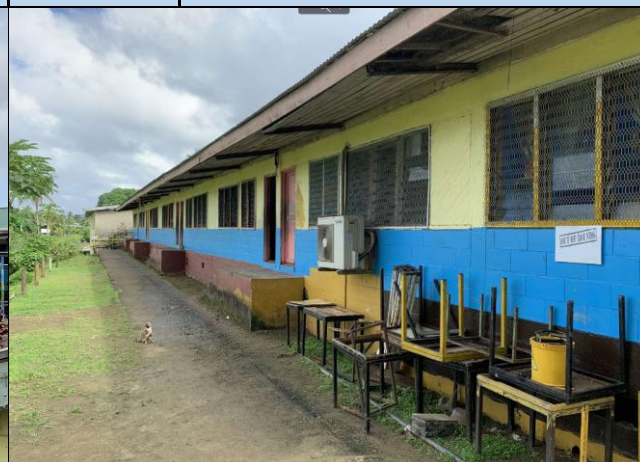
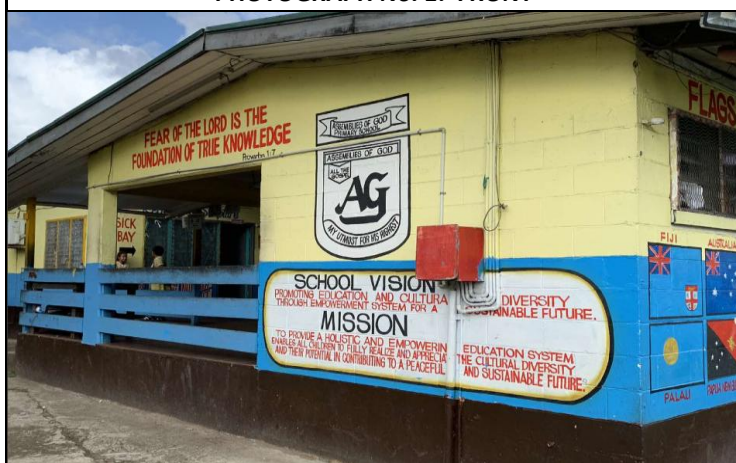
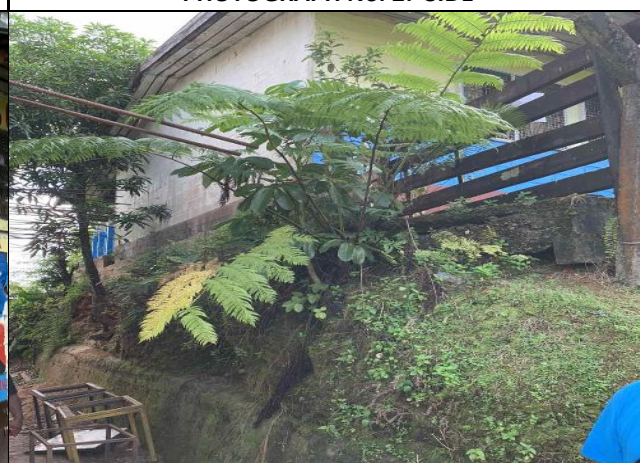
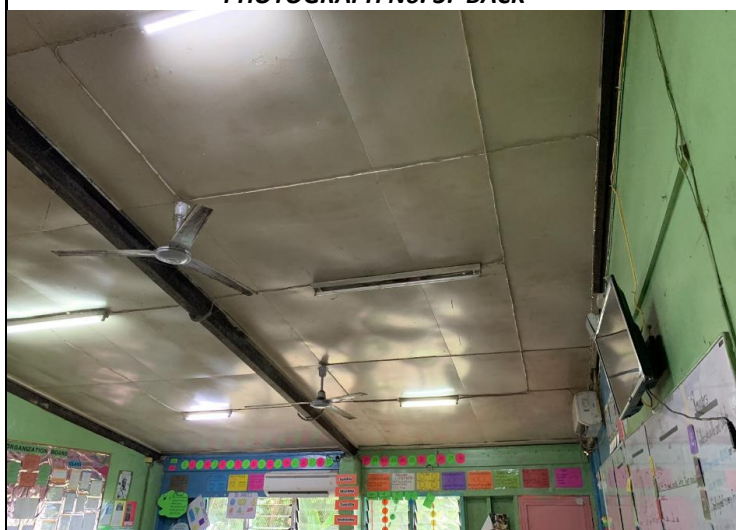
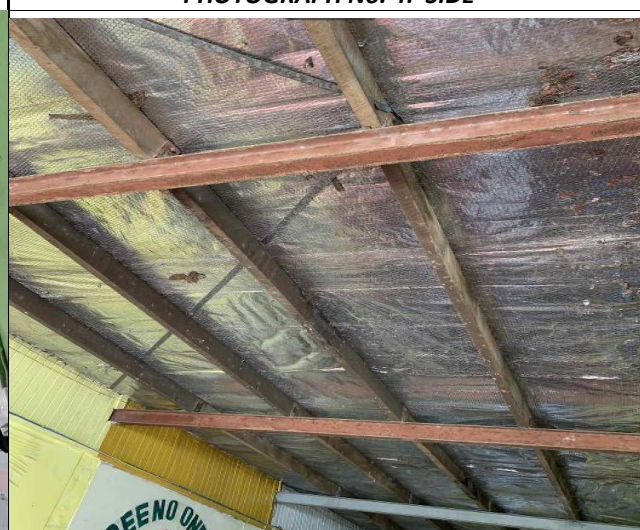
Client:	TETRA TECH INTERNATIONAL DEVELOPMENT (PTY) LTD	School Name:	ASSEMBLIES OF GOD PRIMARY
Project:	INFRASTRUCTURE PLAN FOR SUVA – NAUSORI URBAN SCHOOL.	Building Index:	A

- The water supply, electricity and internet connection are stable with sufficient lighting throughout the building.
- Insufficient lighting at the technical department section (missing tube lights)

- Exposed v-drain with cracks on some sections of administrative block.
- Half covered exterior wall for toilets

- 3 bays of boy's toilets are not enough to cater for 7 Bays of classroom.
- Excessive concrete damage on the open square drain channel under the technical department section. Concrete severely chipped causing water log at various places.

- Interior floor fully tiled with exterior walkway surface having hairline cracks at some sections. Approximately 250mm depth on top floor resting on ground.

- Window shutters are present in almost all windows in administration section used for safety purpose only. Not compliant to cyclone certification. Some sections showed corrosion.

- The paint on the building is being peeled off.
- Fascia board shows water damage (rotting) at some sections.
- Absence of roof gutter.
- Kitchen is properly maintained.

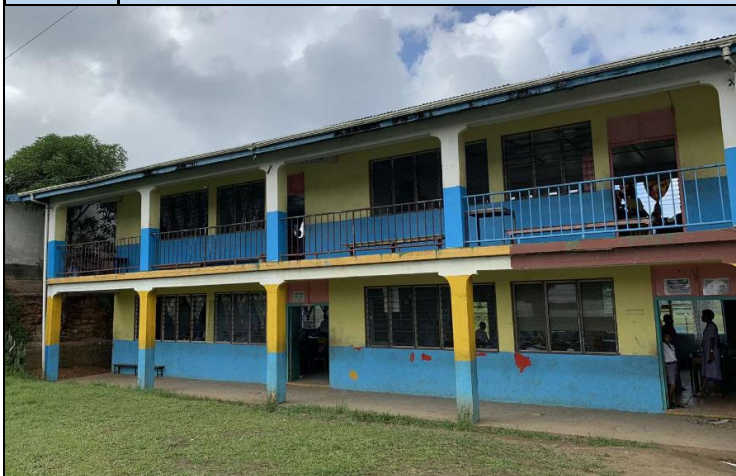
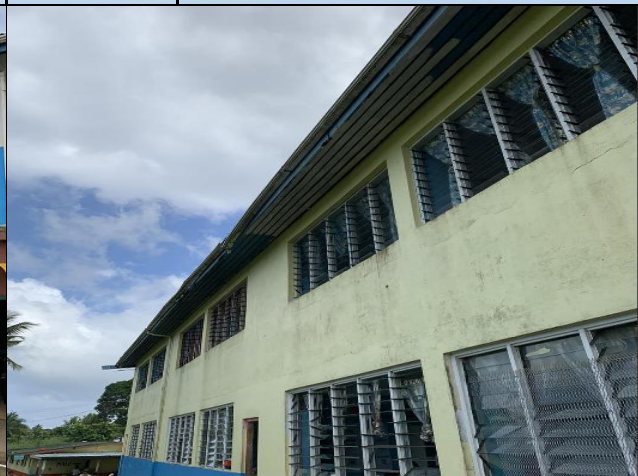
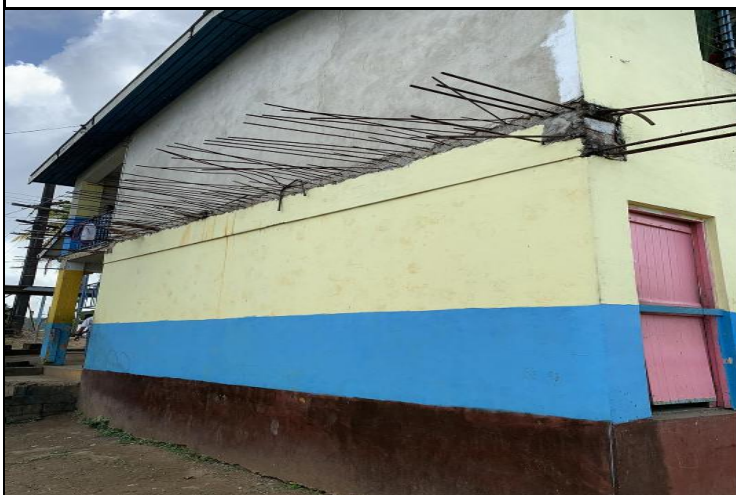
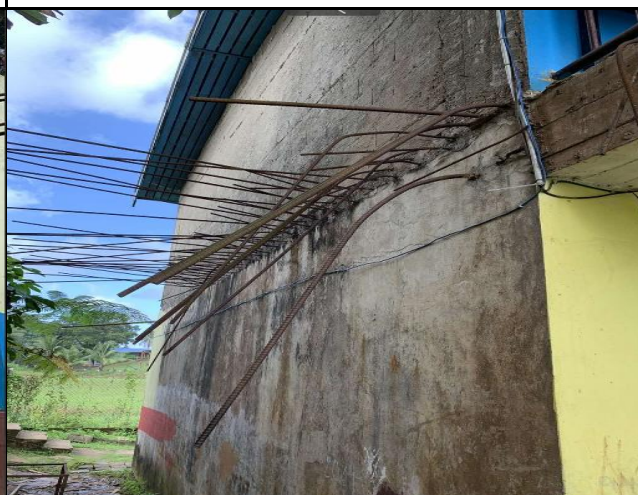
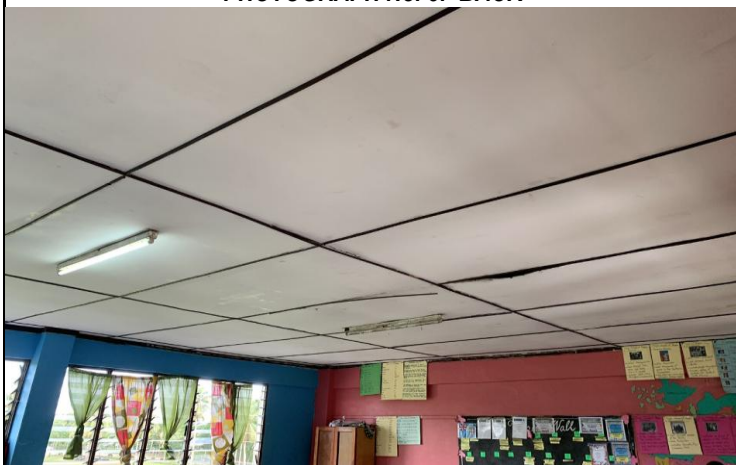
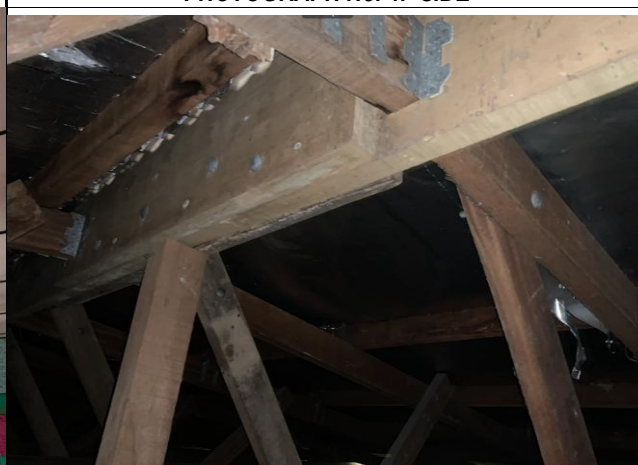
Client:	TETRA TECH INTERNATIONAL DEVELOPMENT (PTY) LTD	School Name:	ASSEMBLIES OF GOD PRIMARY
Project:	INFRASTRUCTURE PLAN FOR SUVA – NAUSORI URBAN SCHOOL.	Building Index:	D

- Overcrowding
- Dimensions of each classroom, labs etc
- Visual defects
- Absence of valley gutter. Corrugation placed irregularly.
- Severe damage to eaves batten at the rear end.
- Fascia board shows algae build up.
- Holes and tear on timber walls inside classrooms.
- Rusted CHs posts at the joints
- Missing rails (especially bottom rail) at sections of railings posing safety hazard.
- Hairline cracks and chips at some sections.
- Missing lights and damaged lights and ports in some classrooms.
- The roof structure was a fink truss entirely made of timber (6 x 2 rafters, 3 x 2 purlins, 6 x 2 ceiling joists, 6 x 1 ridge board, 4 x 2 truss brace, 2 x 2 lateral bracing.
- Truss was connected with just nail connection without any ties or nail plates. Not fully cyclone compliance.

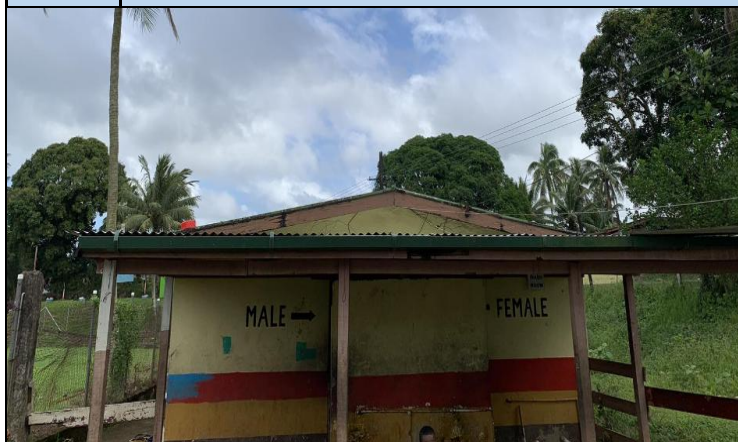
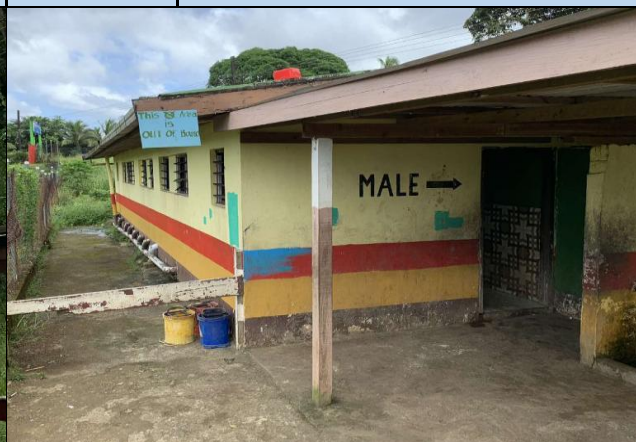
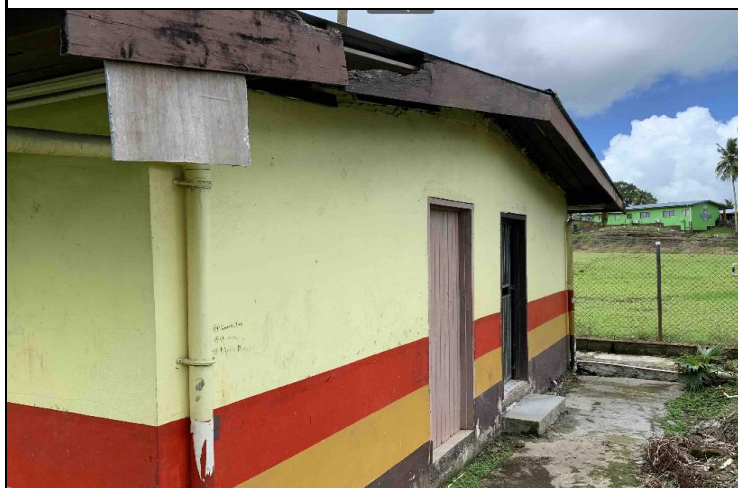
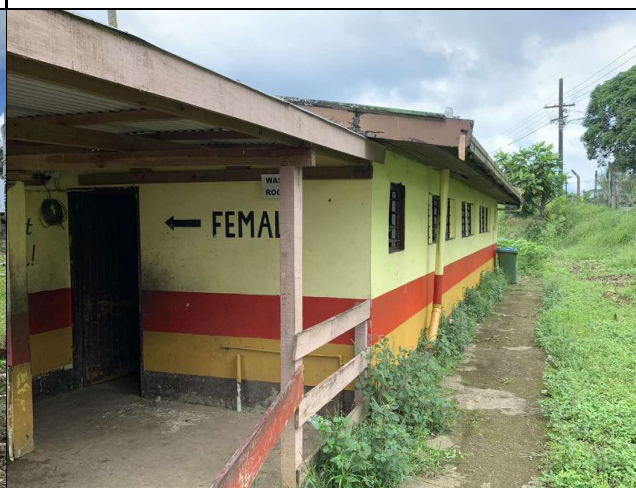
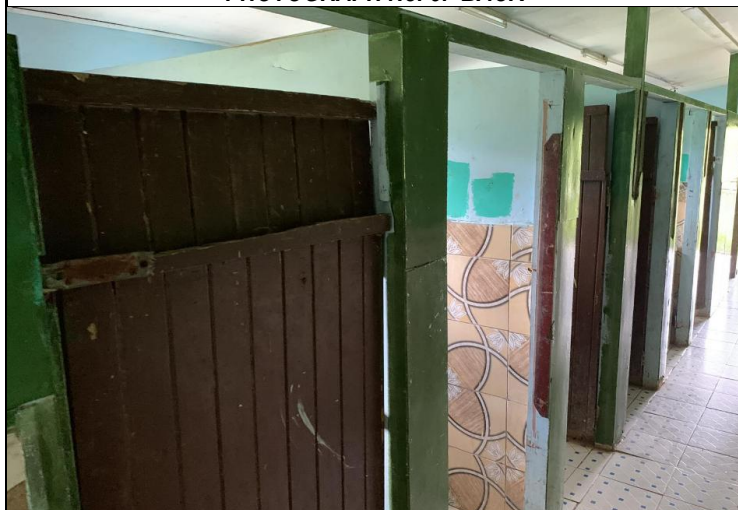
Client:	TETRA TECH INTERNATIONAL DEVELOPMENT (PTY) LTD	School Name:	ASSEMBLIES OF GOD PRIMARY
Project:	INFRASTRUCTURE PLAN FOR SUVA – NAUSORI URBAN SCHOOL.	Building Index:	Toilet Block

- Gable roof.
- Walkways and staircases having roof to accommodate for rainy conditions.
- The paint on the building is being peeled off partially in some sections. Mainly observed in ground floor on the rear wall and front fascia boards.
- Missing gutter system on the toilet roof with partial denting in some sections.
- Interior ceiling shows damage with missing roof cover in one section of a staircase.
- One water storage tank for toilet uses behind the building.
- Building walls required re-painting works.
- Paint peel in some sections of the fascia board.
- Missing gutter system on the toilet roof with partial denting in some sections.
- Absence of window shutters throughout the building.
- Electricity and internet and water is sufficient.
- Toilets WASH easily accessible but requires some maintenance works.

- Drainage adequately maintained with minor damages. Open v-drain with minor concrete damage. Missing drain cover in front facing drains.
- Adequate ventilation is in all levels of the building.
- Easily accessible to non-accessible student.
- Not accommodating to wheelchair users who require a minimum of 1m clearance.
- Absence of ramps throughout the building.
- All toilets are located at a distance away from the main walkway.
- Boys' toilet located at right end is farther away from left end classrooms. This requires boys to travel at a greater distance to reach the toilet.
- The boys and girl's toilets require cleaning.
