INFRASTRUCTURE ASSESSMENT AUDIT FOR SUVA – NAUSORI URBAN SCHOOL

CHRISTIAN MISSION FELLOWSHIP PRIMARY SCHOOL (9862) SUMMARY REPORT

CHRISTIAN MISSION FELLOWSHIP PRIMARY SCHOOL (9862) SITE INSPECTION REPORT

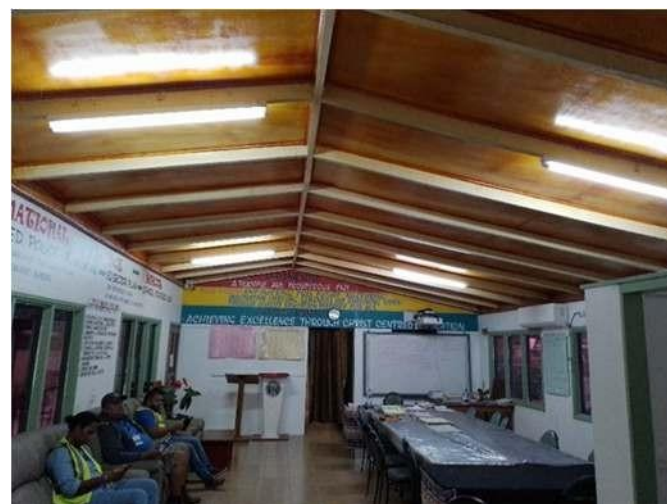
05. EXPOSED CEILING FOR MOST PART OF ADMIN BLOCK.

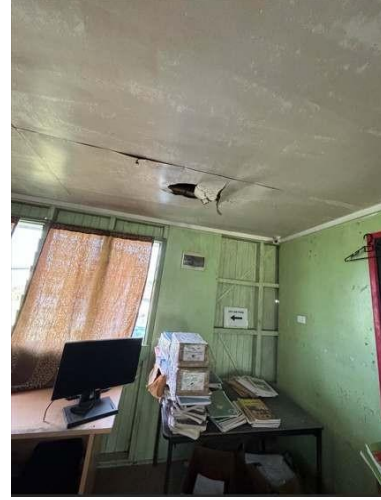
06. DAMAGED CEILING DUE TO ROOF LEAK.

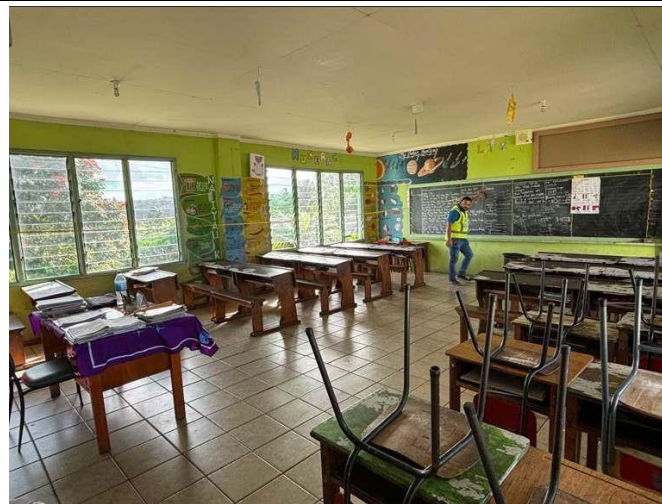
03. YEAR 403 TILED FLOOR, BULB LIGHTS.

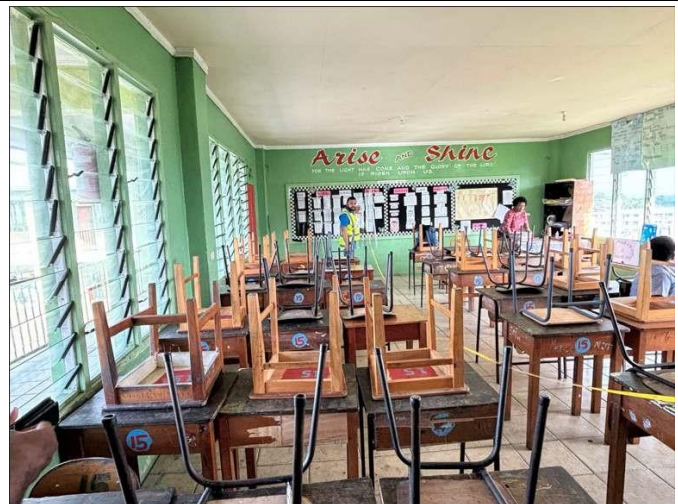
04. YEAR 404 TILED FLOOR, BULB LIGHTS.

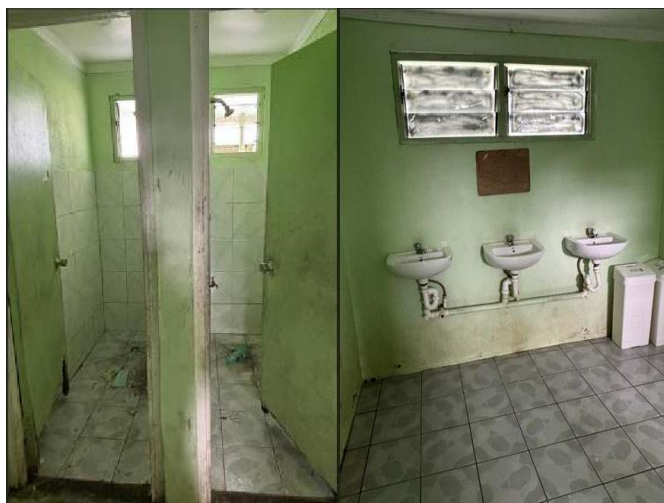
- Cubicle doors for almost all of the water closets and showers for Block 09 Senior Girls and Boys toilet block have deteriorated and needs to be replaced with quality external grade joinery.

03. GIRLS SHOWER CUBICLES, JOINERY DECAY, TAPS.

Recommendations <ul style="list-style-type: none">● Replace all deteriorated cubicle doors & joinery with new lock system.● Replace clear louvre blade glass with opaque type window blades for privacy.● Block 09 walls, floor, ceiling to receive good wash and new paint.

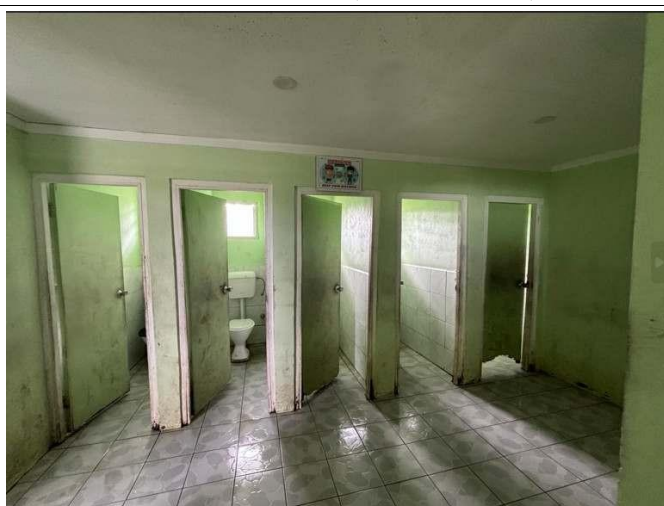
05. GIRLS WC CUBICLES, TILED FLOOR, JOINERY DECAY.

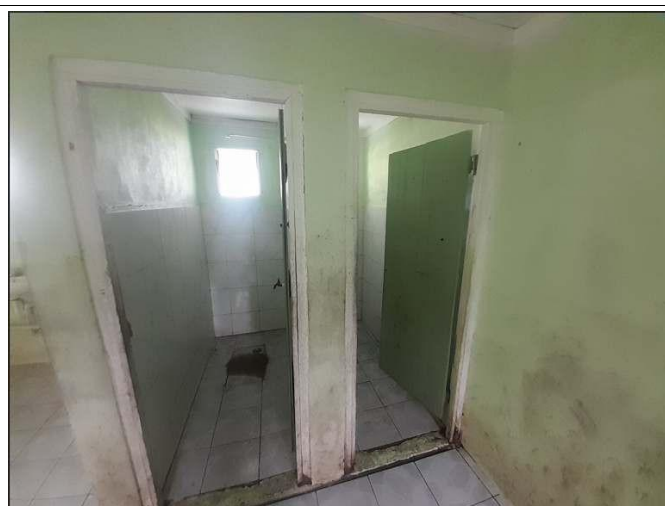
06. BOYS SHOWER CUBICLES, JOINERY DECAY.

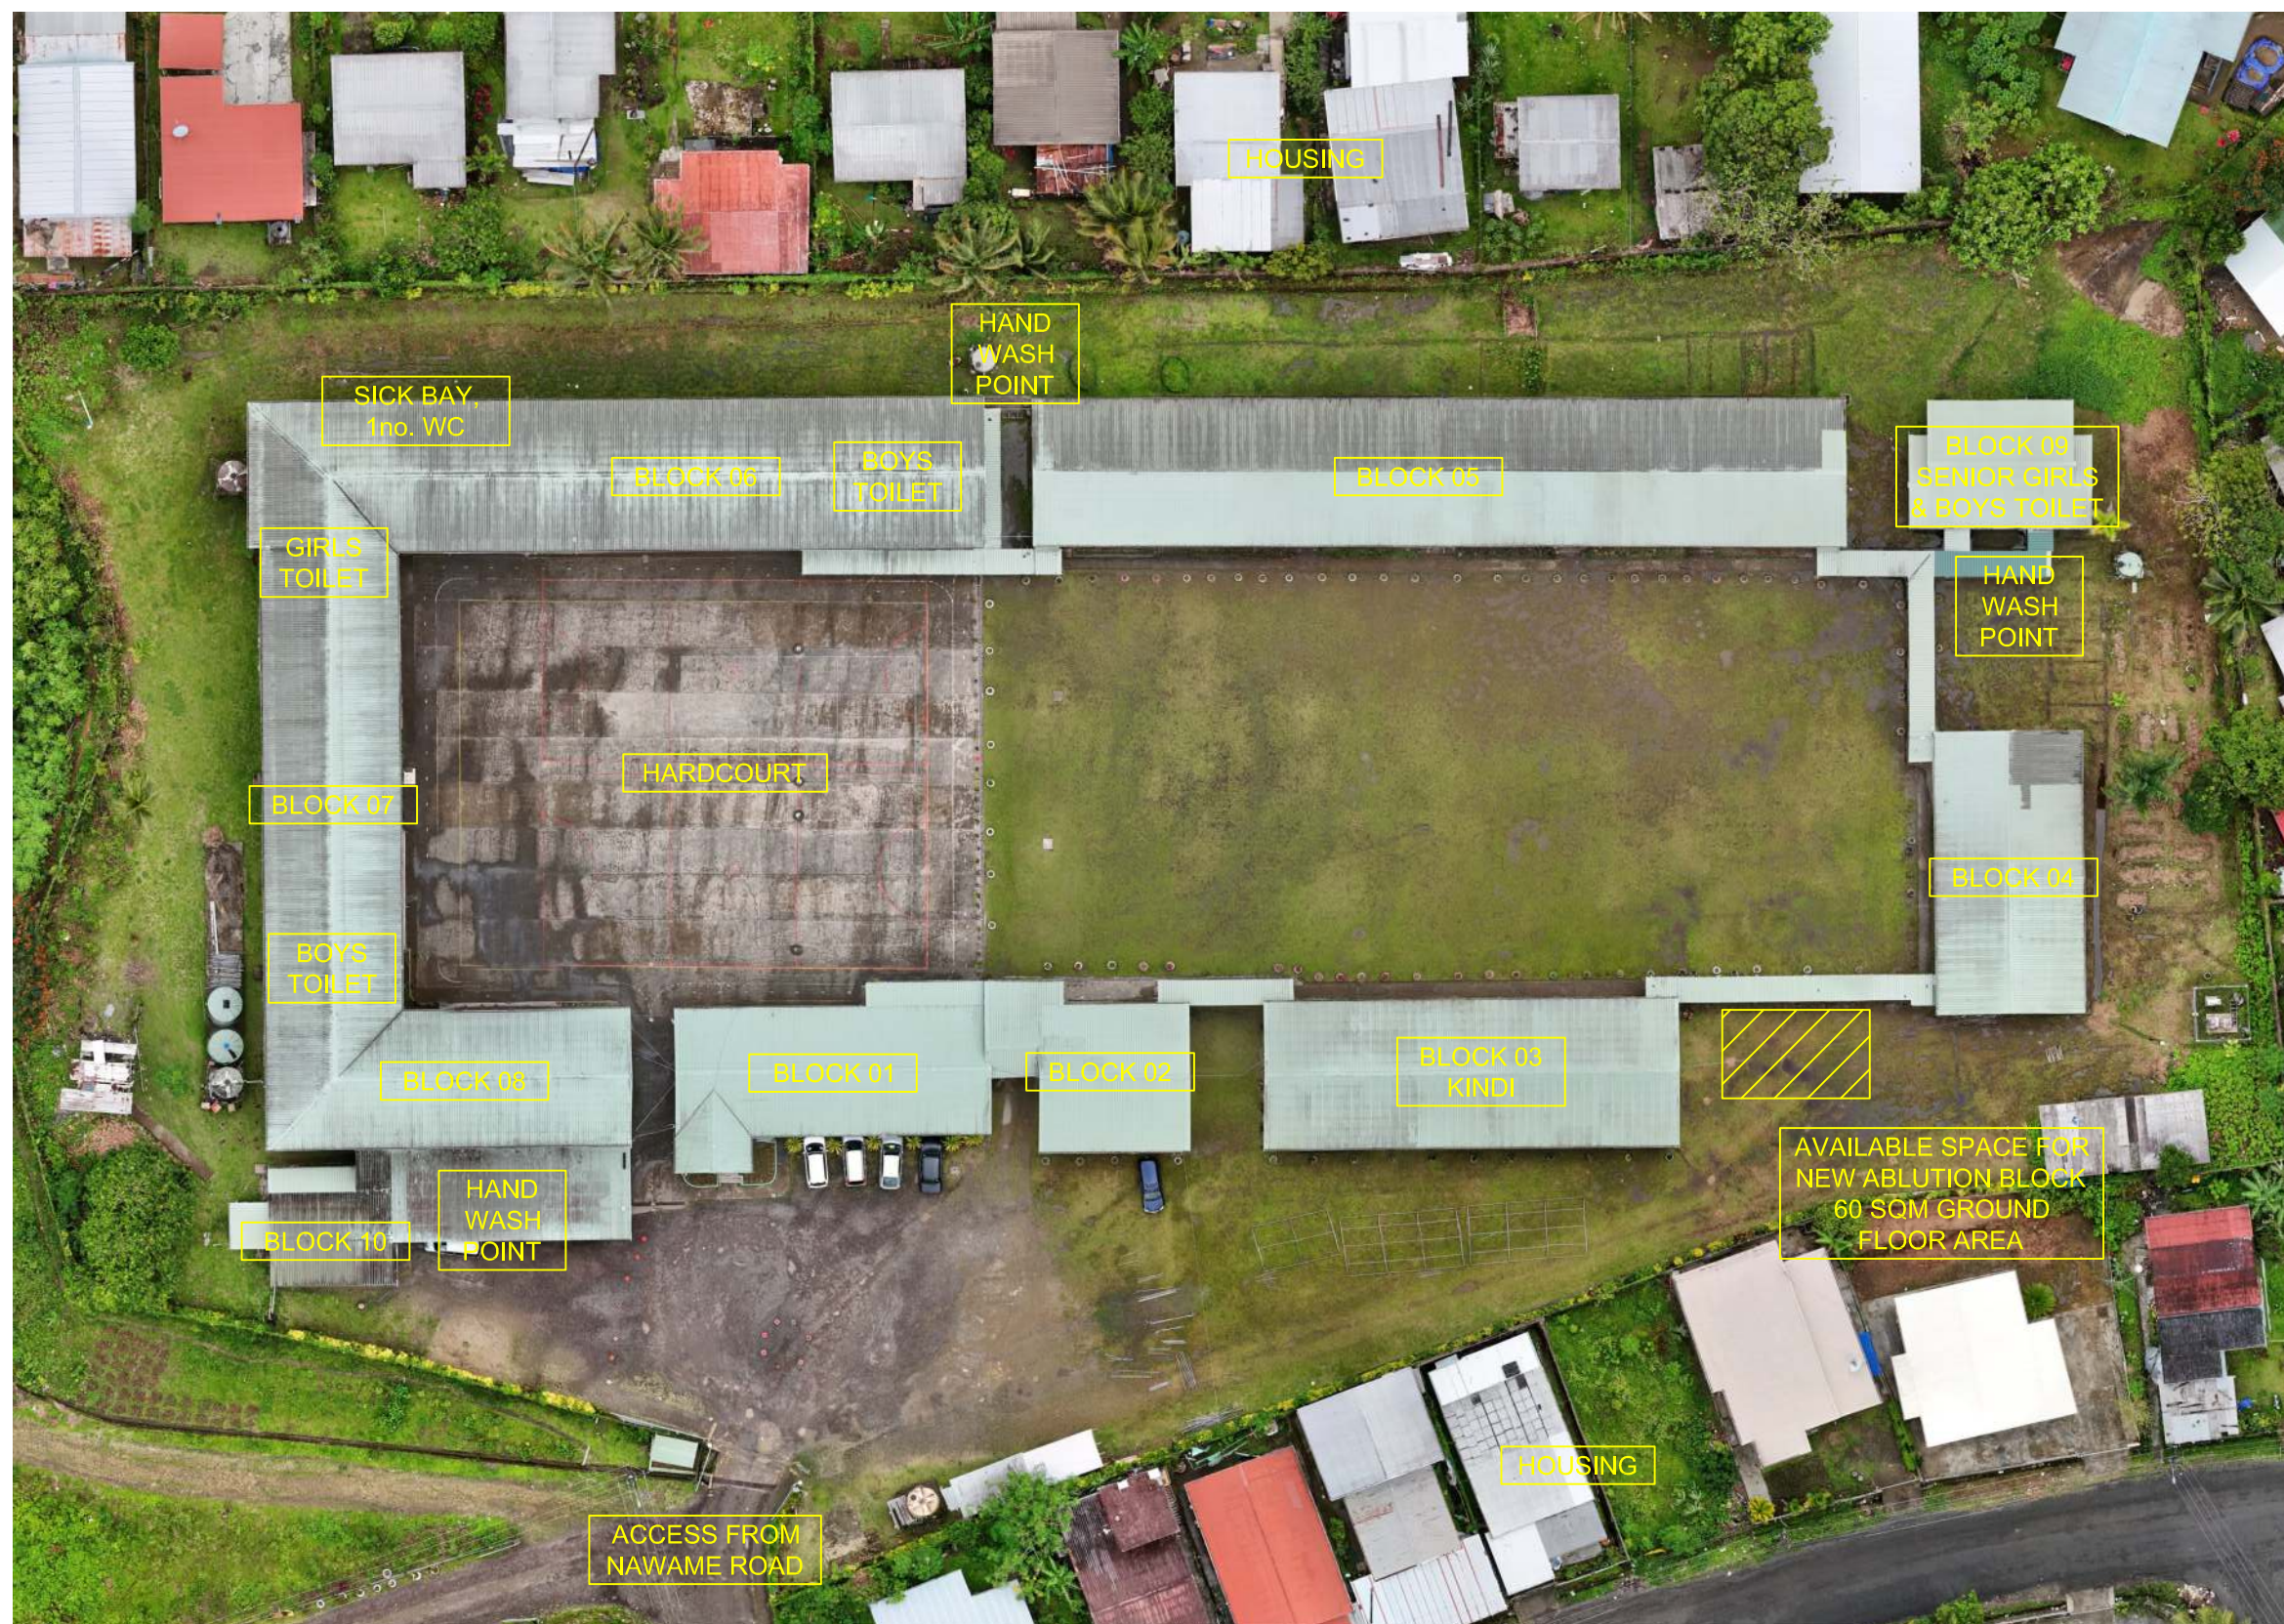
CURRENTLY SENIOR GRADE TOILET BLOCK SHARED WITH ECE STUDENTS. NEW ABLUTION BLOCK TO HAVE 8no. WC, 2 SHOWER CUBICLES, 2no. HAND BASINS FOR GIRLS AND 4no. WC. 2 SHOWER CUBICLES, 2no. HAND BASINS FOR BOYS SEPARATE CUBICLE WITH TOILET SEAT SUITABLE FOR ECE STUDENTS REQUIRED.

SICK BAY WITH 1no. WC USED BY GIRLS. SPACE AVAILABLE TO INTRODUCE CONVERT SICK BAY INTO GIRLS TOILET.

- **WASH Facilities:** It is highly recommended for Ministry to construct a new Ablution Block with Boys having 4no. new water closets, 2no. shower cubicles and 2no. hand basins. Girls to have new 8no. water closets, 2no. shower cubicles and 2no. hand basins.
