INFRASTRUCTURE ASSESSMENT AUDIT FOR SUVA – NAUSORI URBAN SCHOOL

PT. VISHNU DEO MEMORIAL PRIMARY SCHOOL (2379) SUMMARY REPORT

PT. VISHNU DEO MEMORIAL PRIMARY SCHOOL (2379) SITE INSPECTION REPORT

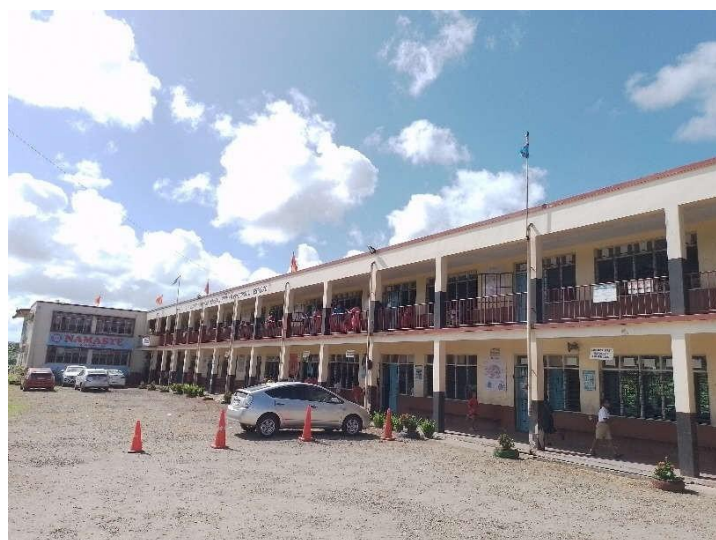
01. CLASSROOM FRONT CORRIDOR & CARPARK

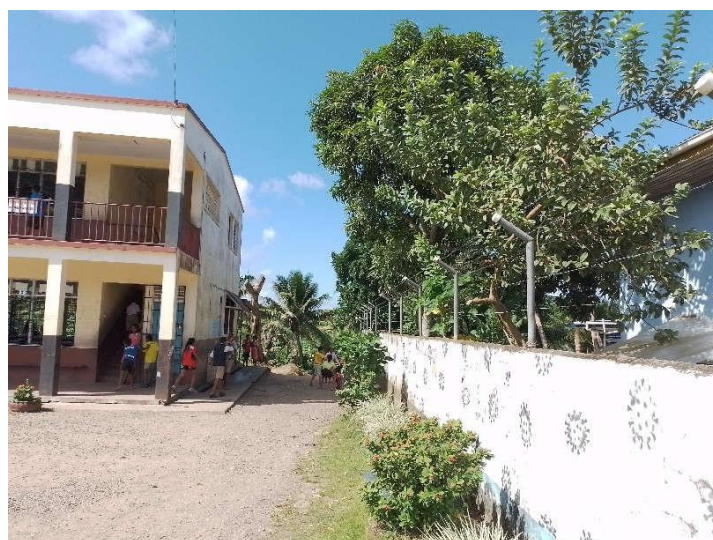
02. TAPS ON SIDE WALL, FENCE SEPARATING HOUSING

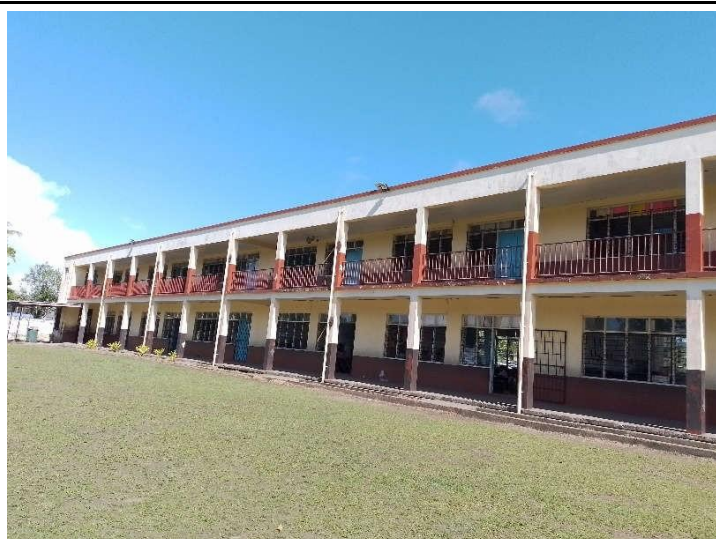
03. CLASSROOM BACK CORRIDOR & LAND SPACE

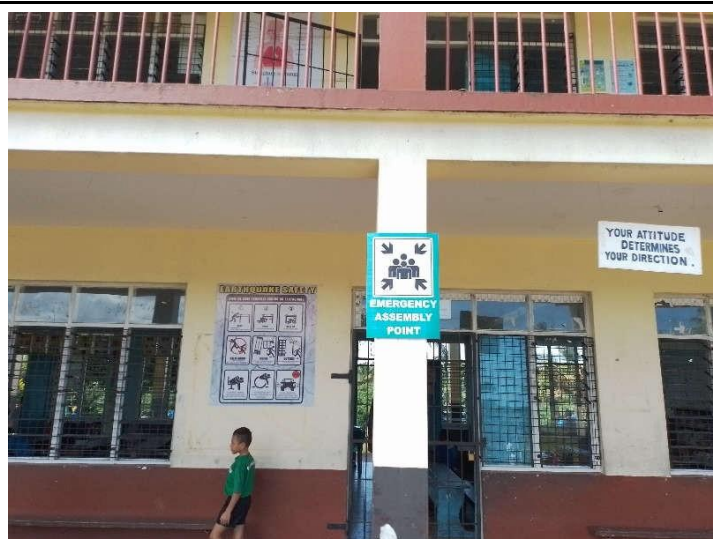
04. SECURED DOORS & WINDOWS, SIGNS ALONG CORRIDOR

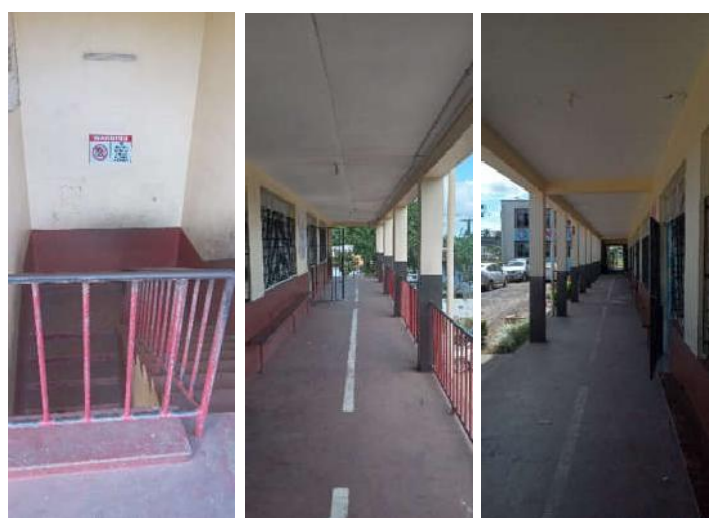
05. CORRIDOR MARKING, STAIRWELL & FIRST FLOOR SAFETY RAIL.

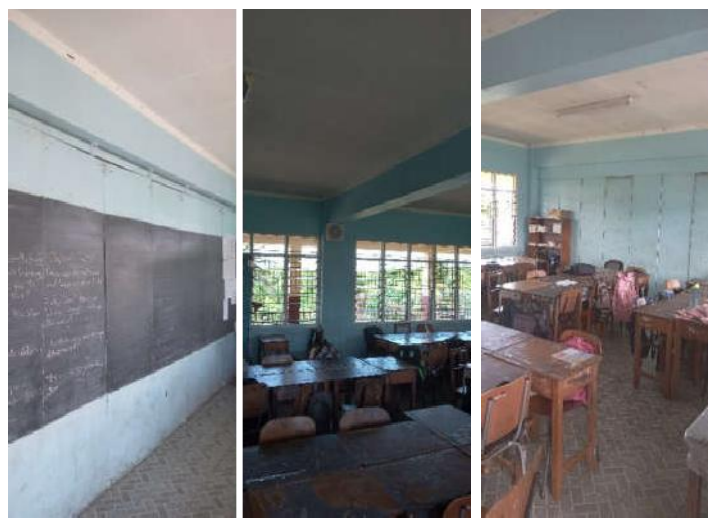
06. TYP CLASSROOM STRUCTURE GROUND & FIRST FLOOR

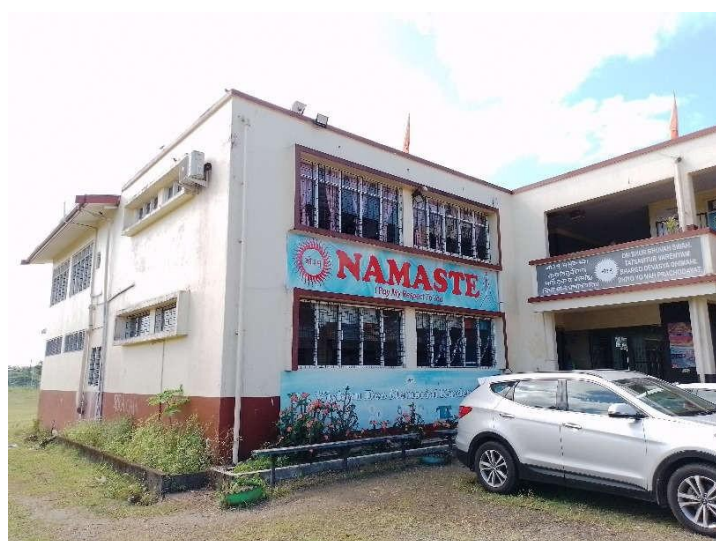
01. GROUND FL ECE ROOM, FIRST FL ADMIN OFFICE

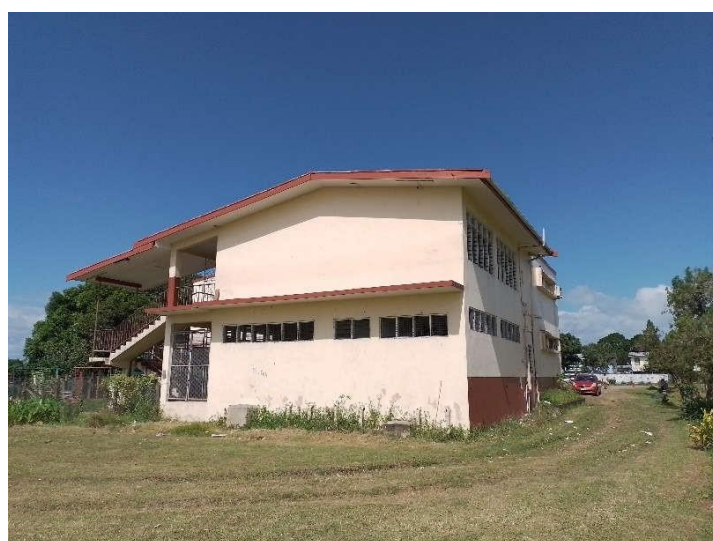
02. GROUND FL TOILETS, FIRST FL CLASSROOM

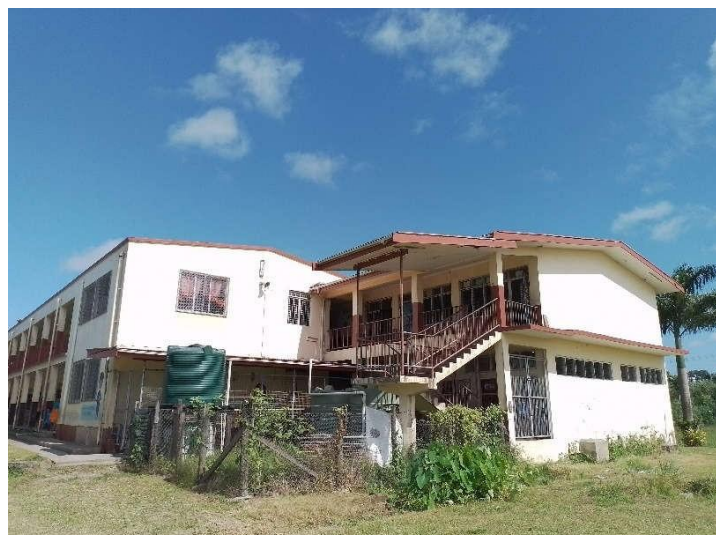
03. CORRIDOR LINK TO BLOCK 01

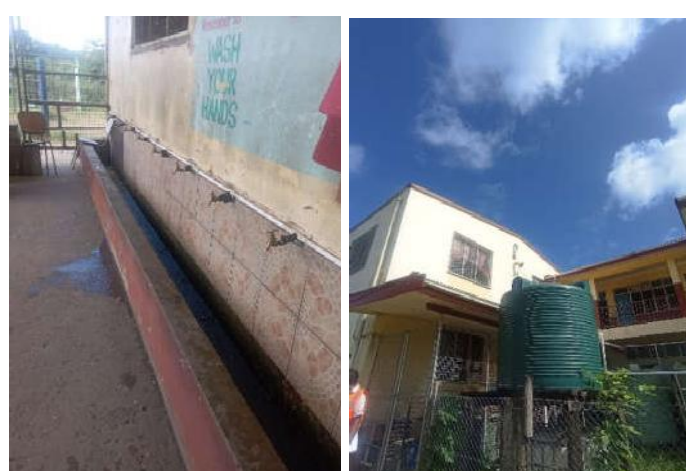
04. TAPS ON SIDE WALL, 1no. WATER TANK

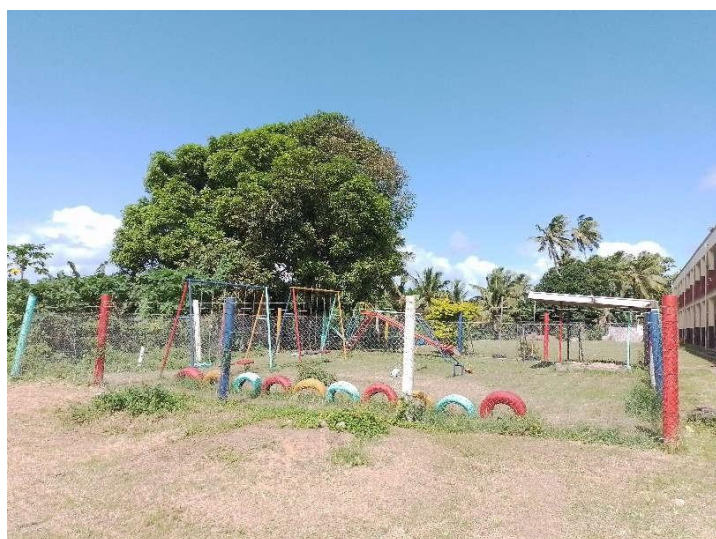
05. SECURED KINDI PLAY AREA BEHIND BLOCK 02.

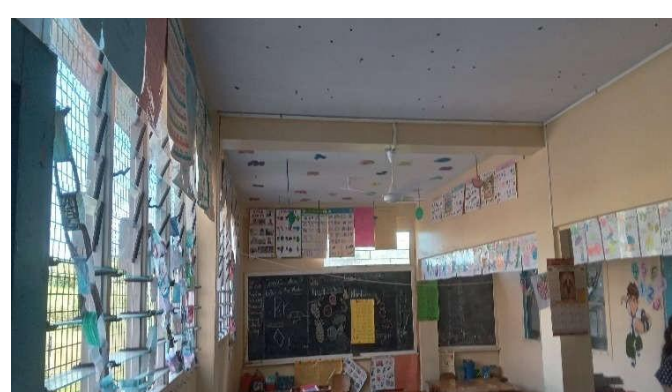
06. ECE ROOM INTERIOR, NATURAL LIGHT & VENTILATION.

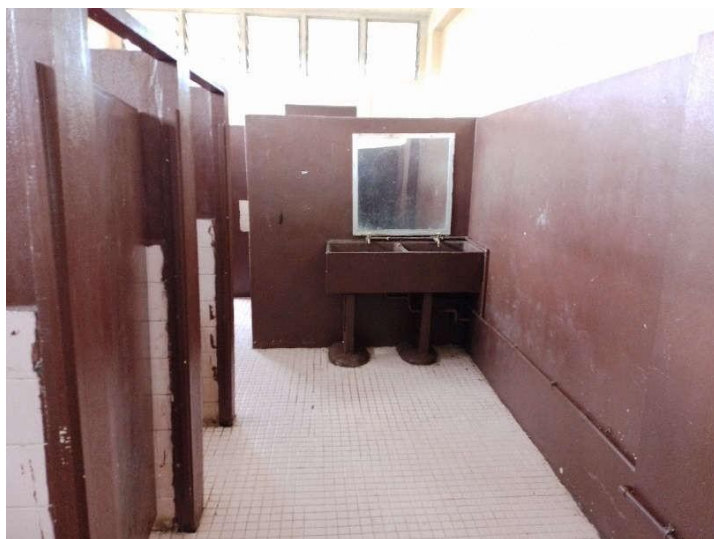
01. BOYS TOILET HAND WASH POINT.

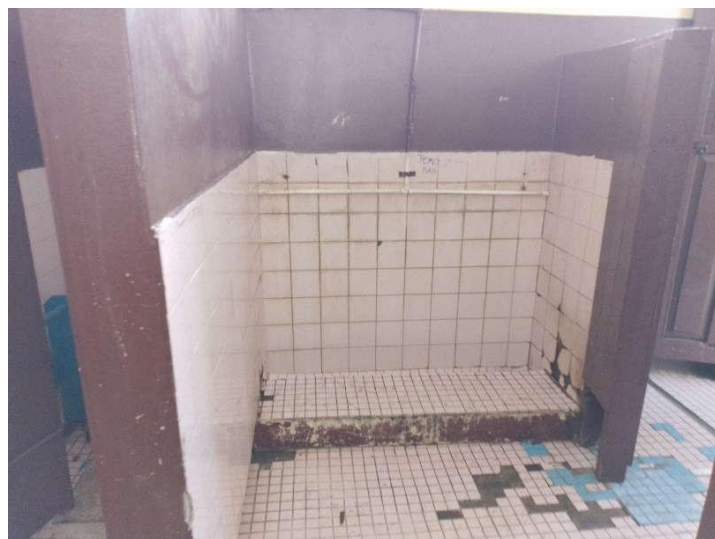
02. BOYS TOILET URINAL.

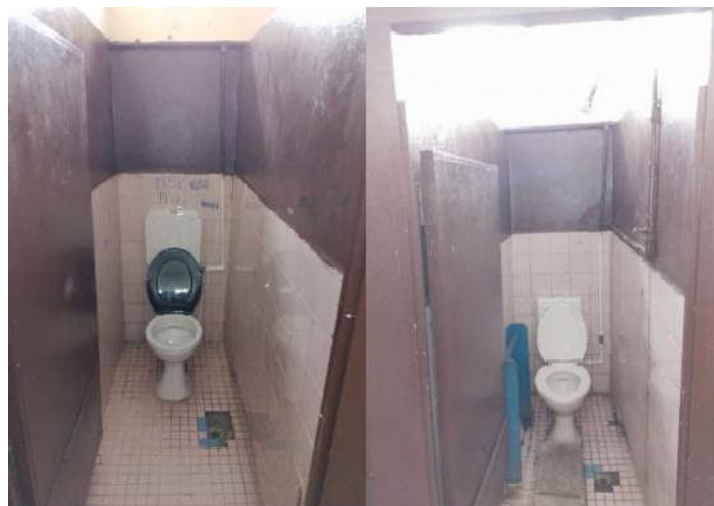
- For both Girls and Boys toilet shower heads provided inside of WC cubicle. No separate shower cubicle.
- For both Girls and Boys some cubicle doors to have locking device readjusted or replaced.
- Toilet seats are at standard height. Not well-suited for ECE and Junior grade students.

03. WATER CLOSET UNIT TYPICAL, SHOWER HEAD

- Separate shower cubicles required for both girls and boys toilet.
- Some cubicle doors to have locking device readjusted or replaced for both girls and boys toilets.
- School requires a new ablution block and hand wash points to cater for all students. School management prepared a strategy to stagger recess and lunch times for different Grades to avoid overcrowding at toilets and taps. Classrooms on first floor have wash buckets and encourage students to have water bottles since all taps are located on ground floor. Land available for new development.

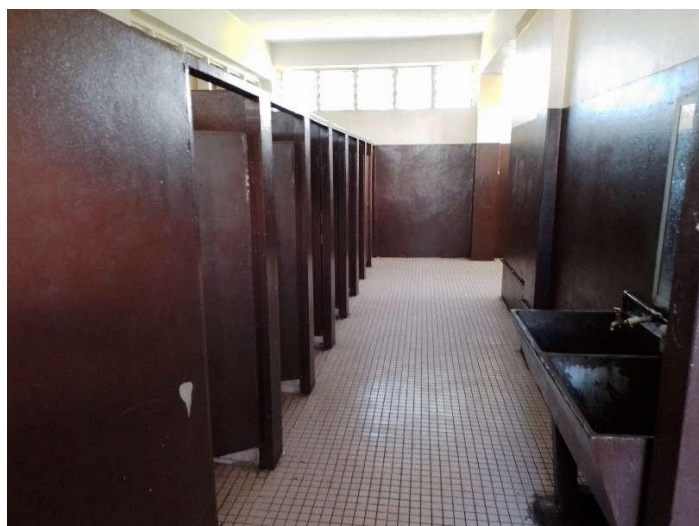
04. GIRLS TOILET HAND WASH POINT.
