# INFRASTRUCTURE ASSESSMENT AUDIT FOR SUVA – NAUSORI URBAN SCHOOLS

RAMBISESSAR CHAUDHARY MEMORIAL PRIMARY SCHOOL (REG 1853)

## SUMMARY REPORT

RAMBISESSAR CHAUNDRY PRIMARY SCHOOL (1853)

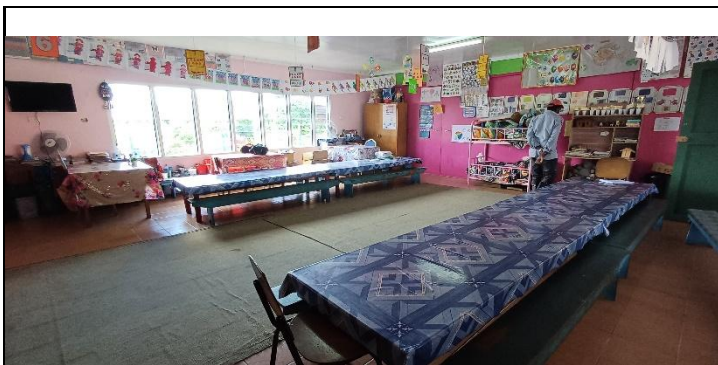
PHOTOGRAPH No. 7 – INTERIOR PHOTO  
Shown here is the typical kindergarten classroom

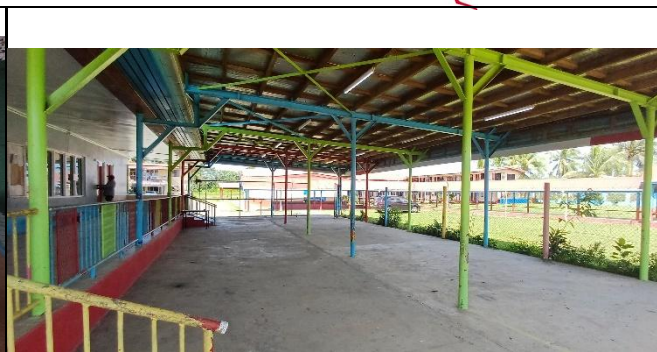
PHOTOGRAPH No. 8 – INTERIOR PHOTO  
Shown here is the Hall space

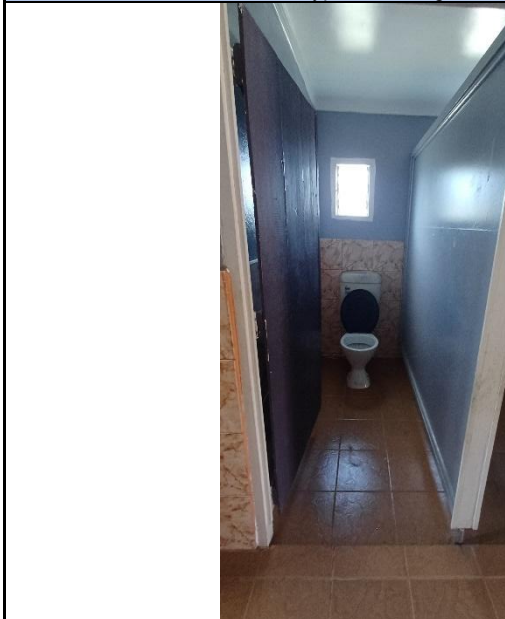
PHOTOGRAPH No. 9 – WASH FACILITY  
Shown here is the typical students toilet

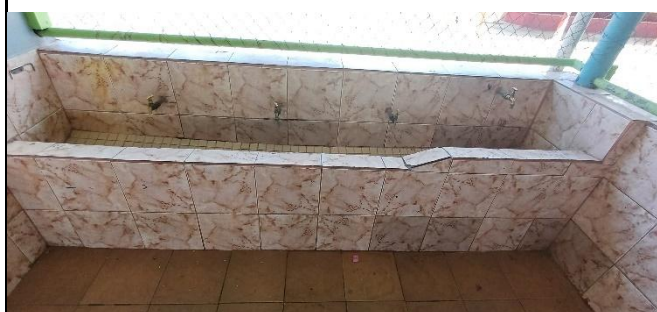
PHOTOGRAPH No. 10 – WASH FACILITY  
Shown here is the taps

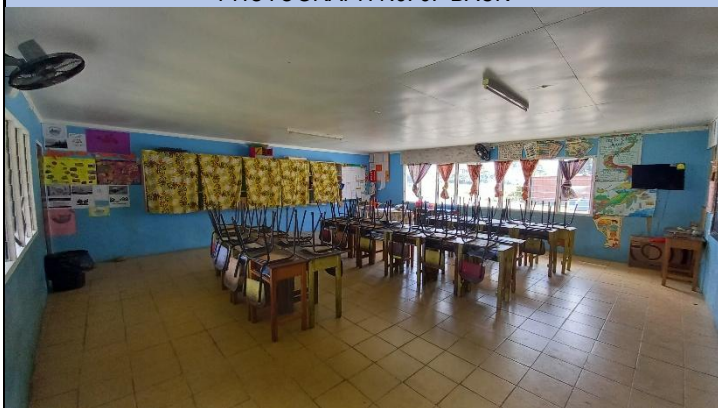
PHOTOGRAPH No. 5: INTERIOR VIEW.  
Shown here is Year 4 Classroom at Level 2.

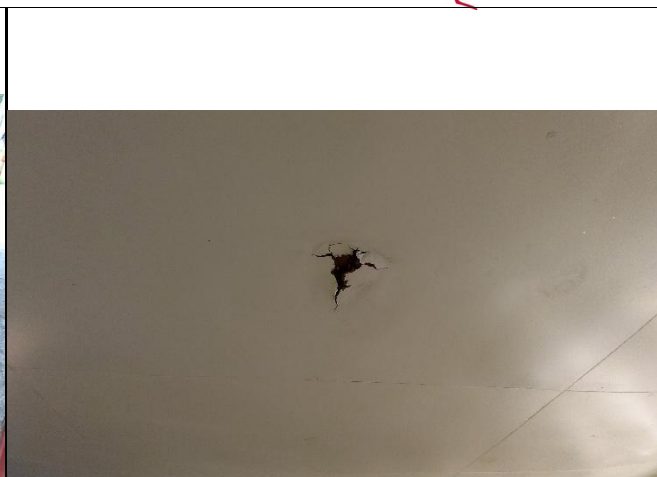
- **Walls and Ceiling** – Cracks and holes were observed on ceiling of the buildings (B2 and B3). Timber walls of all buildings observed to have few minor wear and tears. Concrete walls require upgrading due to visible holes and cracks observed (B3 & B5)

PHOTOGRAPH No. 10: DEFECTS  
Shown here is a damaged ceiling from leakages

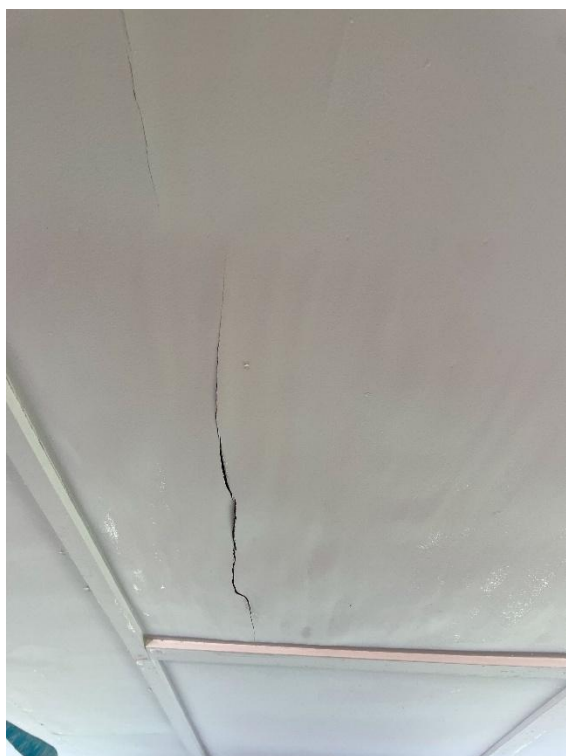
PHOTOGRAPH No. 9: DEFECTS  
Shown here is a visible hole on ceiling possibly due to leakages

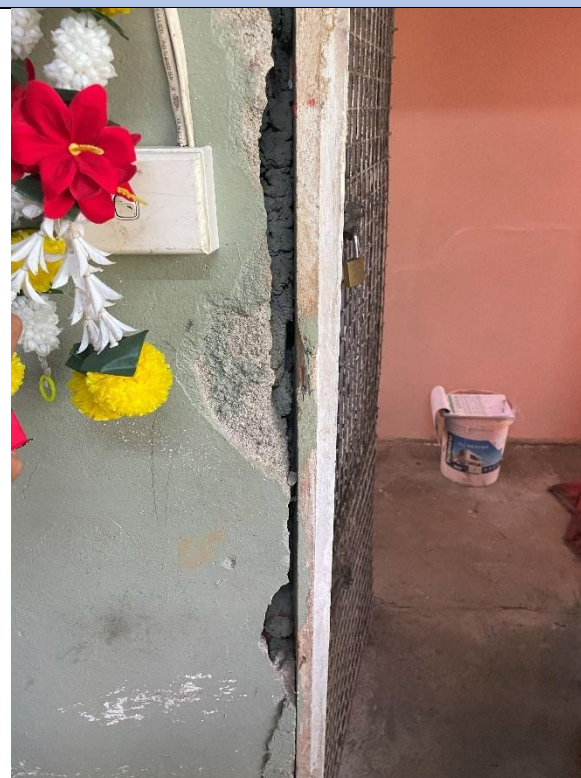
PHOTOGRAPH No. 10: DEFECTS  
Shown here is a damaged concrete along door frame

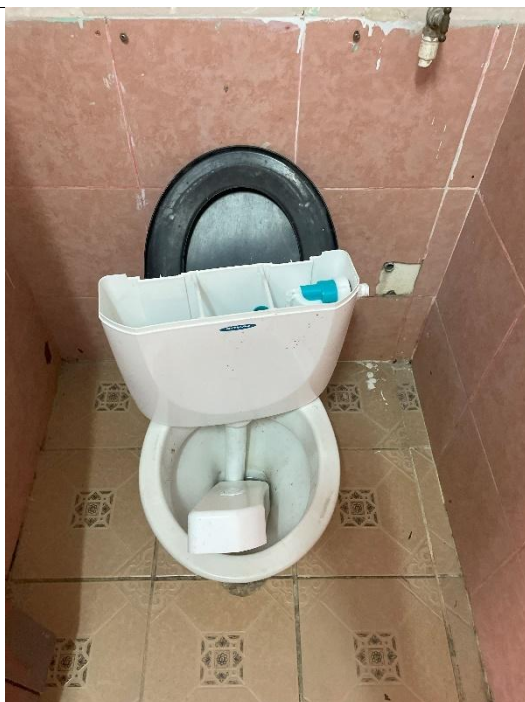
- Damaged toilet cisterns
- Damaged concrete walls with exposed pipe works
- Missing louver blades
- Cracked and chipped off floor and wall tiles
- Damaged steel grated drainage

**PHOTOGRAPH No. 9: DEFECTS**  
Shown here is a damaged cistern

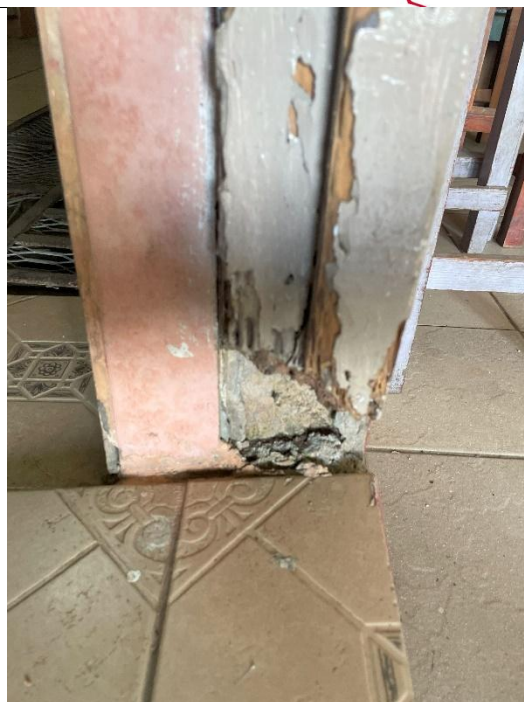
- Damaged light bulbs
- Missing louvre blades
- Peeled off paint on toilet doors
- Damaged toilet cisterns
- Cracked concrete with visible holes
- Cracked and missing tiles
- Deteriorating timber door frames and ceiling frames
- Damaged grated steel drainage (Holes on gratings)
- Few taps not working or missing turning knobs

**PHOTOGRAPH No. 10: DEFECTS**  
Shown here is a deteriorated timber door frame
