INFRASTRUCTURE ASSESSMENT AUDIT FOR SUVA – NAUSORI URBAN SCHOOLS

SAINT AGNES PRIMARY SCHOOL (REG 2333)

SUMMARY REPORT

Appendix A - Site Inspection Report

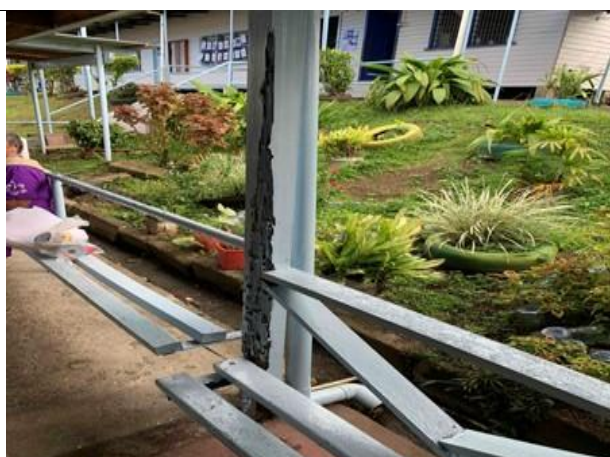
PHOTOGRAPH No. 5: TIMBER RAILS & BENCH

Building Index		Administration office & sick bay- timber Structure on a concrete slab with a gable roof.				
Type:	Timber building – Single Storey. - timber Structure on a concrete slab with a gable roof.				No. of Levels: 1	
Dimensions	Length (m): 8.5		Width (m): 8.4		Height (m): 2.6	
Existing State of Building						
REF. No.	Building Component	Good ¹	Fair ²	Poor ³	Structure Type ⁴	Comments
1	Roof Lining		✓		Steel	Corrugated Roofing Iron (CGI)
2	Roof Structure				Timber	The roof structure was concealed. However, could be said to be timber framing.
3	Walls	✓			Timber	Minor damage to timber weatherboard
4	Columns / Beams (where required)		✓		Timber	100 Sq. timber post for the walkway, with a 150x50 timber roof beam. One post is to be replaced due to worn out and damaged. Deteriorating
5	Floor	✓			Concrete	Ok
6	Handrails		✓		Timber Steel	Hand railings require proper fixings. Steel post, handrail with timber bench.

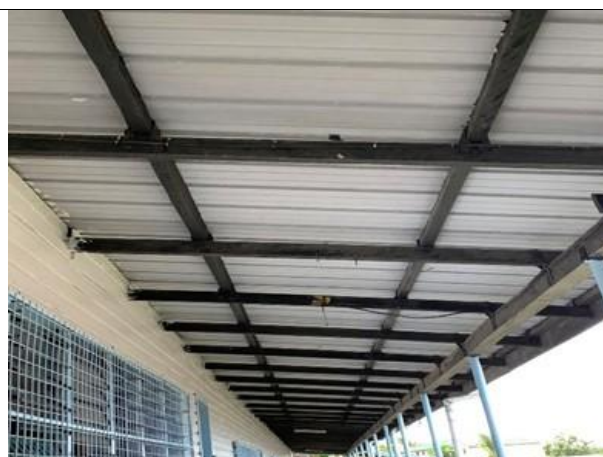
PHOTOGRAPH No. 6: ROOF SPACE

- Corrugated iron roof cladding has algae buildup and is rusted in some sections.
- Gutters have algae buildup and are damaged in some sections.
- Timber purlin to timber top chord hold-down straps are missing in some areas.
- Interior ceilings are cracked and water leakage is occurring in some areas.
- The installed glazings do not have cyclone-rated shutters and are not cyclone-rated glazings.
- Timber window frames are damaged in some areas.
- Louvres are missing from the windows.
- The walkway ceiling is damaged and water leakage is occurring in some areas.
- Handrails do not meet building code requirements and are not adequately fixed to CHS posts in some areas.
- Minor cracks in the pavement are present.
