INFRASTRUCTURE ASSESSMENT AUDIT FOR SUVA – NAUSORI URBAN SCHOOLS

SUVA MUSLIM PRIMARY SCHOOL – REG 2345

SUMMARY REPORT

SITE INSPECTION REPORT

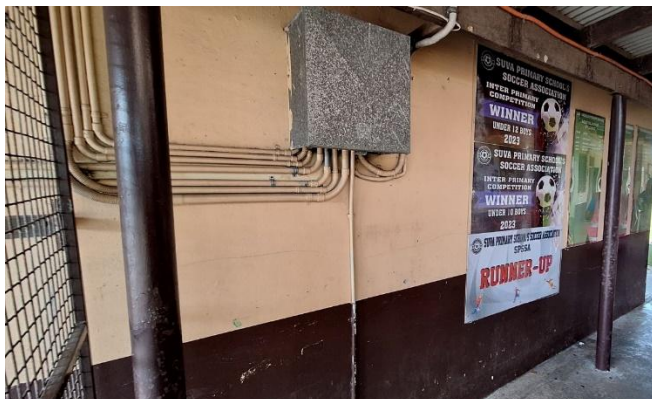
PHOTOGRAPH No. 3: SIDE VIEW	PHOTOGRAPH No. 4: INTERIOR CLASSROOM CEILING/FAN PROVIDED
-----------------------------	---
