INFRASTRUCTURE ASSESSMENT AUDIT FOR SUVA – NAUSORI URBAN SCHOOL

VEIUTO PRIMARY SCHOOL (2302)

SUMMARY REPORT

VEIUTO PRIMARY SCHOOL (2302) SITE INSPECTION REPORT

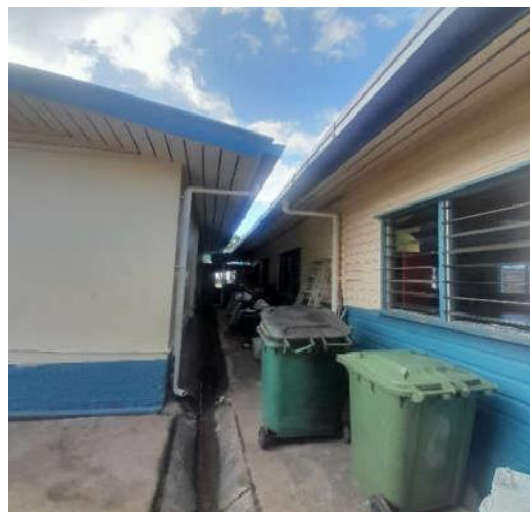
04. BLOCK 03 & LIBRARY STORM DISCHARGE INTO DRAIN.

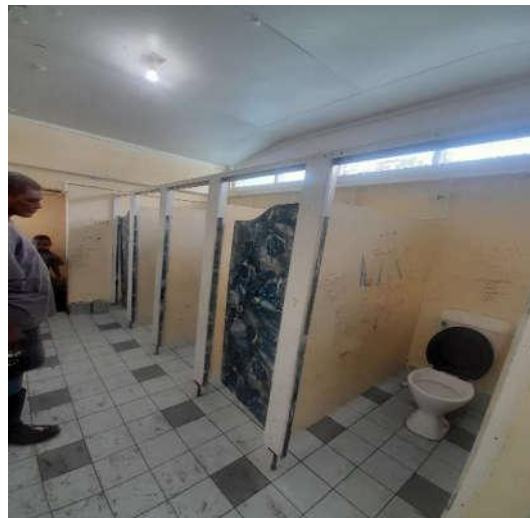
06. JUNIOR BOYS TOILET CUBICLES.

Recommendations							
<ul style="list-style-type: none">● Block 04 main roof to receive new paint and gutters to be cleaned.● Block 04 requires new fire extinguishers with regular tests.● Block 04 Toilet block walls to receive new paint to cover graffiti and some cubicles to have new doors with new lock system.● Refer to Table 03 on page 6 for classroom dimension and overcrowding details.

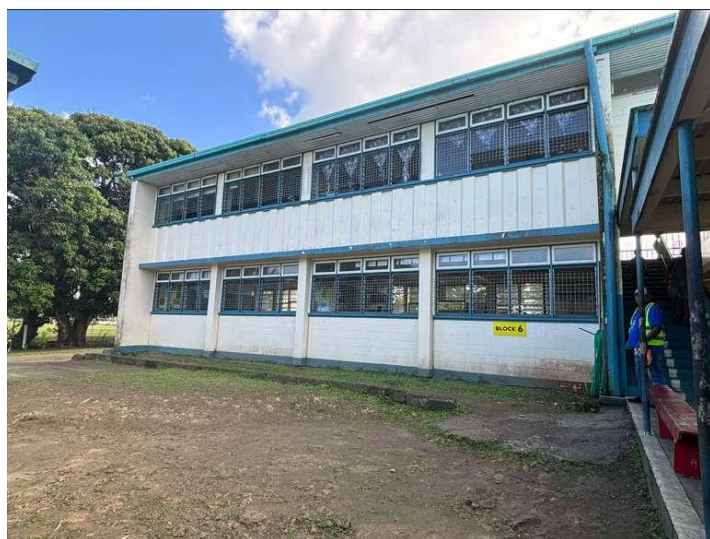
01. WINDOWS ALONG SIDE WALLS, MISSING DOWN PIPES.

Recommendations <ul style="list-style-type: none">● Block 06 main roof to receive new paint and gutters to be cleaned. New downpipes with brackets to wall.● Block 06 requires new fire extinguishers with regular tests.● Refer to Table 03 on page 6 for classroom dimension and overcrowding details.

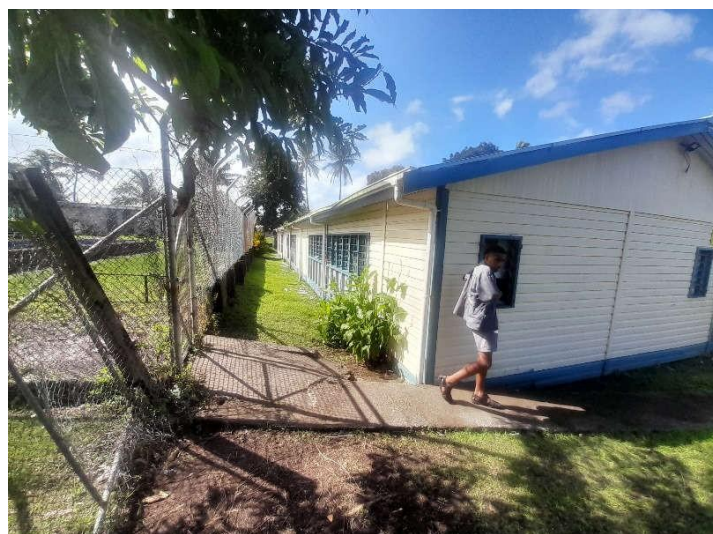
02. FENCE ALONG GRAMMAR SCHOOL END.

Recommendations <ul style="list-style-type: none">● Fencing to be repaired along Grammar School end.● Block 01 requires new fire extinguishers with regular tests.● Refer to Table 03 on page 6 for classroom dimension and overcrowding details.

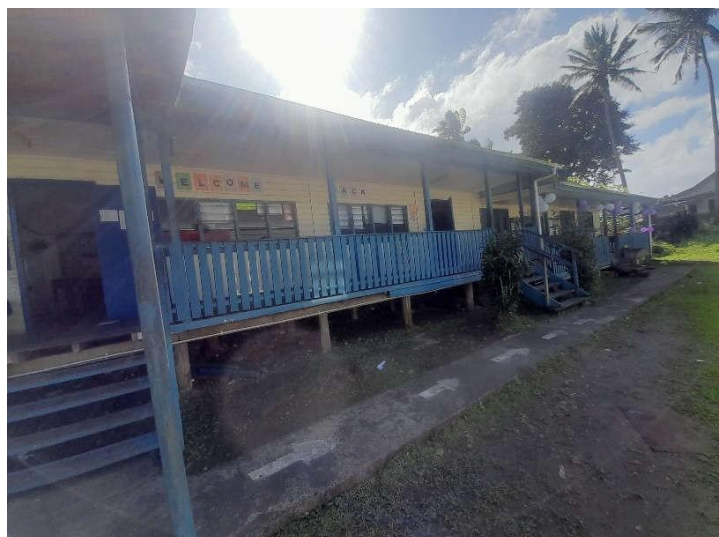
- **Floor and Foundation** – All of the structures have no signs of ground settlement. Buildings with block wall have concrete slab on ground. Block 08 sub floor timber framing supported on timber poles.

03. TIMBER FLOOR RAISED ABOVE GROUND.

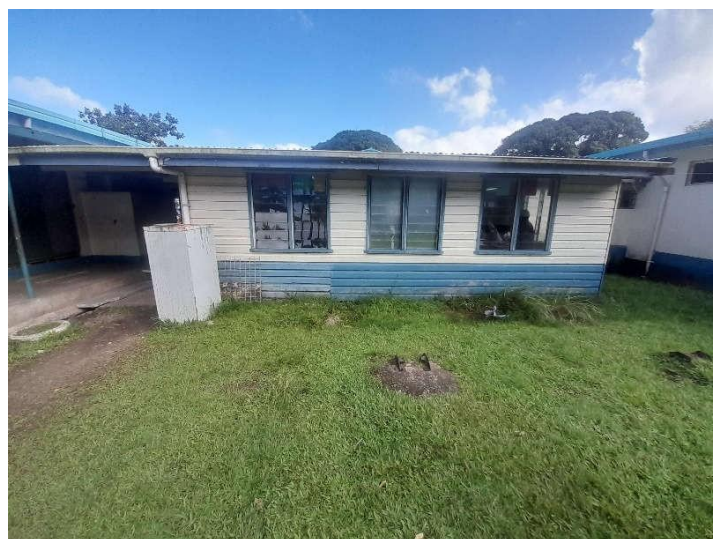
02. BLOCK 09 BACK & SIDES TIMBER FRAME.

School Inspection Summary	
School name:	VEIUTO PRIMARY SCHOOL
Overall condition state:	FAIR
Key recommendations:	
<ul style="list-style-type: none"> • Overcrowding – new reinforced concrete structure with eight new classrooms required. • Overcrowding – 6 new classrooms required based on recommended sizing (1.5m²) • WASH – one new ablution block to have ten water closets with four shower cubicles complete with four hand basins for Boys and fourteen water closets with four shower cubicles complete with four hand basins for Girls • Accessibility – new disable toilet cubicle. • Safety – new security block fence to replace existing chain link along Grammar side and new set of fire extinguishers. 	
Comments:	
Major defects were noted as follows:	
<ul style="list-style-type: none"> • Block 08 timber sub floor deteriorated. Remedial works required. • Block 09 all timber wall needs to be replaced with block wall.

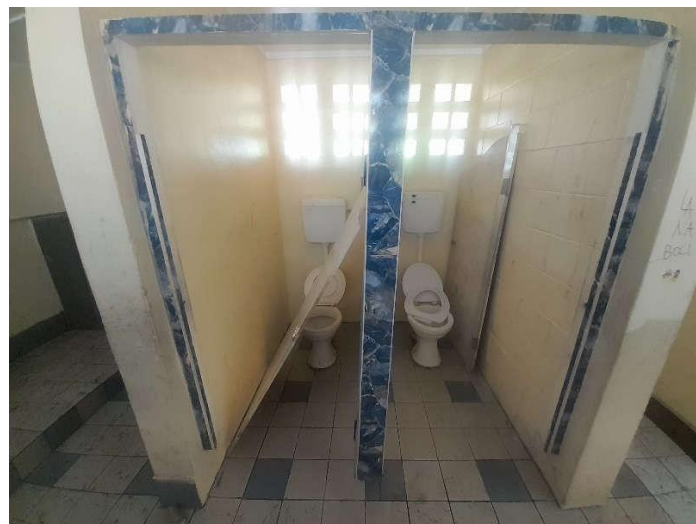
- Damaged water closet seats and cubicle doors for Senior boys' toilets. Graffiti on walls and cistern most common.

04. BOYS WC CUBICLES, URINAL, TILED FLOOR.

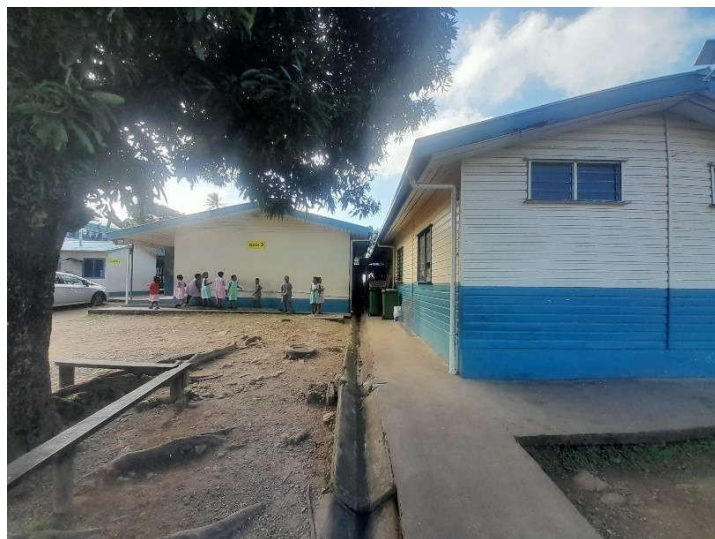
02. STORMWATER DRAINAGE OUTLET.
