# INFRASTRUCTURE ASSESSMENT AUDIT FOR SUVA – NAUSORI URBAN SCHOOLS

YAT SEN PRIMARY SCHOOL (REG 2360)

## SUMMARY REPORT

SITE INSPECTION REPORT

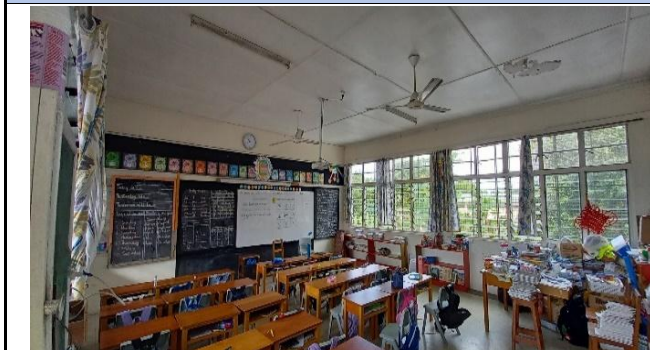
Photograph No. 5: Interior View Of Class 101 Located At Top Floor

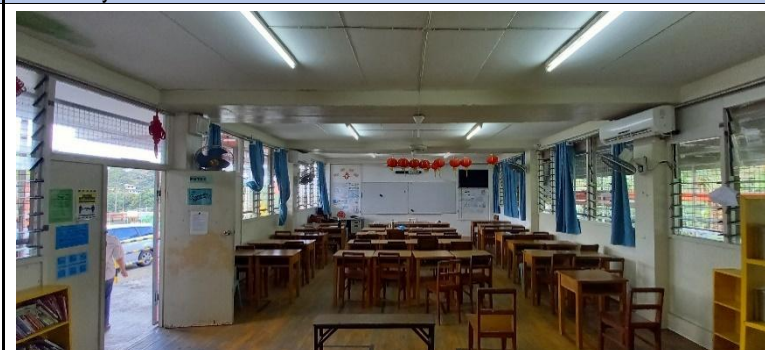
Photograph No. 6: Interior View Of Chinese Classroom Located At Ground Floor

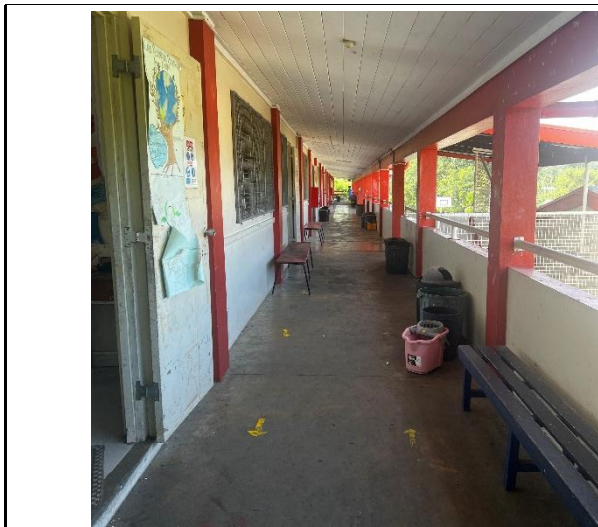
Photograph 7: Typical Walkway. Shows Walkway At Top Floor Of B2.

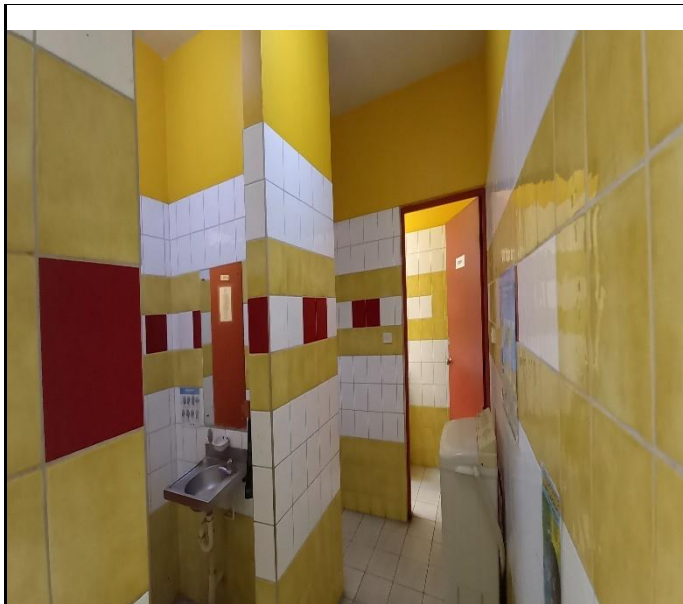
PHOTOGRAPH 7: SHOWS OVERALL VIEW OF THE KINDY TOILET ROOM, Seen Here Is Passageway To Female Toilet, Male Toilet And Staff Toilet.

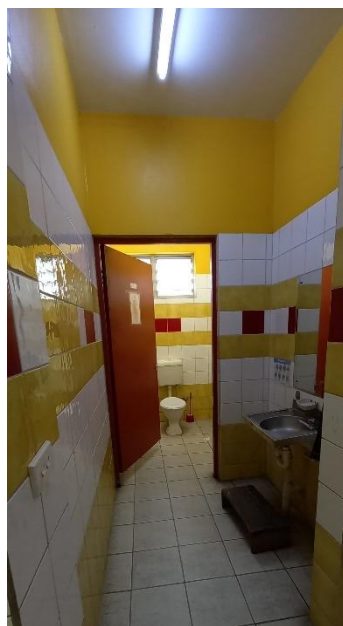
PHOTOGRAPH 8: TYPICAL TOILET AREA TO A CUBICLE. Seen Here Is Toilet Cubicle For Females. One Toilet Each

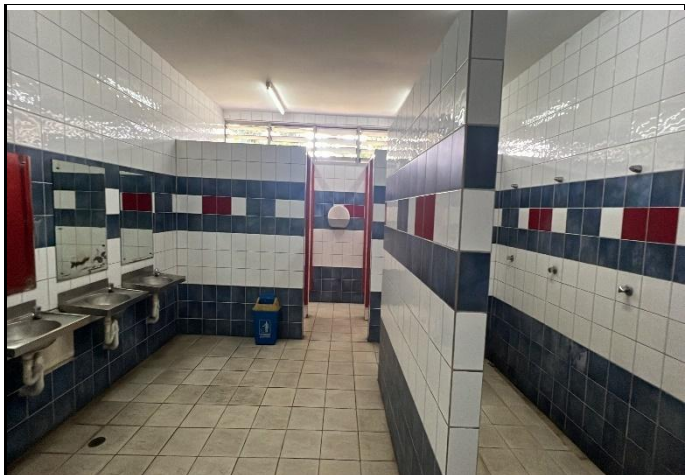
Photograph 11: Interior View Of A Typical Toilet Block

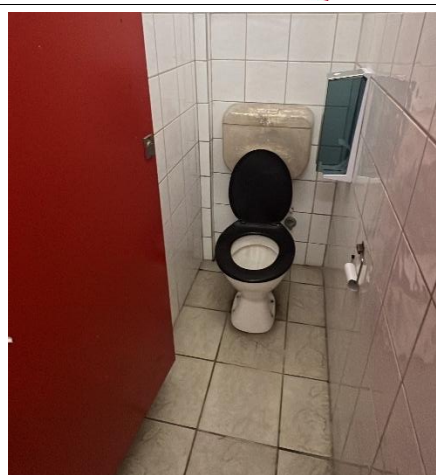
Photograph 12: Typical Toilet Cubicle & Amenities

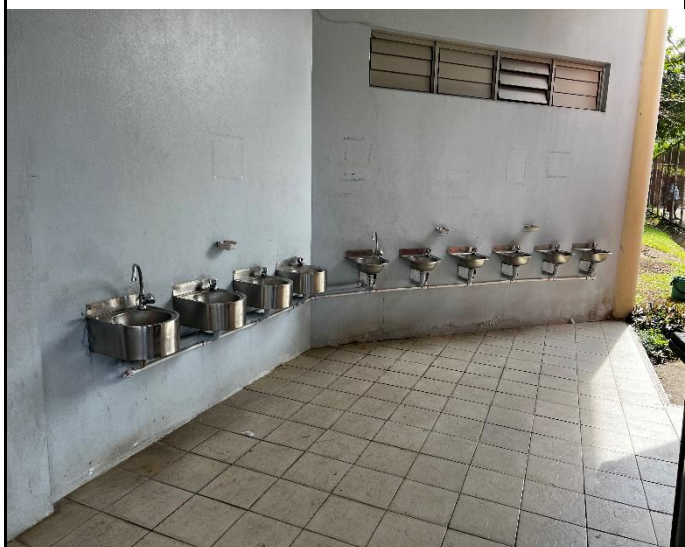
Photograph 13: Outdoor Taps/Hand Basin Near The School Hall Entrance

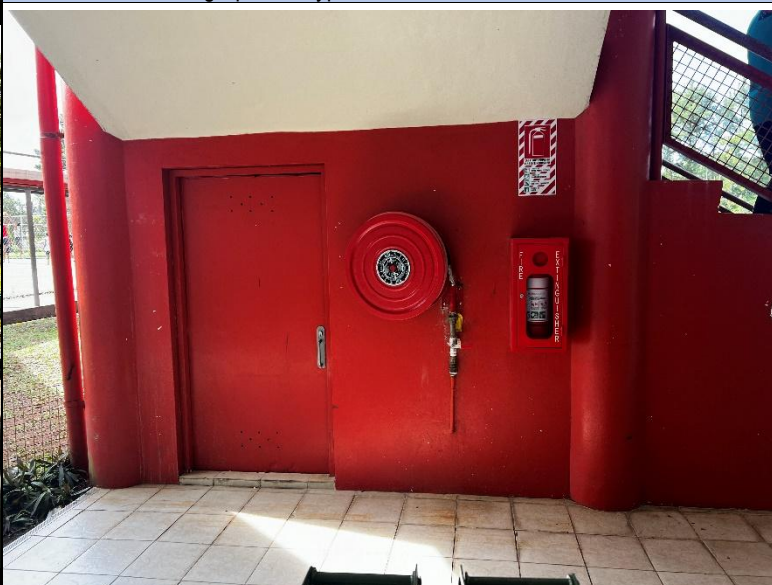
Photograph 14: Fire Hose Reel & Extinguisher Placed Under The Staircase At The Front Of The School Hall Entrance

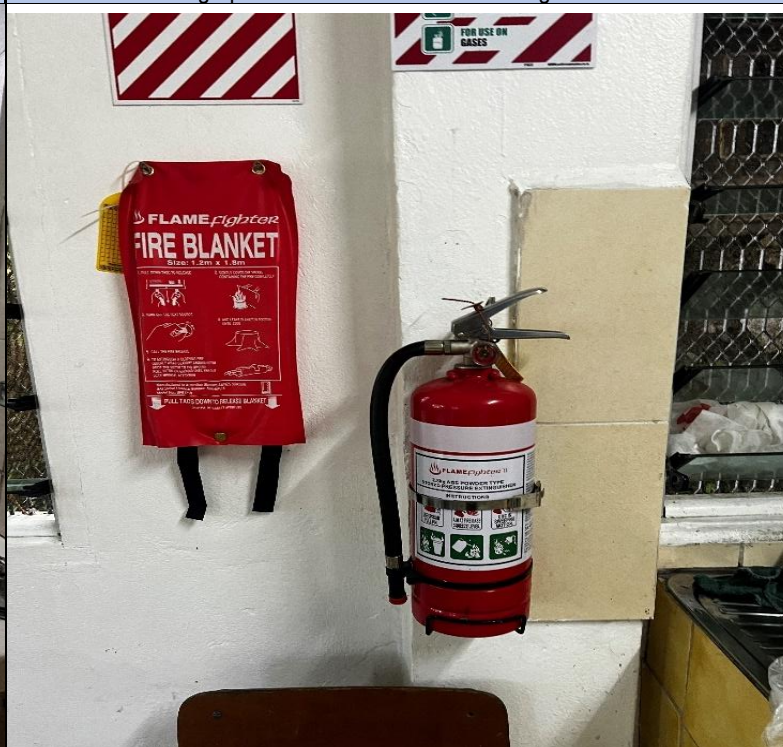
Photograph 8: Fire Safety equipment at kitchen area
