INFRASTRUCTURE ASSESSMENT AUDIT FOR SUVA – NAUSORI URBAN SCHOOLS

BHAWANI DAYAL MEMORIAL PRIMARY SCHOOL (2348)

SUMMARY REPORT

SITE INSPECTION REPORT

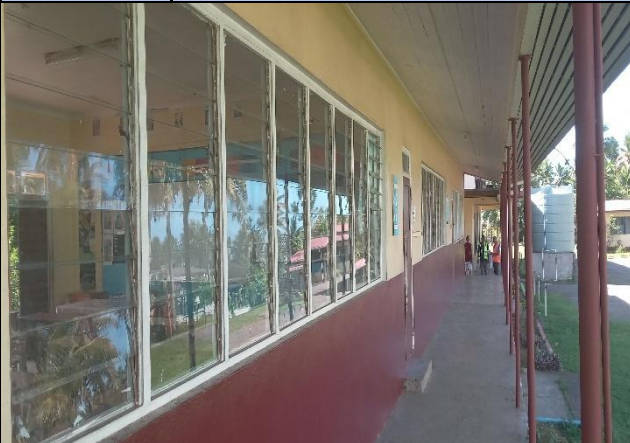
Figure 3: PHOTOGRAPHIC VIEW OF BLOCK 2

PHOTOGRAPH No. 1: FRONT		PHOTOGRAPH No. 2: WALKWAY

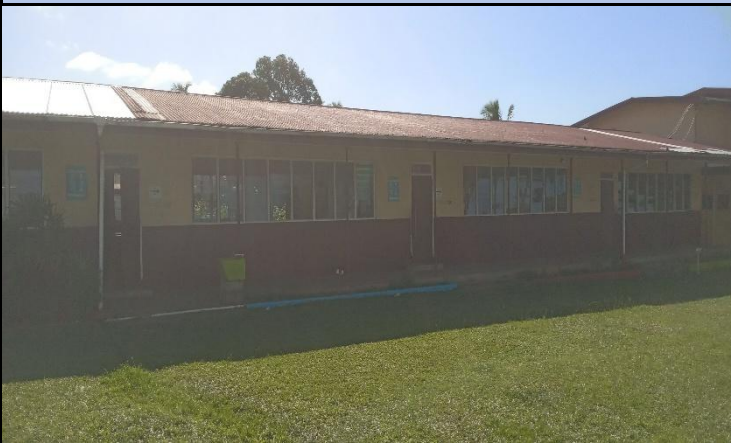
PHOTOGRAPH No. 3: BACK		PHOTOGRAPH No. 4: GENERAL TAPS

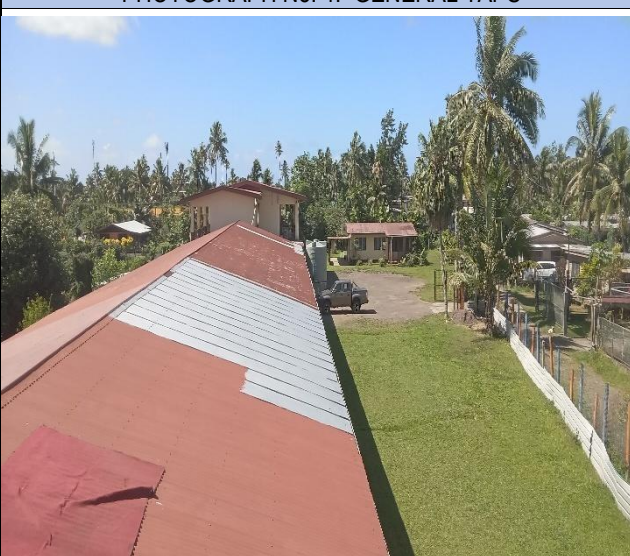
PHOTOGRAPH No. 5: INTERIOR		PHOTOGRAPH No. 6: ROOF
