INFRASTRUCTURE ASSESSMENT AUDIT FOR SUVA – NAUSORI URBAN SCHOOL

CHRISTIAN MISSION FELLOWSHIP COLLEGE (2585) SUMMARY REPORT

CHRISTIAN MISSION FELLOWSHIP COLLEGE (2585) SITE INSPECTION REPORT

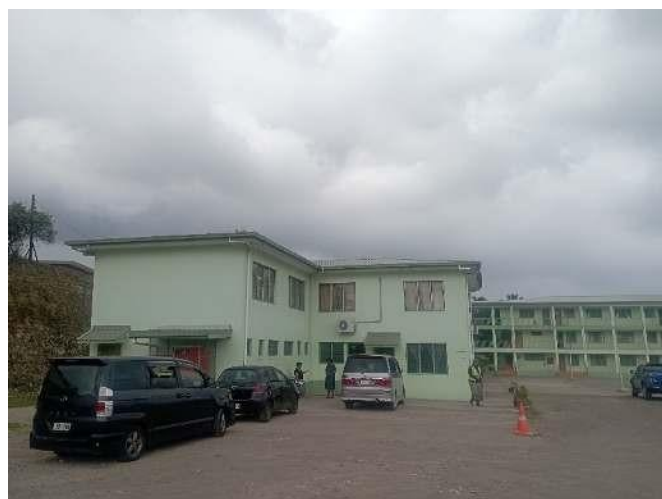
01. FRONT VIEW, ENTRY ACCESS TO ADMIN OFFICE, CARPARK.

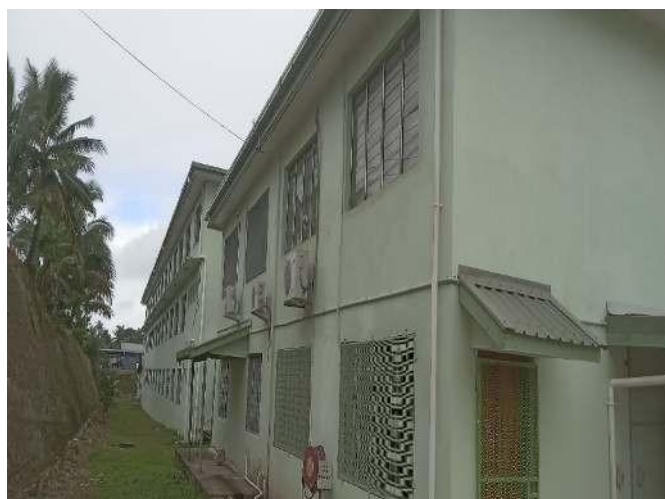
02. BACK VIEW, FIRE HOSE, SIDE CLEARANCE.

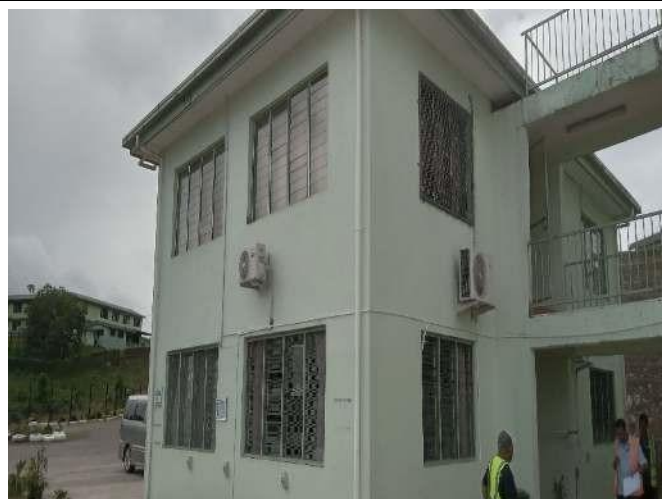
03. WINDOW OPENINGS ON ALL SIDES.

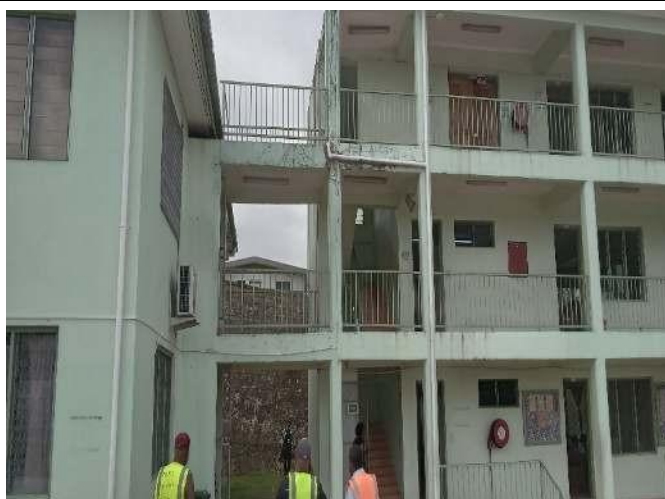
04. ENTRY TO FIRST FLOOR FROM BLOCK 02.

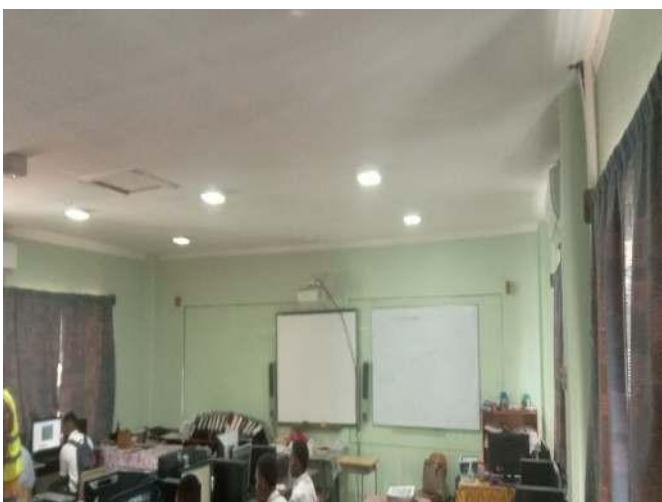
05. COMPUTER LAB CEILING LIGHTS & AIR CON.

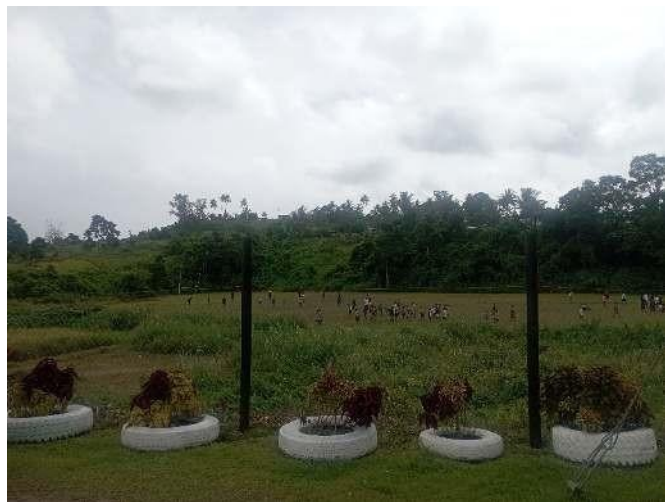
06. SCHOOL PLAYGROUND, COMPOUND FENCED.

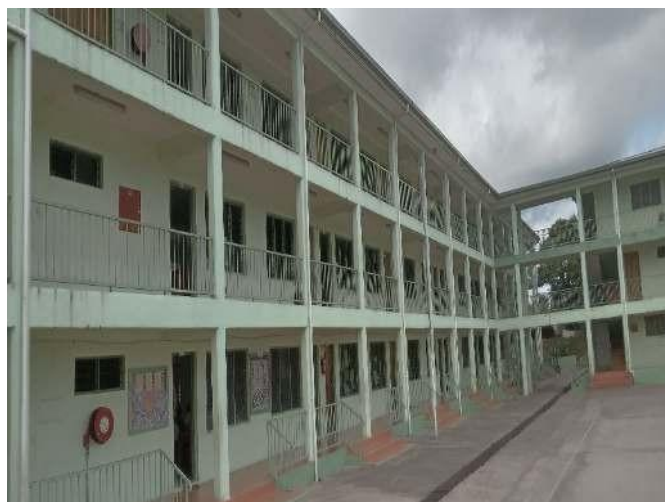
01. FRONT VIEW, RAILING & FIRE HOSE TO ALL FLOORS.

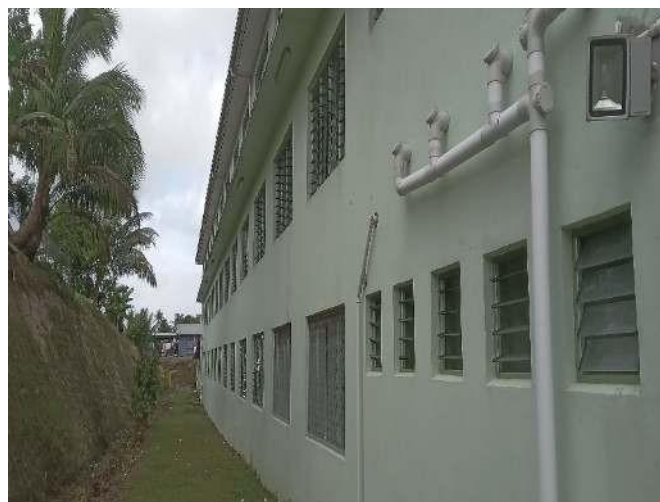
02. BACK VIEW, LIGHTS & PLUMBING.

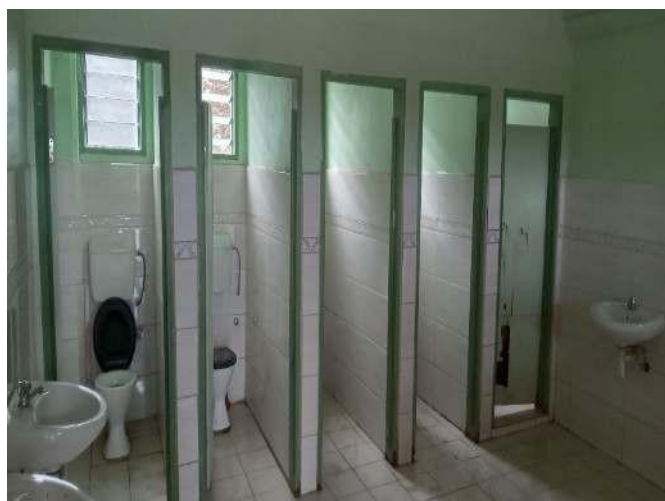
- Block 02 ground floor Boys washroom – 4no. water closets, 1no. shower, 8no. hand basin with taps, 2no. urinal.
- Block 02 ground floor Girls washroom – 7no. water closet, 1no. shower, 6no. hand basin with taps. 2no. basins damaged. Sanitary bin provided.

03. GROUND FL BOYS TOILET CUBICLES & HAND BASINS.

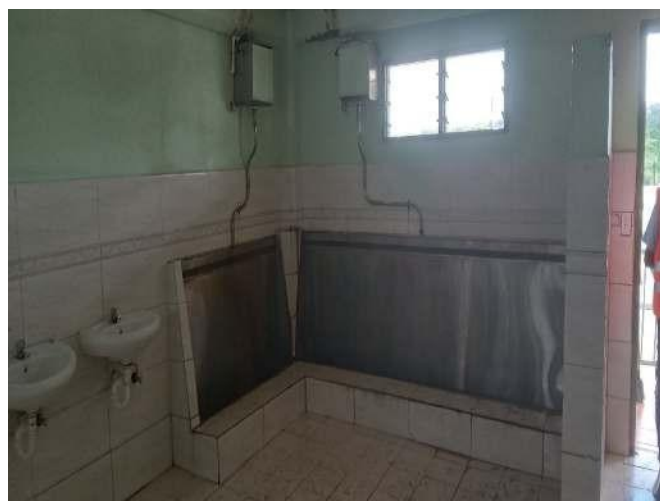
04. GROUND FL BOYS TOILET SSS URINALS.

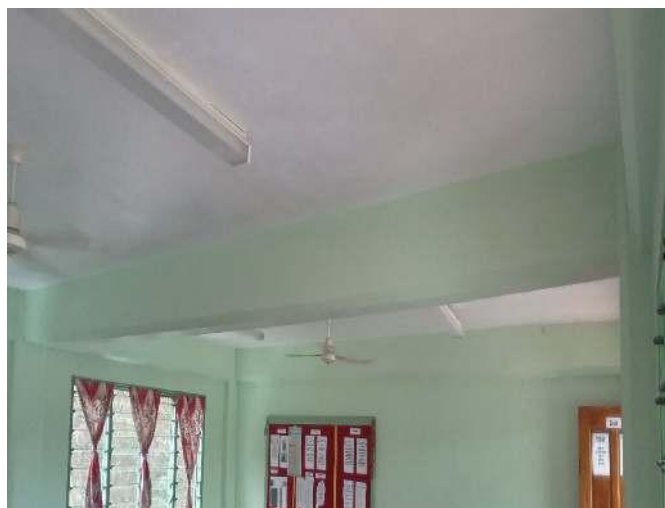
05. GROUND FL ROOM TYPICAL 4 LIGHTS, 2 CEILING FANS.

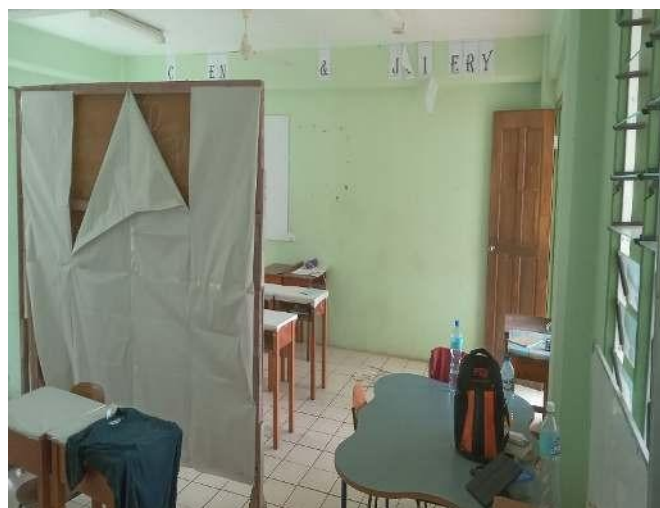
06. TILED FLOOR, SOLID TIMBER ACCESS DOORS.

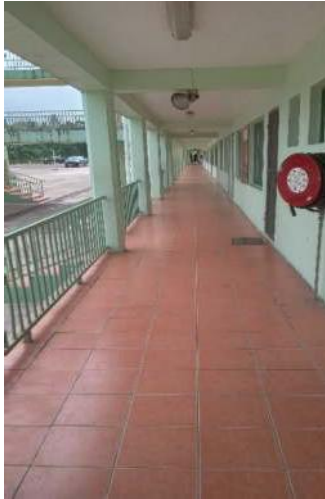
01. FIRST FL CORRDIOR, FIRE HOSE, STAIRWELL, HAND RAILS.

Recommendations - install new 4no. hand basins with taps for first floor and second floor corridor for ease of access.

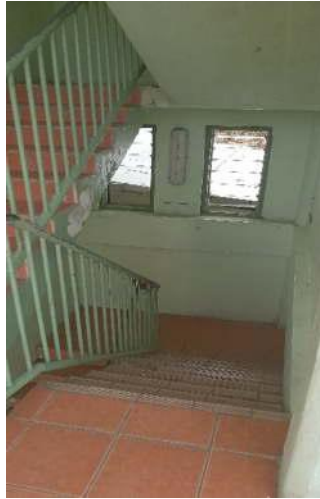
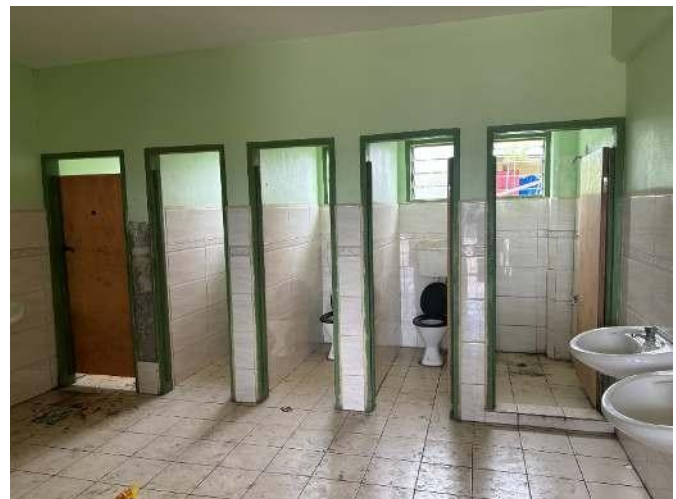
02. FIRST FL GIRLS TOILET CUBICLES, TILED FLOOR & WALLS.

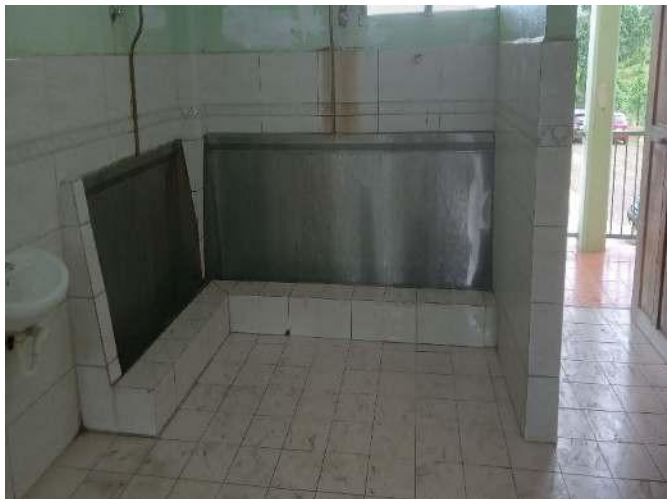
03. FIRST FL BOYS TOILET SSS URINALS.

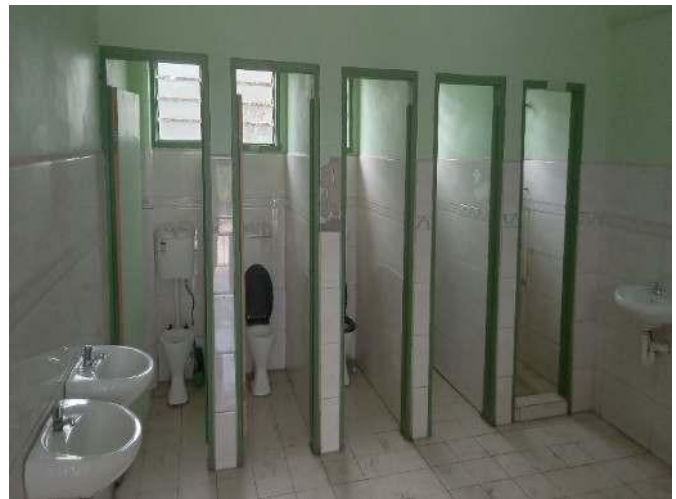
- Block 02 first floor Boys washroom – 4no. water closets, 1no. shower, 6no. hand basin with taps, 2no. urinal. 2no. basins damaged.
- Block 02 first floor Girls washroom – 7no. water closet, 1no. shower, 8no. hand basin with taps. Sanitary bin provided.

04. FIRST FL BOYS TOILET CUBICLES & HAND BASINS.

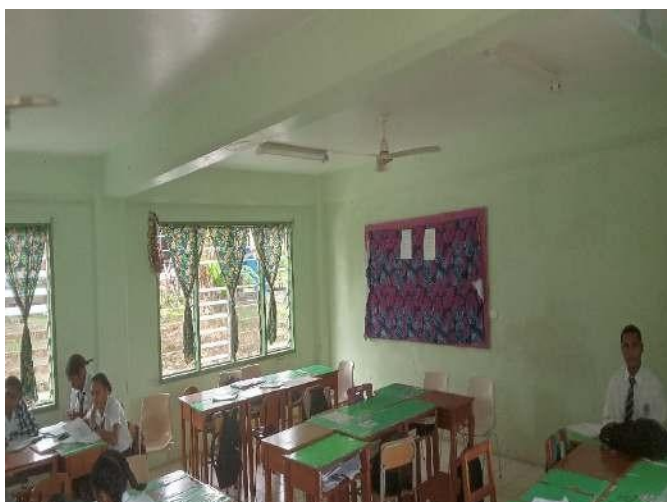
05. RIGID CONC FRAME WITH BEAMS & COLUMNS.

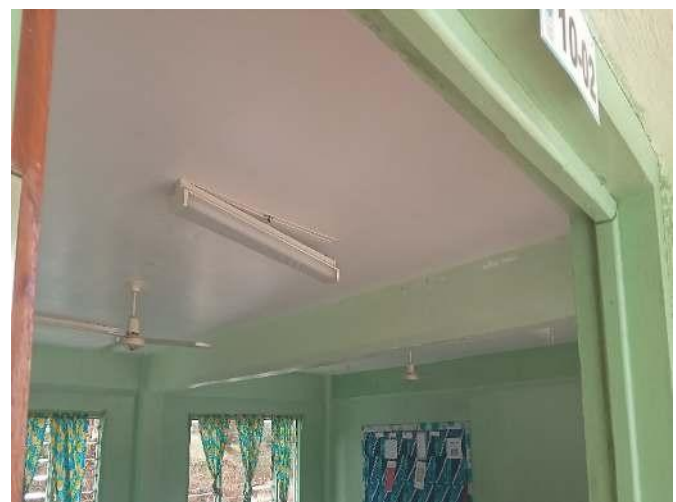
06. FIRST FL ROOM TYPICAL 4 LIGHTS, 2 CEILING FANS.

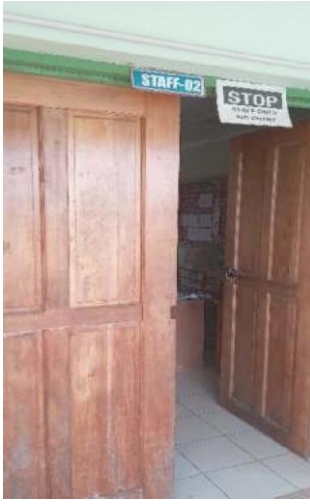
01. DOOR JOINERY FOR STAFF & EACH CLASSROOM.

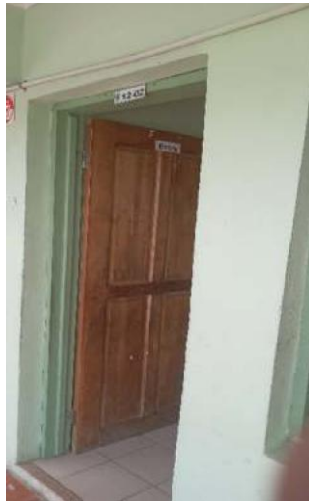
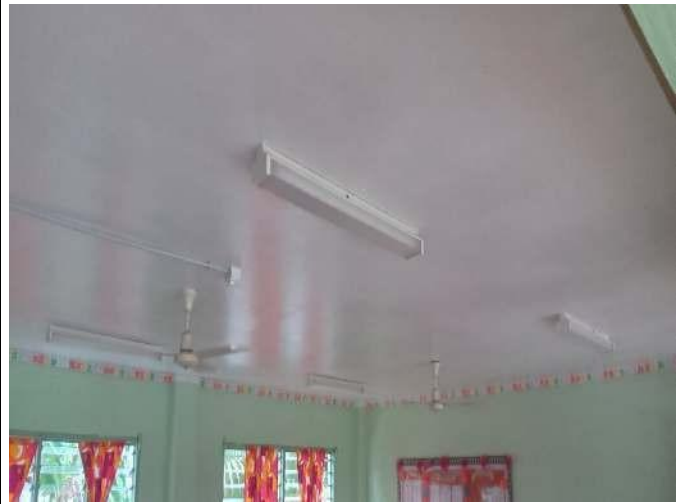
02. SECOND FL CEILING TO U/S OF ROOF FRAME.

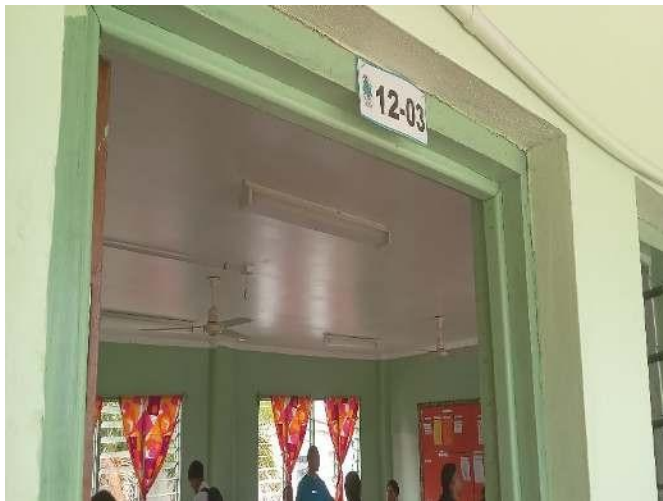
03. SECOND FL ROOM TYPICAL 4 LIGHTS, 2 CEILING FANS.

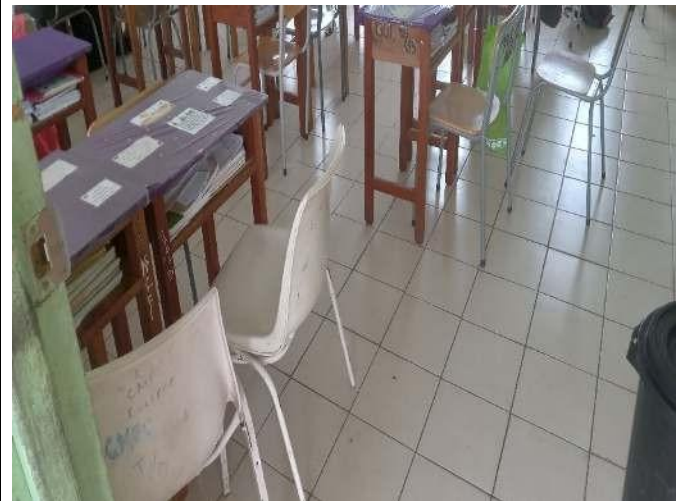
04. SECOND FL ROOM TYPICAL TILED FLOOR.

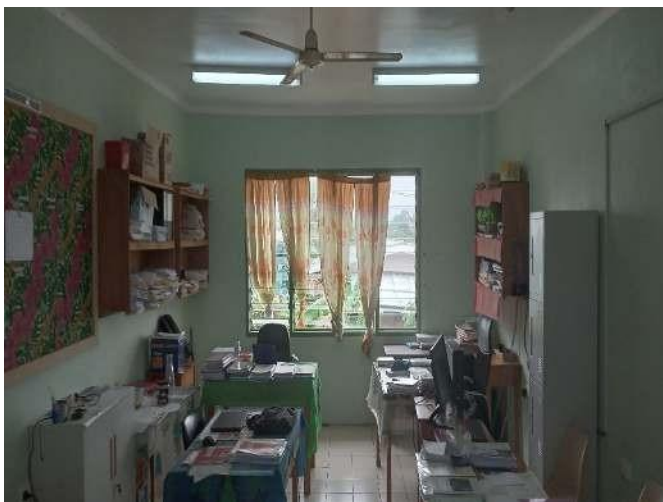
05. SECOND FL STAFF ROOM LIGHT & VENT.

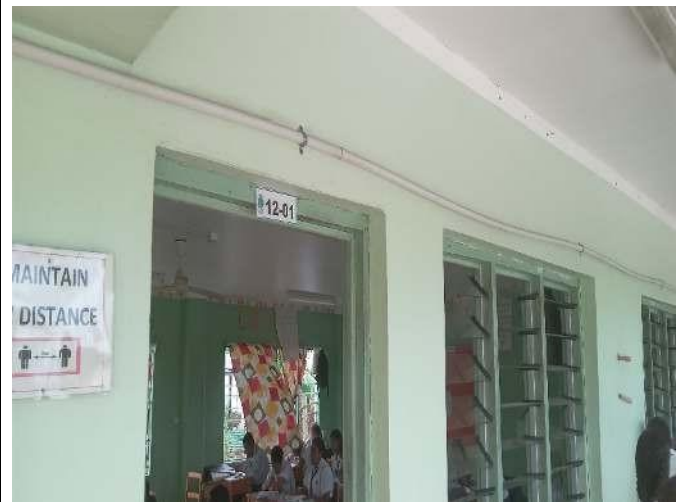
06. TYPICAL WINDOW FOR EACH ROOM ON EVERY FLOOR.

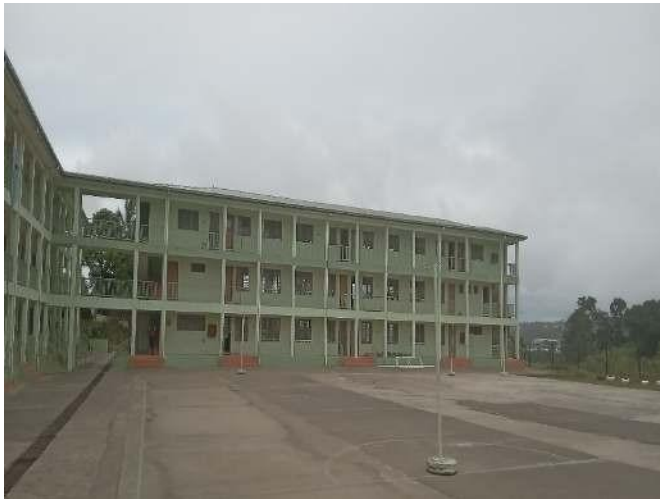
01. FRONT VIEW, ACCESS ONTO HARD COURT – ASSEMBLY AREA.

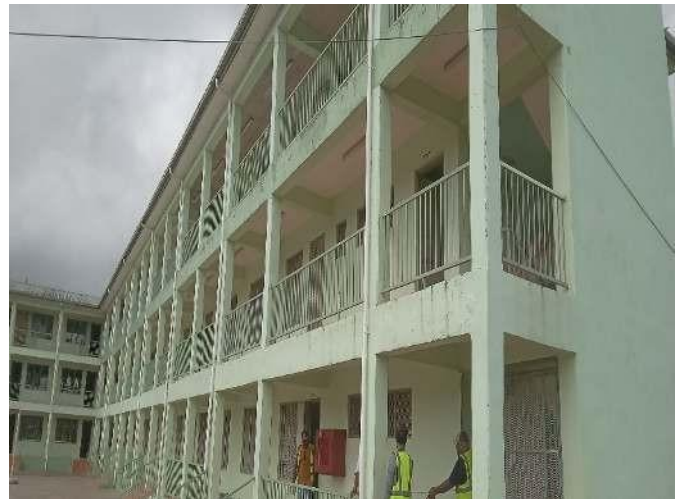
02. SIDE VIEW, RAILING TO ALL CORRIDORS.

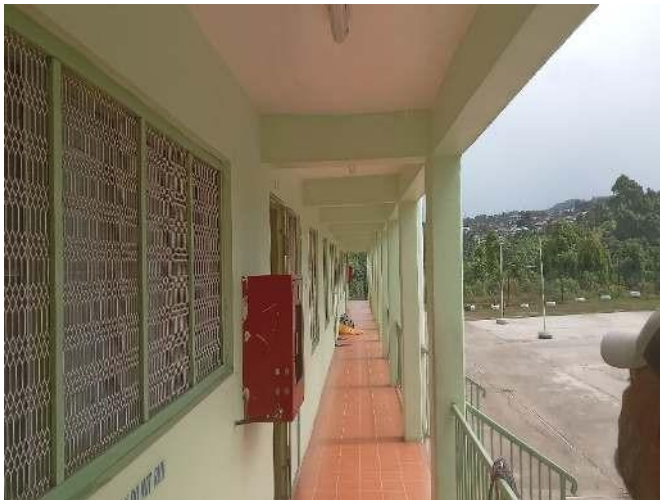
03. GROUND FL CORRIDOR, FIRE HOSE.

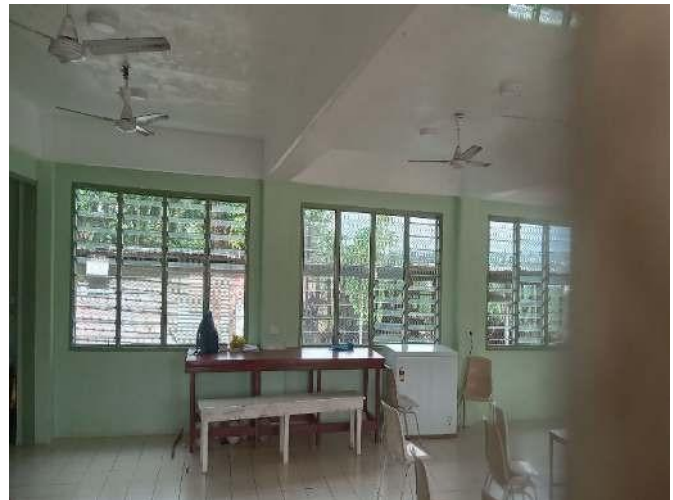
04. HOSPITALITY ROOM, LIGHTS & CEILING FANS.

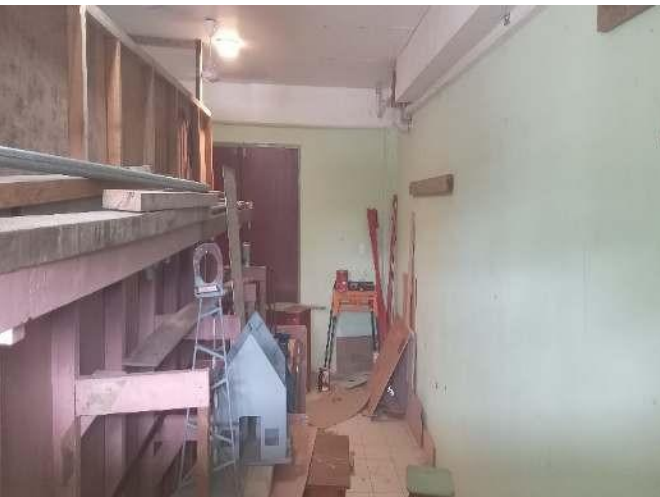
05. WOODWORK – INTERNAL PARTITION FULL HEIGHT BLOCK WALL.

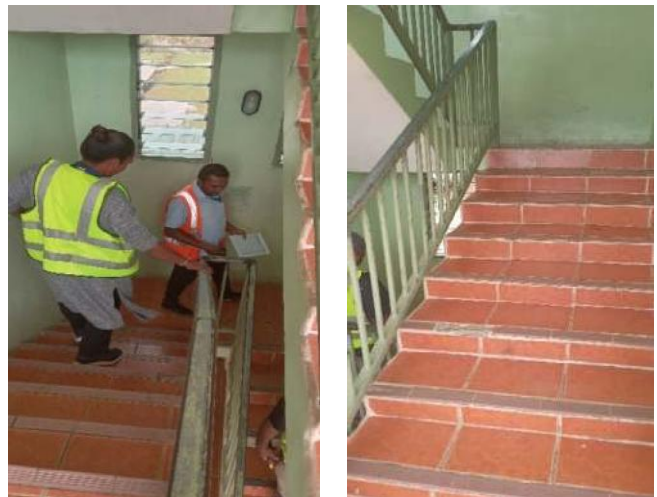
06. STAIRWELL 320 BY 180 RISER, 900 WIDE CLEAR.

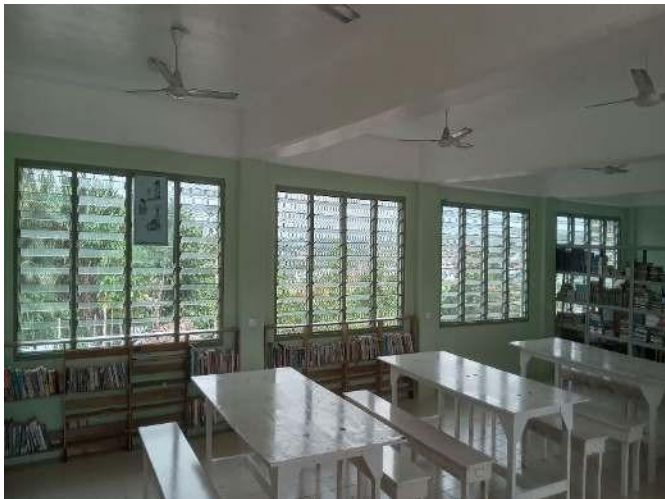
01. LIBRARY ROOM, TILED FLOOR, CEILING FANS, LIGHTS.

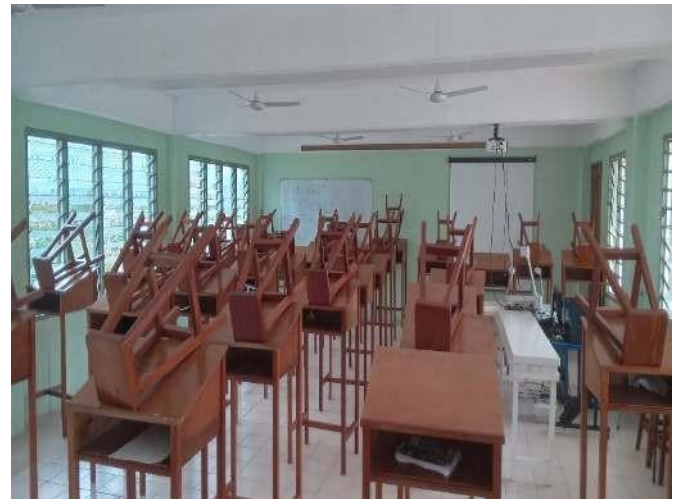
02. TECHNICAL DWG, NATURAL LIGHT & VENTILATION.

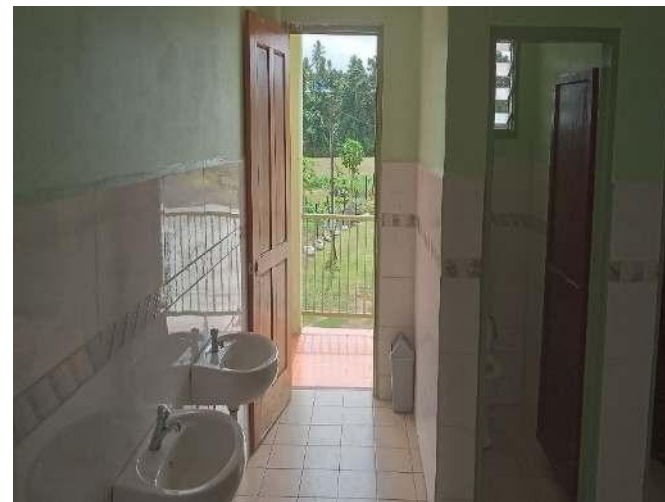
03. FIRST FL BOYS TOILET, TILED FLOOR, WALL TILES.

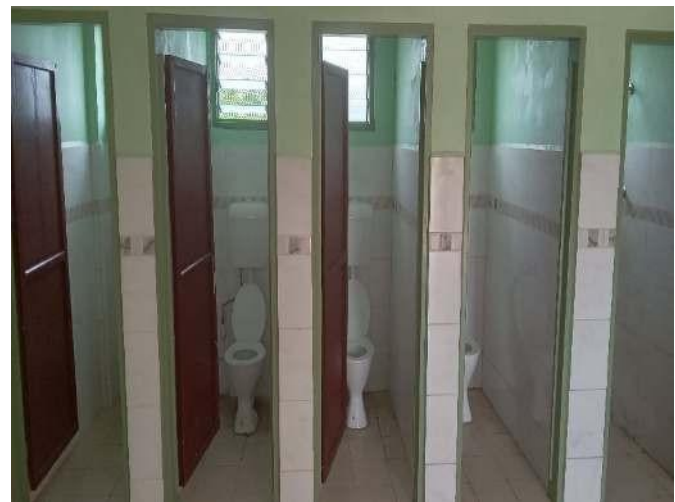
04. FIRST FL BOYS SHR & WC CUBICLES.

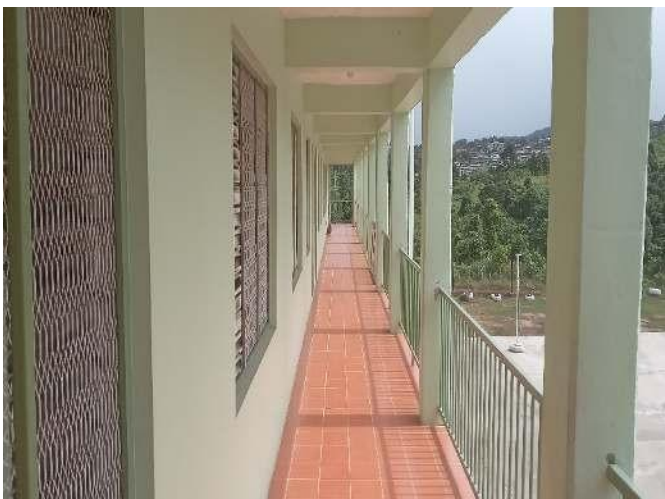
05. FIRST FL CORRIDOR, TILED FLOOR, GRILLED WINDOWS.

Recommendations <ul style="list-style-type: none">● Install new 4no. hand basins with taps for first floor and second floor corridors for ease of access.

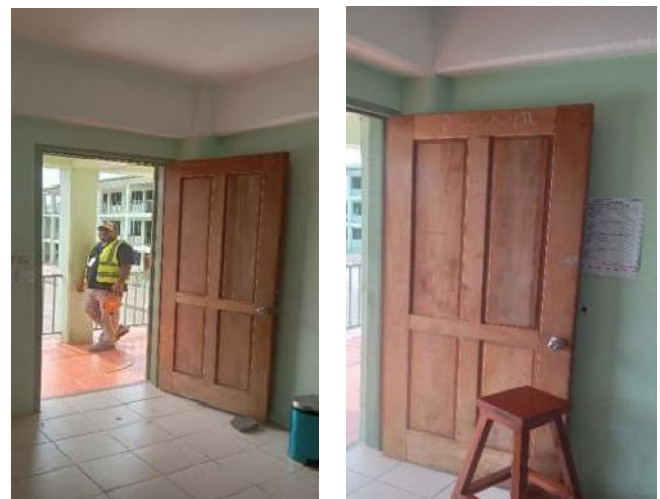
06. SOLID CORE ACCESS DOORS HUNG ON SSS HINGES.

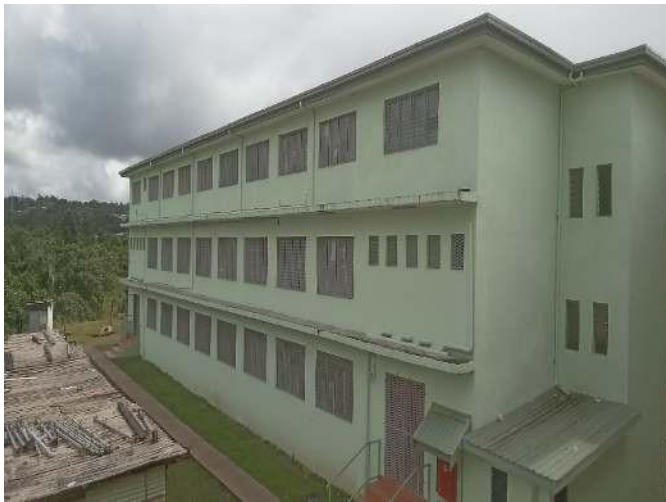
01. ROOF STORM DRAINAGE DOWN PIPES & SEWER VENTS.

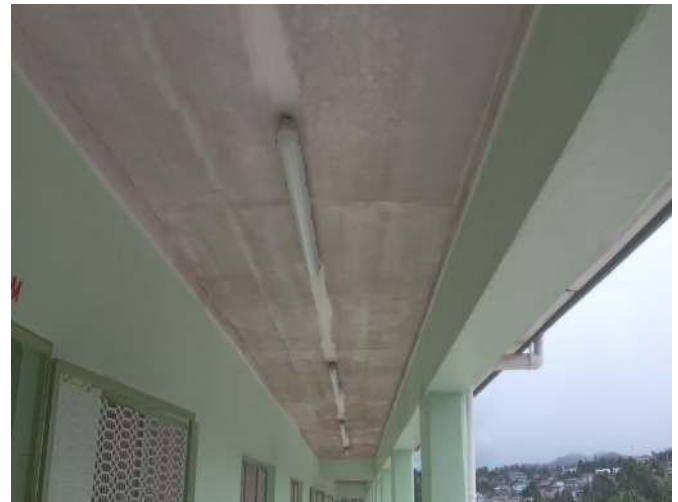
02. CORRIDOR CEILING TO U/S OF ROOF FRAME.

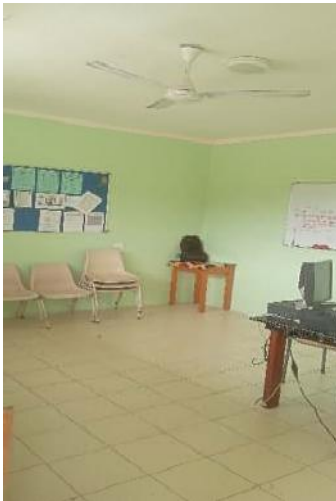
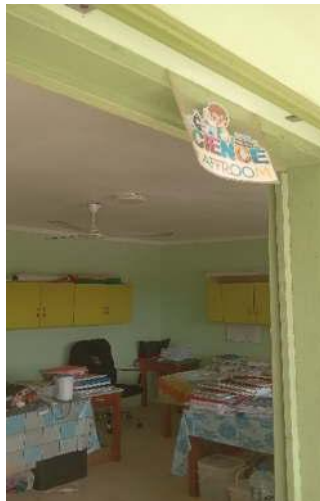
03. CHAPLIN & STAFF OFFICE, TILED FLOOR, LIGHT, CEILING FAN.

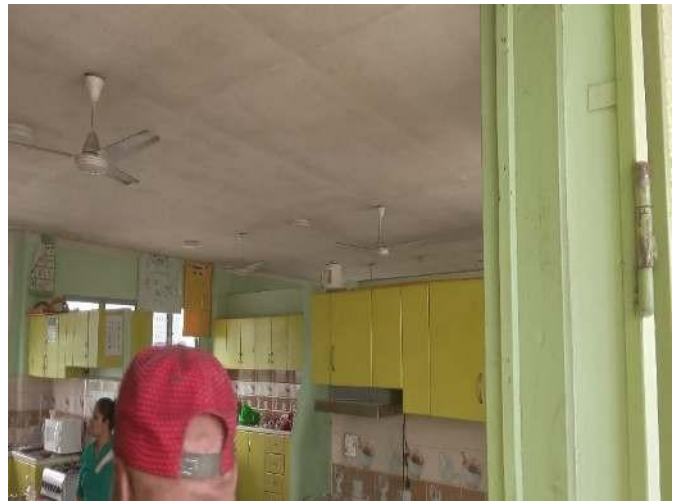
04. FOOD & NUTRI ROOM, CEILING FANS, LIGHTS.

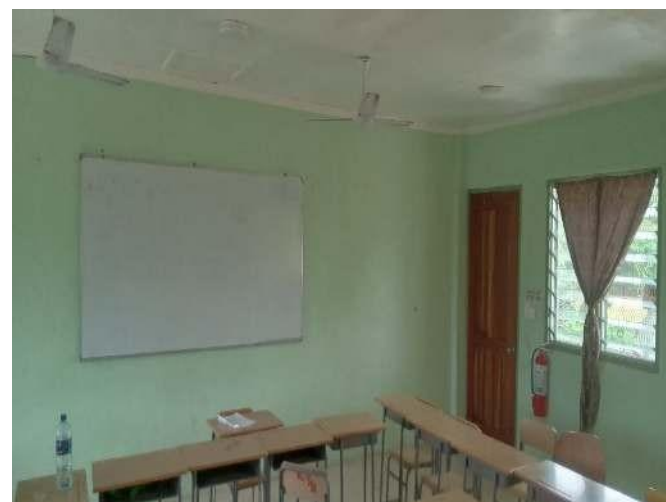
05. THEORY ROOM, CEILING LIGHTS, FANS, EXTINGUISHER.

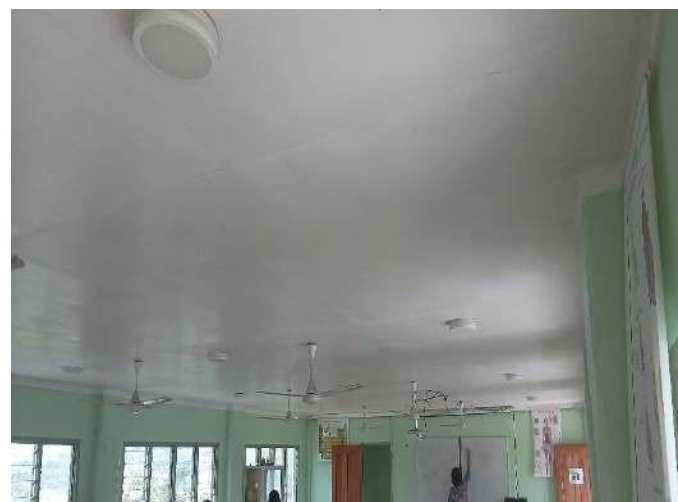
06. SCIENCE LAB CEILING LIGHTS, FANS, EXTINGUISHER.

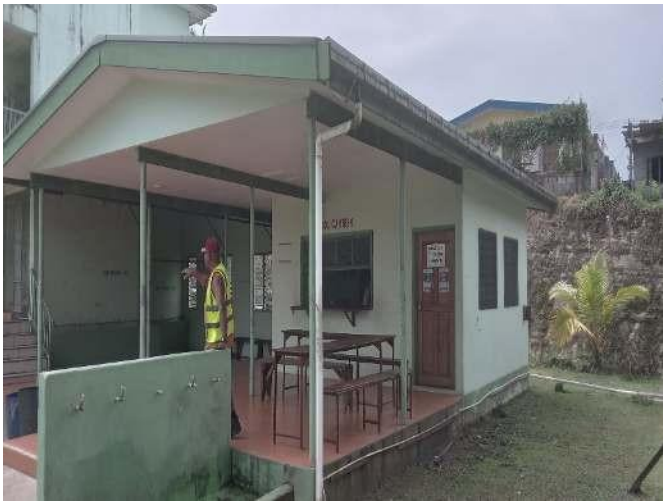
01. CANTEEN DOWNPIPE OUTLET & HAND WASH POINT.

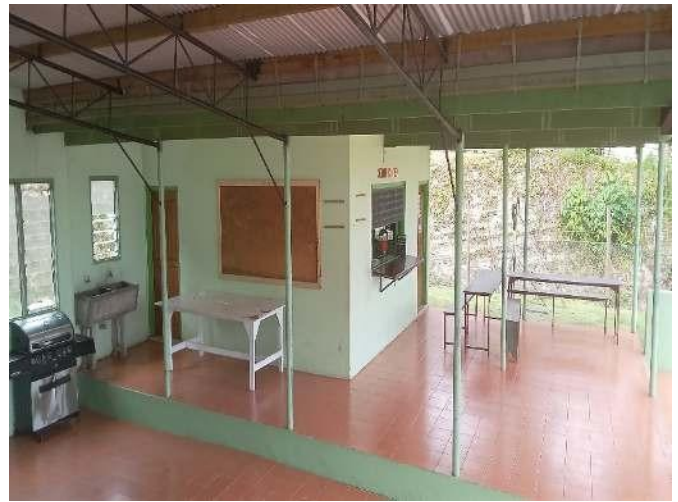
02. CANTEEN ACCESS & SERVICE COUNTER.

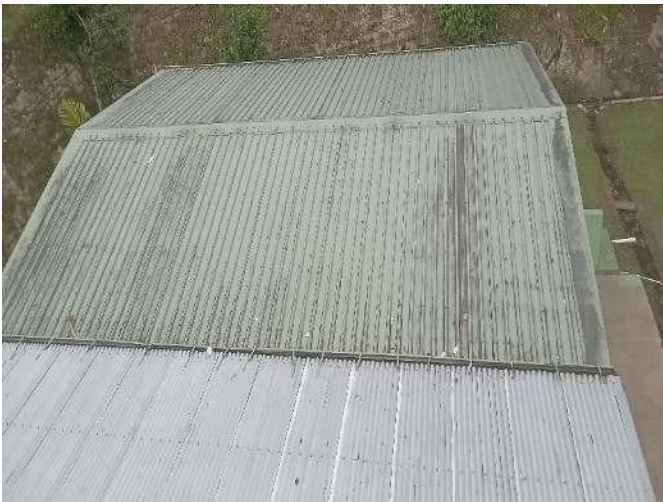
03. TRIMDEK ROOF CANTEEN, CORRUGATED ROOF WASH BAY.

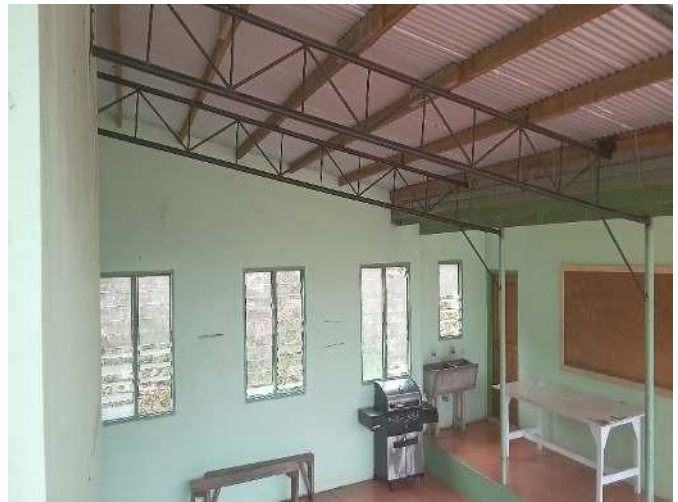
04. ROOF FRAMING OVER WASH BAY.

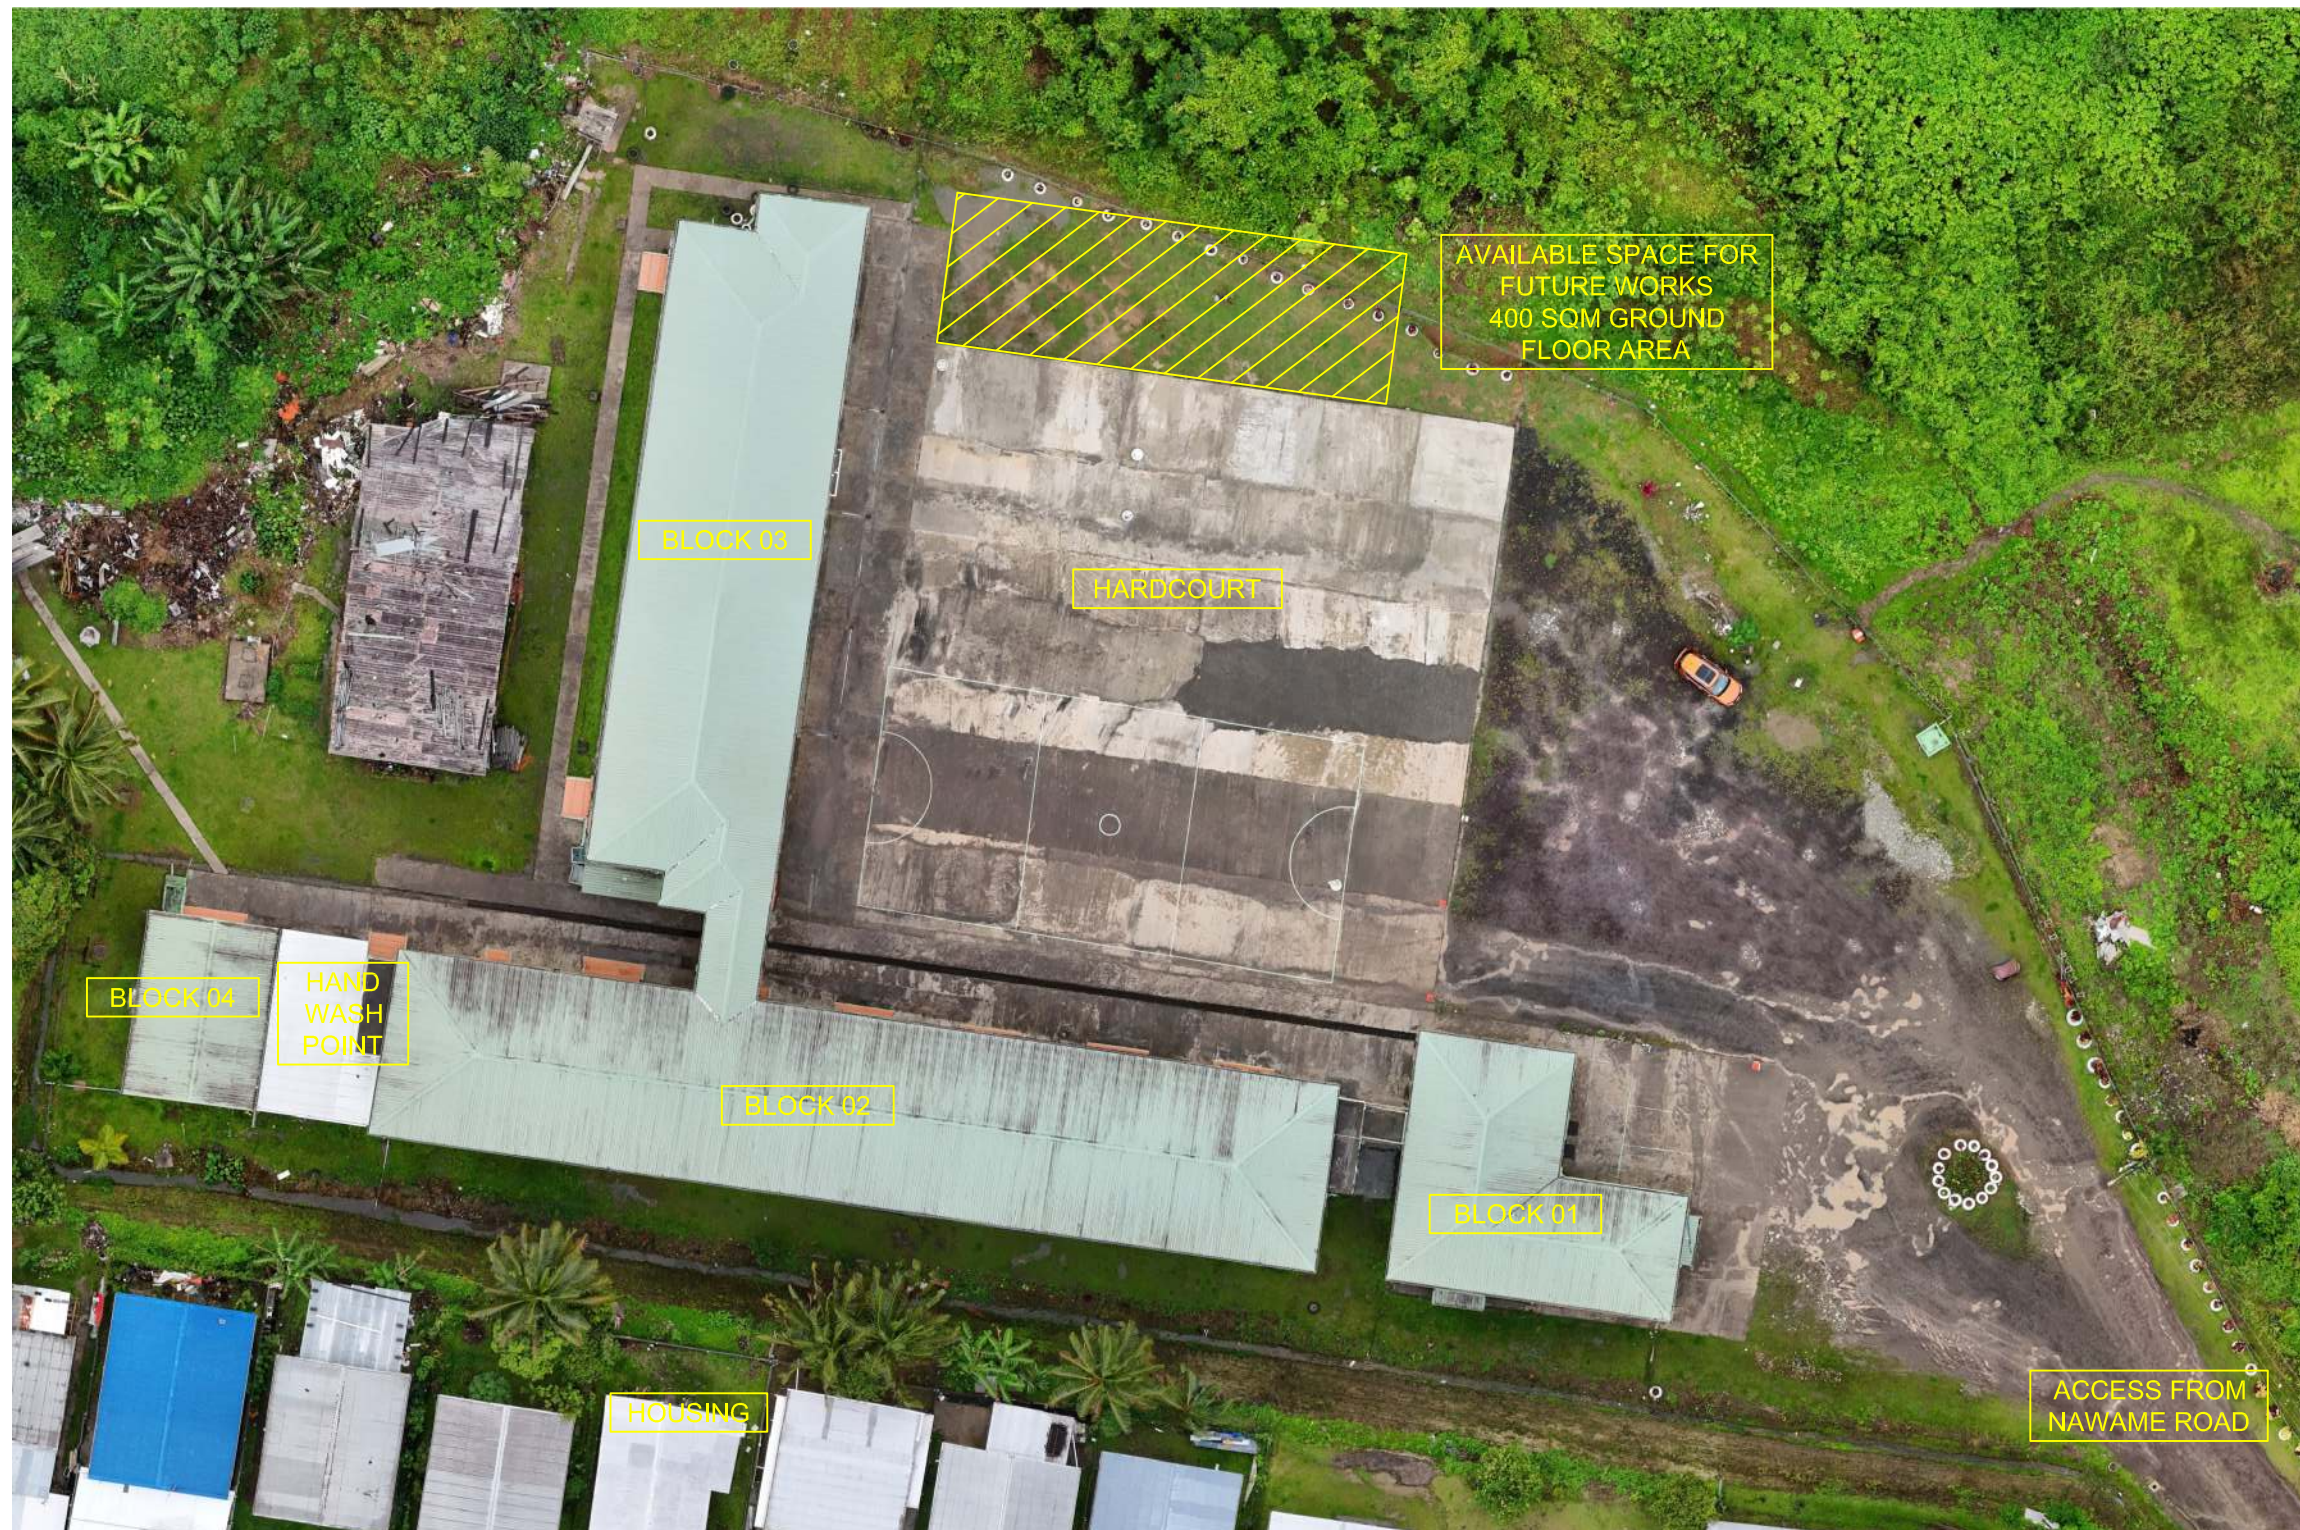
Appendix C – Land Available for Expansion

SCHOOL PROPOSE TO FUND FOR NEW 4no. LEVEL REINFORCED CONCRETE BUILDING AT MARKED FUTURE WORKS. NEW STRUCTURE WILL HAVE VOCATIONAL WORK SHOPS AND AMENITIES ACCESSIBLE TO DISABLE STUDENTS.
