INFRASTRUCTURE ASSESSMENT AUDIT FOR SUVA – NAUSORI URBAN SCHOOLS

DAV GIRLS COLLEGE (REG 2329)

SUMMARY REPORT

SITE INSPECTION REPORT

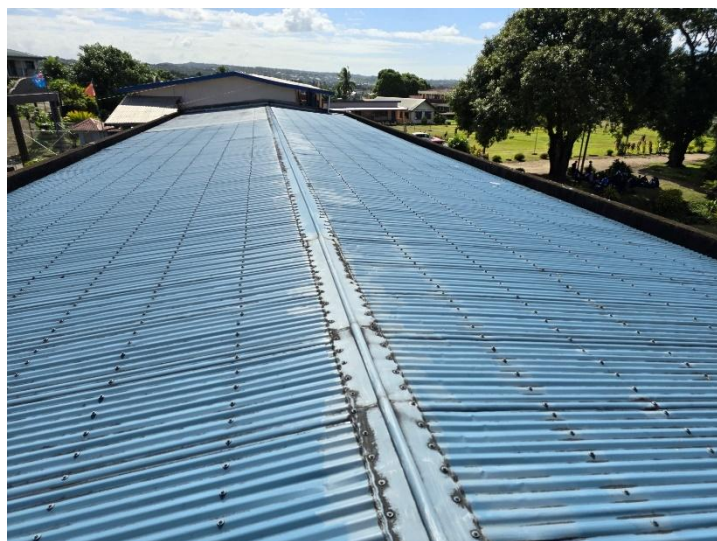
PHOTOGRAPH No. 7: ROOF SPACE

Figure 7: B1 ROOF CLADDING.

- Roof repairs due to rusting of cladding, roofing nails, gutter and gutter straps.
- Regular wire brushing and recoating of steel fixture especially steel fixtures that are exposed.
- Removing and replacing cracked tiles that could be a potential hazard for the students.
- The cracks floor beam at B2 veranda require patching.

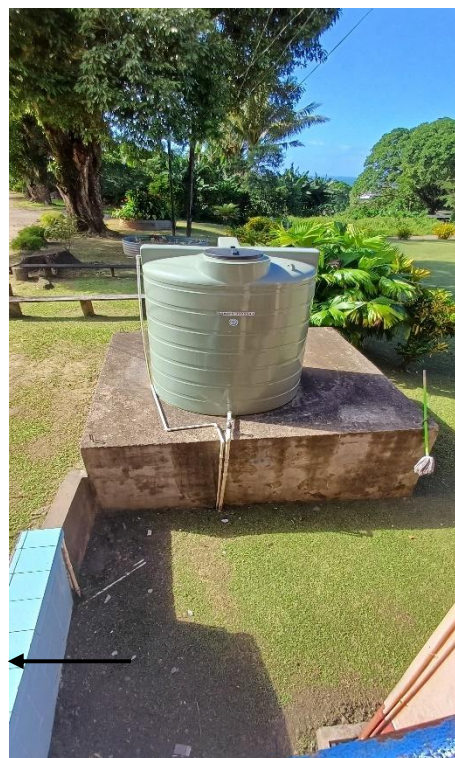
PHOTOGRAPH No. 8: WATER TANK

Figure 8: B1 WATER TANK WITH TAPS.

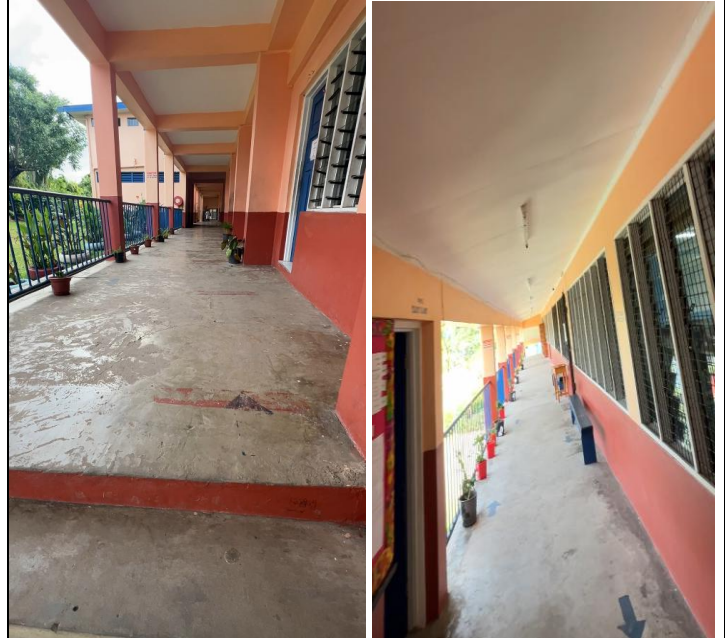
PHOTOGRAPH No. 10: WALKWAYS

Figure 18: B2 WALKWAYS AT GL AND SF.

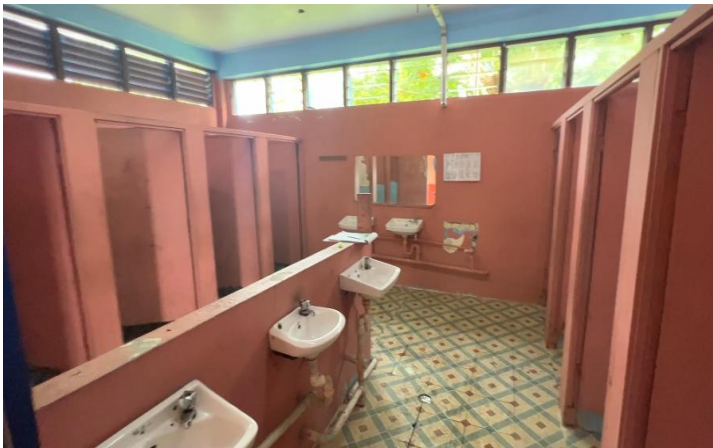
PHOTOGRAPH No. 11: TOILETS

Figure 19: B2 STUDENT TOILET INTERIOR.

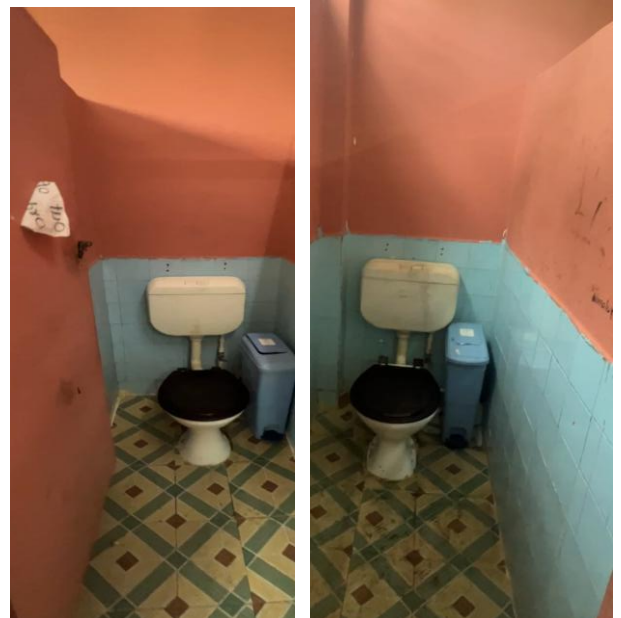
PHOTOGRAPH No. 12: TOILETS

Figure 20: B2 STUDENT TOILET

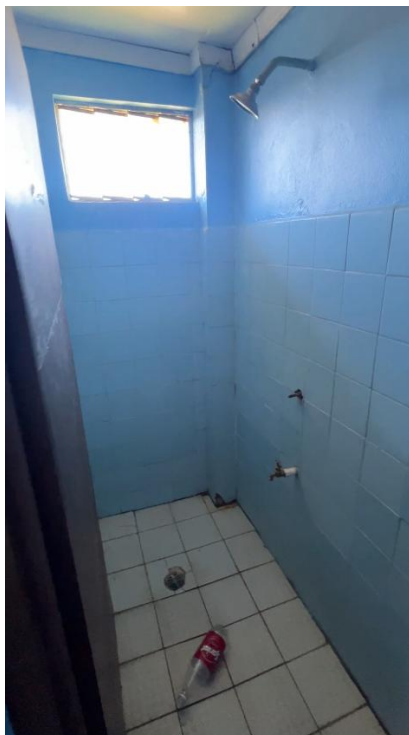
PHOTOGRAPH No. 13: SHOWER.

Figure 21: B2 FEMALE STAFF SHOWER.

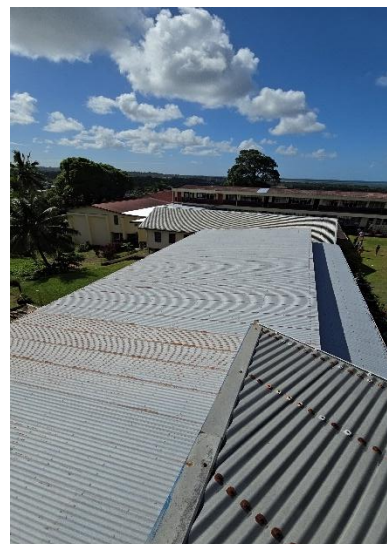
PHOTOGRAPH No. 6: ROOF SHEET

Figure 28: B3 ROOF SHEETING.
