INFRASTRUCTURE ASSESSMENT AUDIT FOR SUVA – NAUSORI URBAN SCHOOLS

DUDLEY HIGH SCHOOL (REG 2352)

SUMMARY REPORT

SITE INSPECTION REPORT

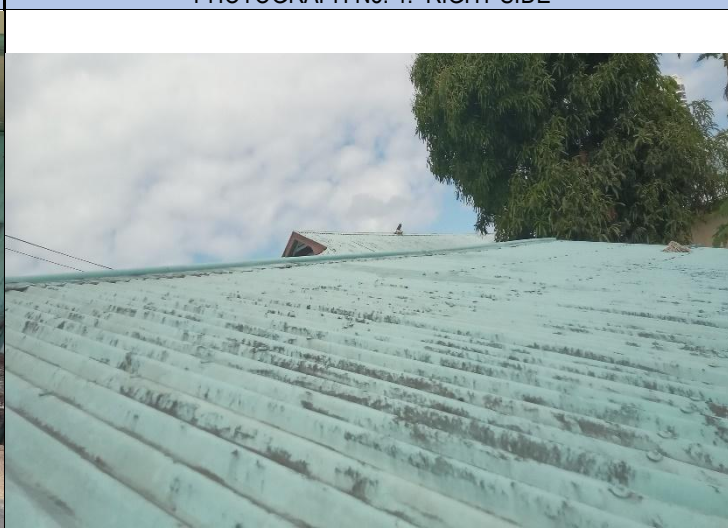
PHOTOGRAPH No. 6: ROOF

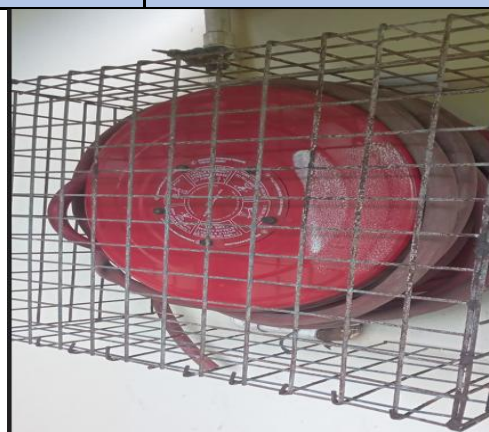
PHOTOGRAPH No. 2: FIRE HOSE REEL

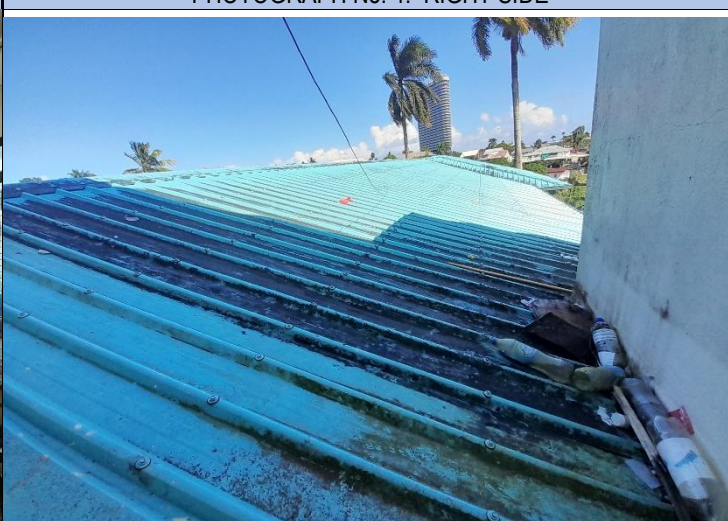
PHOTOGRAPH No. 6: ROOF

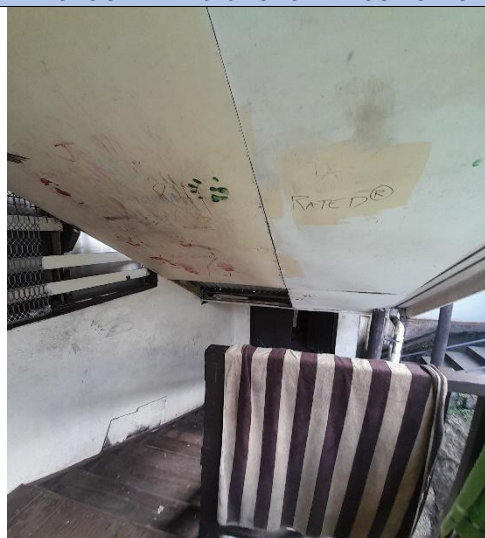
PHOTOGRAPH No. 5: STAIARS LEADING TO GIRLS TOILET
