INFRASTRUCTURE ASSESSMENT AUDIT FOR SUVA – NAUSORI URBAN SCHOOLS

JEREMIAH RAIBEVU COLLEGE (REG 1683)

SUMMARY REPORT

INFRASTRUCTURE REPORT

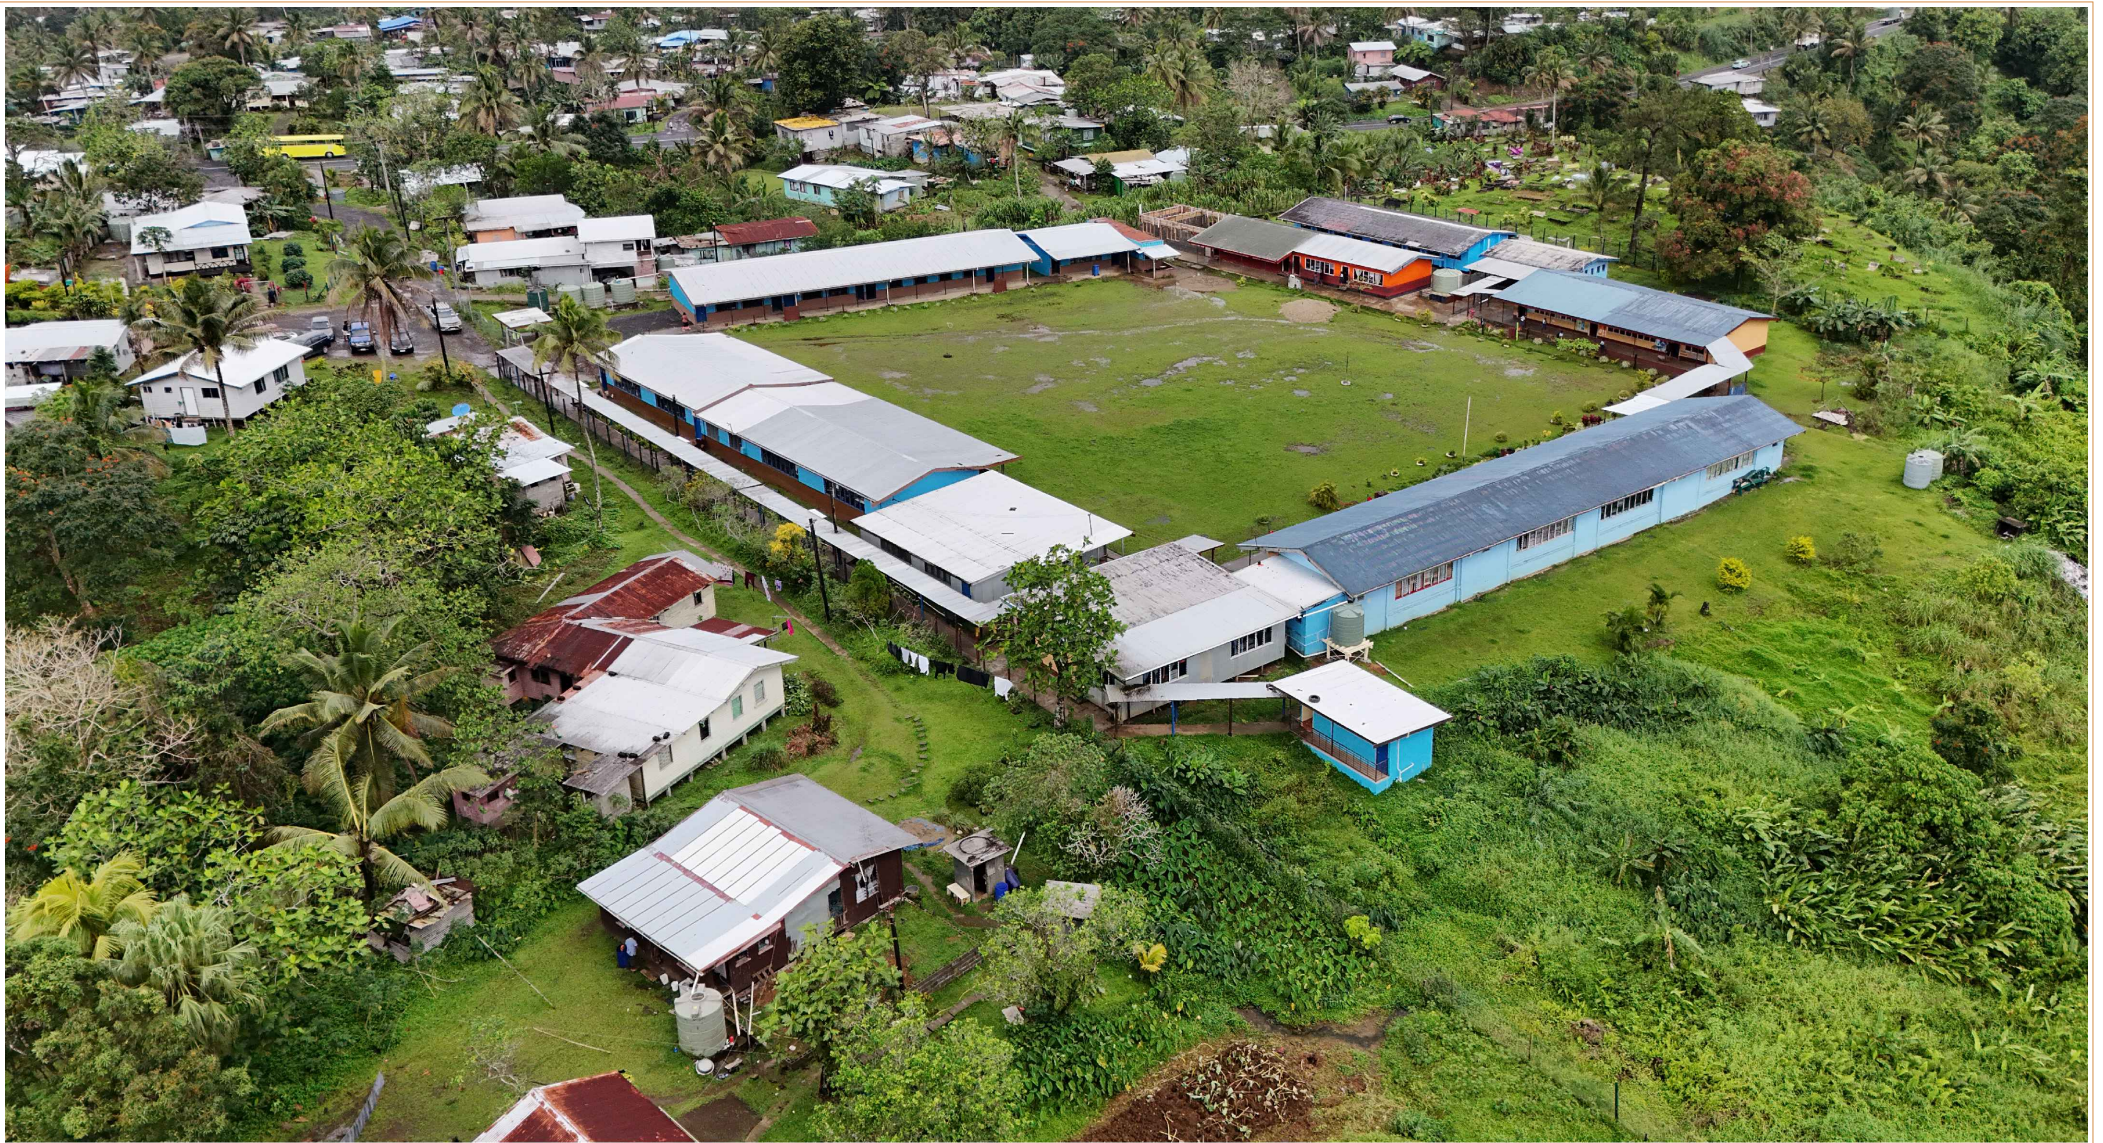
NO LOCATION OR LAND AVAILABLE FOR EXPANSION

SCHOOL BOARD & TRUSTEES ARE STILL IN TALKS
WITH ITLTB ON A PIECE OF LAND WHERE THE
SCHOOL CAN BE RELOCATED.
