INFRASTRUCTURE ASSESSMENT AUDIT FOR SUVA – NAUSORI URBAN SCHOOLS

LELEAN MEMORIAL SCHOOL – REG 1826

SUMMARY REPORT

SITE INSPECTION REPORT

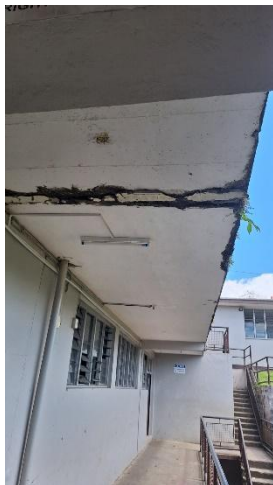
PHOTOGRAPH No. 3: WALKWAY AT TOP LEVEL WITH CONCRETE SPLIT AT ROOF BEAM

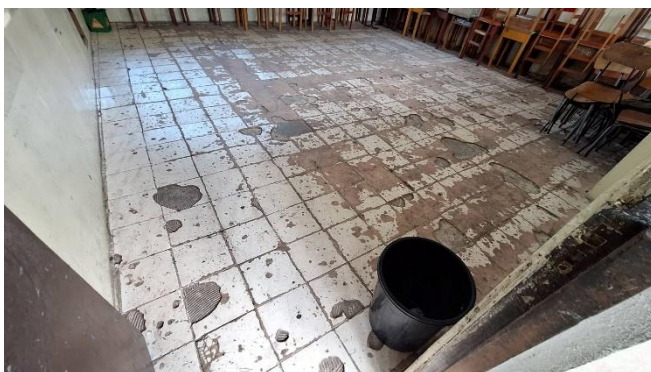
PHOTOGRAPH No. 5: EXTERIOR CLASSROOM FLOOR TILES

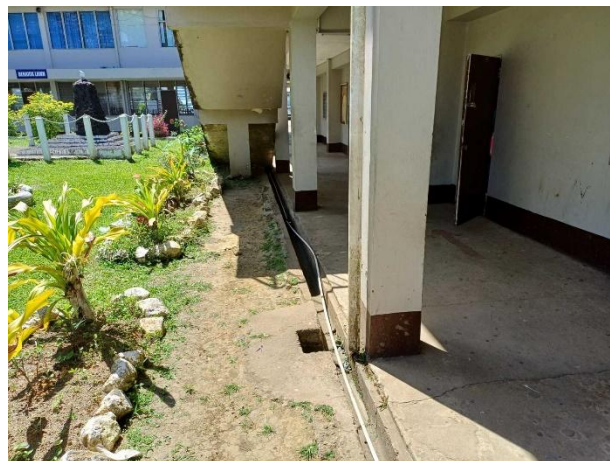
PHOTOGRAPH No. 2: WALKWAY AND DRAINAGE

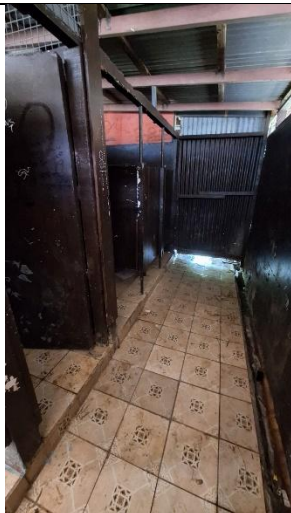
PHOTOGRAPH No. 3: TOILET BAYS

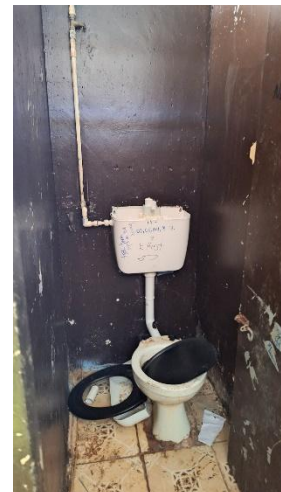
PHOTOGRAPH No. 4: TOILET SYSTEM

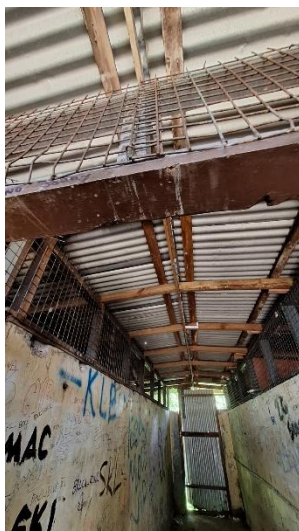
PHOTOGRAPH No. 5: EXPOSED TIMBER ROOF FRAME

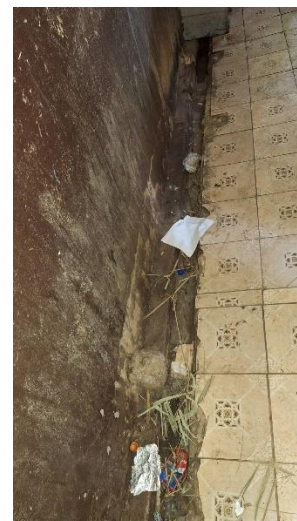
PHOTOGRAPH No. 6: DRAINAGE
