INFRASTRUCTURE ASSESSMENT AUDIT FOR SUVA – NAUSORI URBAN SCHOOLS

MARIST BROTHERS HIGH SCHOOL (REG 2309)

SUMMARY REPORT

INFRASTRUCTURE ASSESSMENT FOR MARIST BROTHERS HIGH SCHOOL (2309)
SITE INSPECTION REPORT

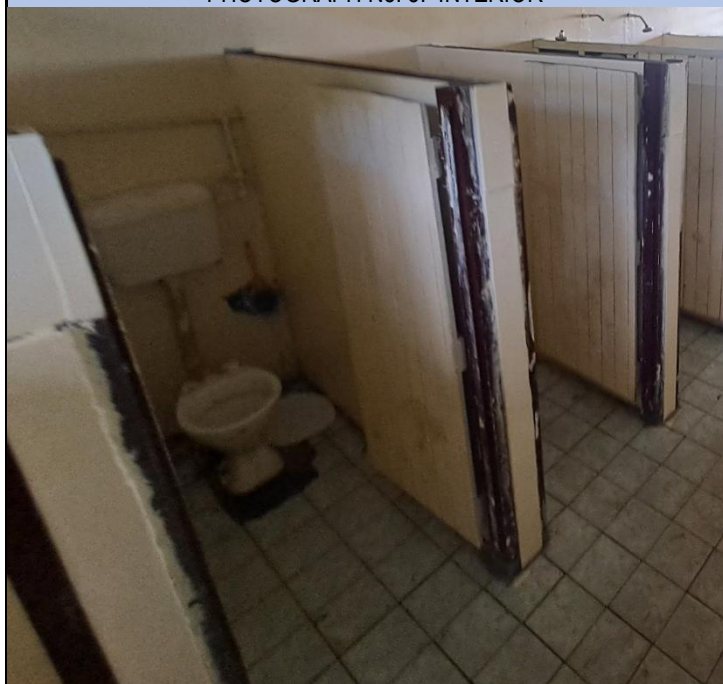
PHOTOGRAPH NO 7 - TOILETS

- The cubicle doors were damaged.
- Some toilet seat pans were missing.
- Rust was found on the door hinges and steel connectors of the PVC pipe outlets in the toilet system.
- The floor and walls had damaged and missing tiles.

The WASH facilities were unclean and lacked maintenance .
