INFRASTRUCTURE ASSESSMENT AUDIT FOR SUVA – NAUSORI URBAN SCHOOLS

MAHATMA GANDHI MEMORIAL HIGH SCHOOL (REG 2337)

SUMMARY REPORT

SITE INSPECTION REPORT

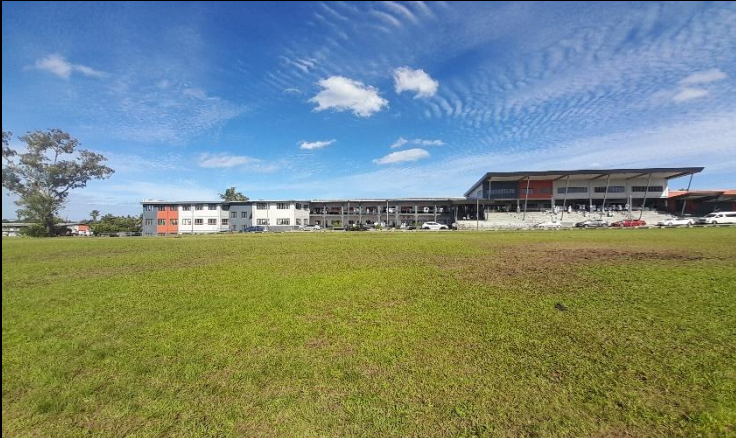
PHOTOGRAPH No. 1: FRONT		PHOTOGRAPH No. 2: LEFT SIDE

Block 1 is constructed out of concrete beams and column with slab on ground and suspended floor slab for 1st, 2nd and 3rd floor. Block walls for external load bearing. Partition walls are split in to 2 types, it is either concrete or timber framed. Doors and windows present on length wise of the structure. Gable roof with metal cladding, old building with timber framed and new building with steel framed roof members. Staircase present at strategic locations with hand railing in entire building. Ventilation is satisfactory with adequate lighting. Classrooms are well maintained.

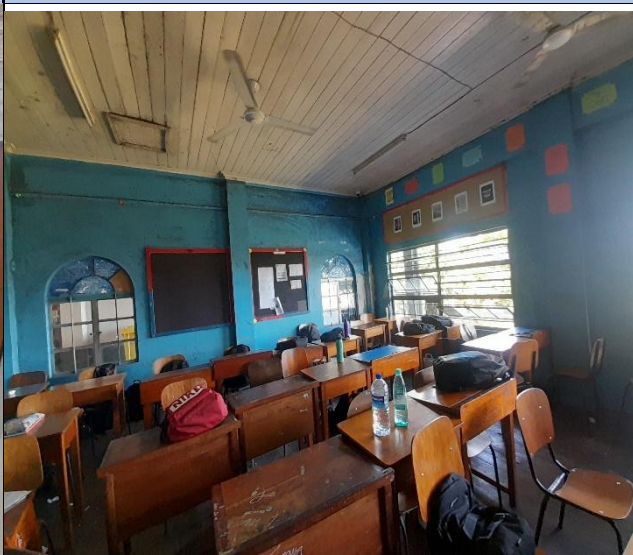
PHOTOGRAPH No. 5: LIBRARY		PHOTOGRAPH No. 6: CLASSROOM

Classrooms has fan and adequate exterior and interior electricity lighting. All switches are working

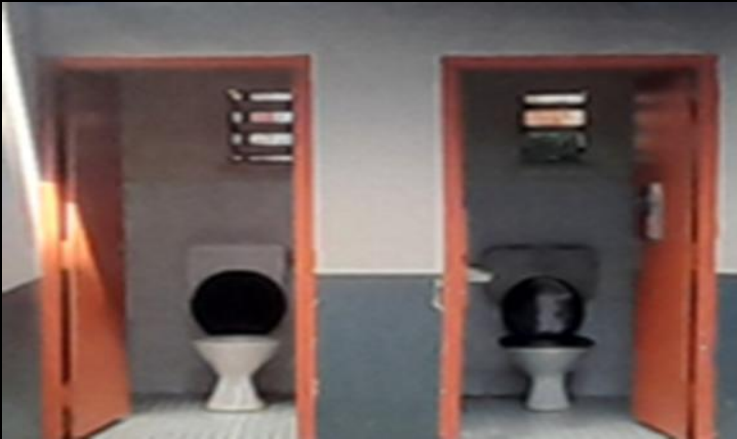
PHOTOGRAPH No. 1: GIRLS TOILET		PHOTOGRAPH No. 2:

Each student water closet cubicles measured to be 1.6m long and width of 1m. all water closet are operational, shall there be any damages or mis-function, handyman of the school is tasked to execute repairs. All cubicles have swing doors on hinges. Whole floor provided with tiles.
