# INFRASTRUCTURE ASSESSMENT AUDIT FOR SUVA – NAUSORI URBAN SCHOOLS

ST JOSEPH'S SECONDARY SCHOOL (REG 2319)

## SUMMARY REPORT

## SITE INSPECTION REPORT

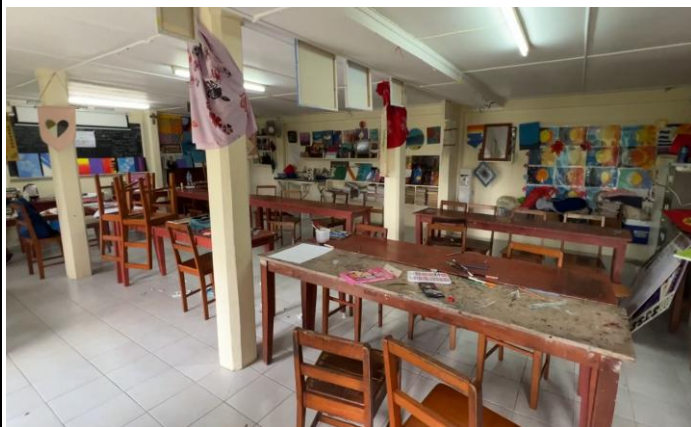
PHOTOGRAPH No. 5: INTERIOR

- Ventilation at GF is poor and insufficient.
- All laboratories consist of 2 double doors, one at the front and one at the rear.
- Fire Extinguishers are present in the Chemistry Room and Sprinklers are in the Chemistry Storage Room.
- A first Aid Kit was also noted in the Biology Lab.

Figure 5: B1 ART/PE CLASSROOM INTERIOR AT GF.

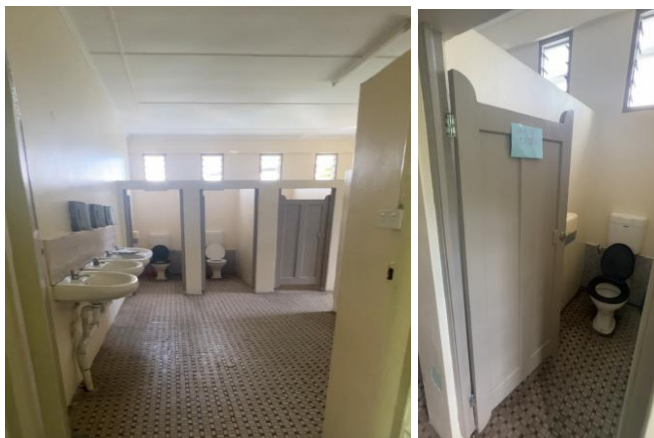
PHOTOGRAPH No. 11: B1 STUDENT FEMALE TOILET

- The tiles are not non-slip, which could result in potential accidents.

Figure 11: B1 STUDENT FEMALE TOILET.

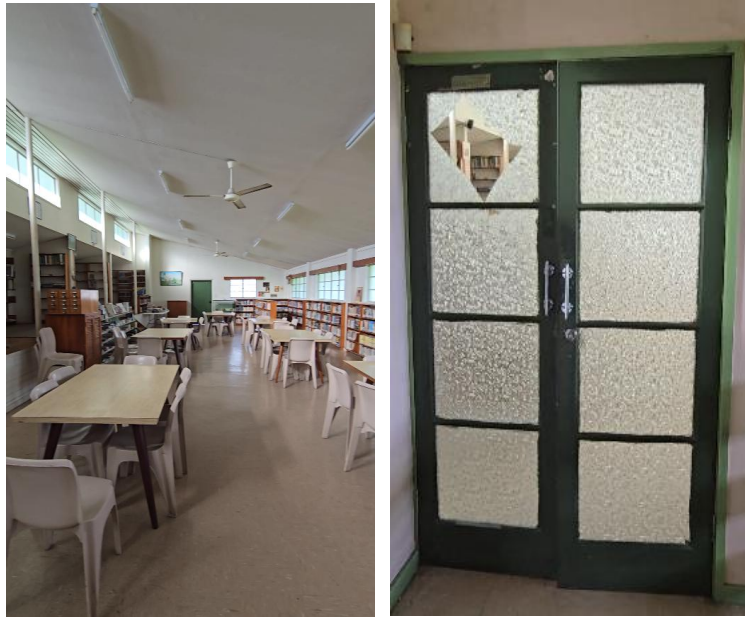
PHOTOGRAPH No. 11: LIBRARY ROOM.

6	Floor	✓			Concrete	The rooms consisted of concrete slab with tiles that were not non-slip tiles. The library consisted of cracked tiles.		
7	Handrails	✓			Steel	The steel handrails were along the stairways at a height of approx. 1m. The handrails consisted of defected paint and corrosion.		
8	Walkway(s)	✓			Concrete	The concrete walkways were approx. 3 wide and consisted of lights. The walkways also consisted of concrete stairs at certain areas.		
9	Services – water supply	✓				There are 9 taps provided at the FL.		
10	Available taps for general use	✓				9 Taps	Student – tap ratio = 44: 1	
11	Services – electricity	✓				Each Room consists of 4 lights and 2 ceiling fans with 1 projector. The electrical fixtures are satisfactory.		
12	Services – communication (internet)	✓				1 intercom per room. Internet is TFL and only accessible at the Staff Room.		
13	Drainage	✓				Drainage is good. Only the grounds consist of poor drainage.

*Figure 26: B2 LIBRARY ROOM.*

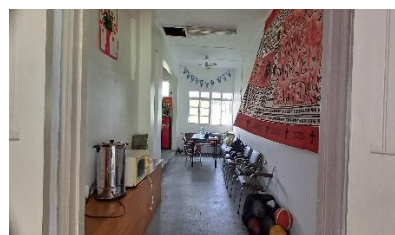
PHOTOGRAPH No. 6: INTERIOR

- **Walls and Ceiling** – The walls and ceilings are in good condition. In B2, there are leakage stains on the ceiling board, which the school indicated were due to a previous roof leak. However, the school has since carried out repairs.
- **Floors and Foundation** – Buildings with concrete flooring were satisfactory, however, tiles were not non-slip that could be hazard when wet.
- **Roofs** – It was assumed that the roofs were timber, however, it was concealed upon inspection. Roof Cladding was satisfactory, minor defects such as worn-out paint.
- **Windows** – Windows were push out windows with not shutters.
- **Earthquake** – Not Applicable
- **Cyclone** – A detailed investigation is required for the existing roofs and B4 as the structure is mainly concrete and glazed around. However, concrete structures are compliant to withstanding wind loadings.

Figure 32: B3 COMMON ROOM – SIGN OF LEAKAGE.
