# INFRASTRUCTURE ASSESSMENT AUDIT FOR SUVA – NAUSORI URBAN SCHOOLS

SUVA MUSLIM HIGH SCHOOL – REG 2393

## SUMMARY REPORT

SITE INSPECTION REPORT

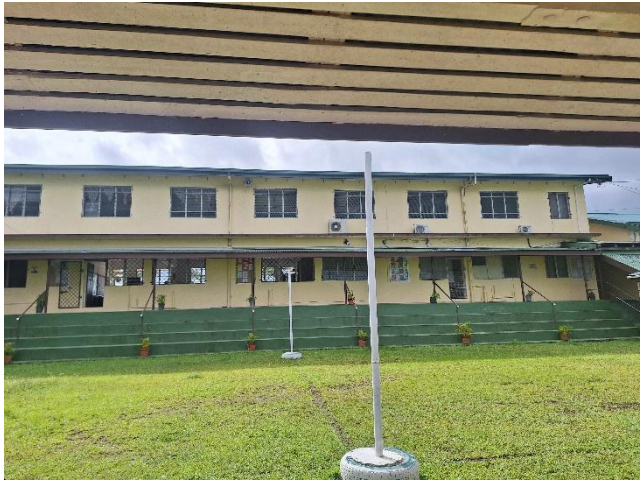
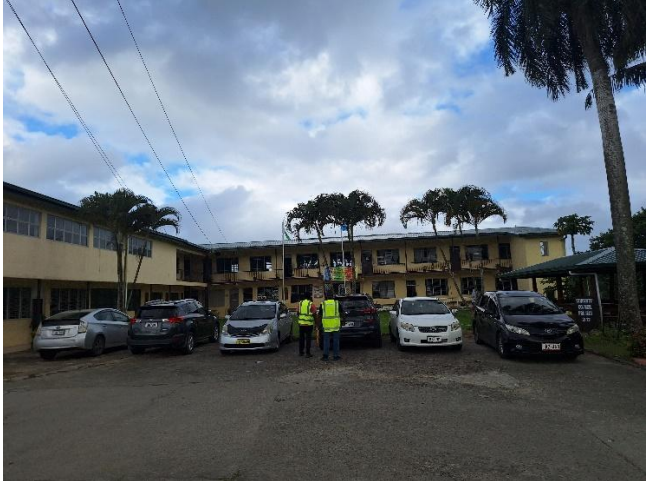
PHOTOGRAPH No. 1: FRONT VIEW		PHOTOGRAPH No. 2: SIDE VIEW	
PHOTOGRAPH No.9: MISSING TREADS ON TIMBER STAIR		PHOTOGRAPH No. 10: DAMAGE DOORS AND UNSECURED CONNECTION
