INFRASTRUCTURE ASSESSMENT AUDIT FOR SUVA – NAUSORI URBAN SCHOOLS

DEENBHANDHOO MEMORIAL SCHOOL (REG 2306)

SUMMARY REPORT

SITE INSPECTION REPORT

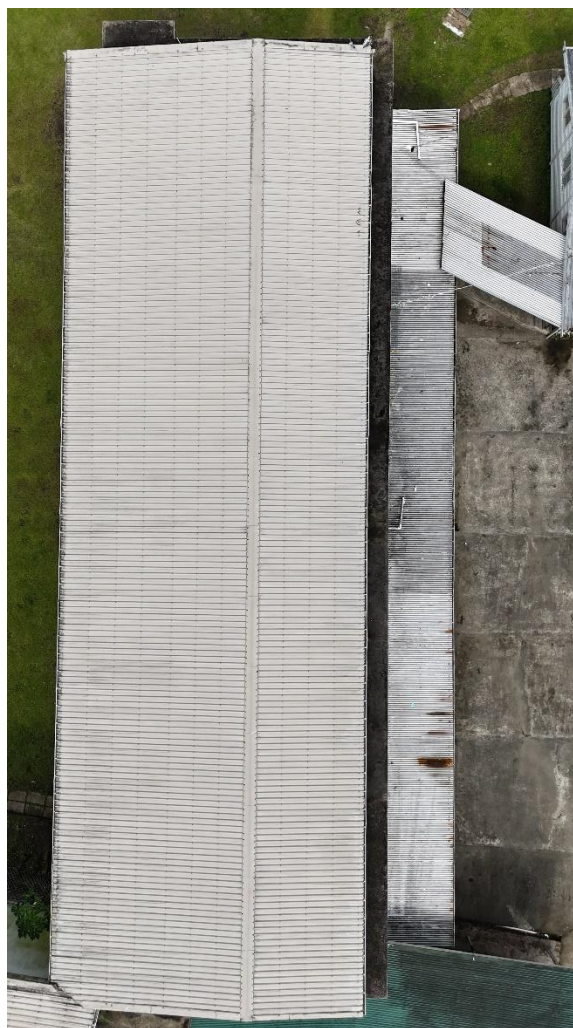
PHOTOGRAPH No. 6: ROOF LINING ON BUILDING ONE

- **Walls and Ceiling**
 - B1 – require further investigation on suspended slab at top floor (facing carpark area) pieces of concrete had fallen off, leaving the reinforcements exposed.

1. Concrete falling at suspended slab of first floor. This is located at eaves height, facing building 4.
2. There were no fire extinguishers at any of the classrooms
3. Hairline cracks on windows at first floor of building 1.

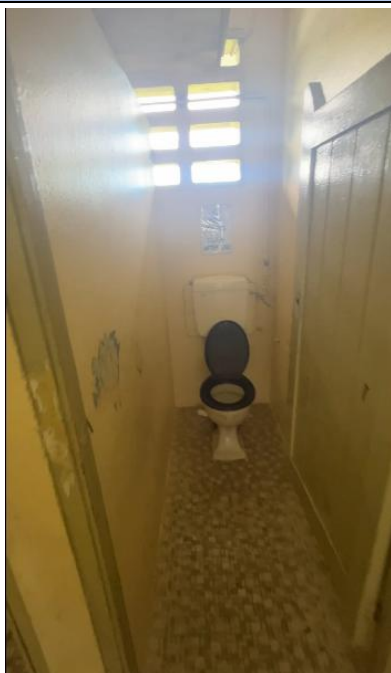
PHOTOGRAPH NO 7 - TOILETS

- The floor minor damaged and missing tiles.
- The ceiling at female toilet block were partially damaged and missing.

- Overall condition, regarding the functionality of the toilets and its building is in good condition. There were no major issues observed at the time of the school and teachers present during the visit confirmed this. However, there were minor defects such as:
 - Paint on walls were peeled at some areas in the toilet;
 - Ceiling board was damaged near the entry of the female toilet;

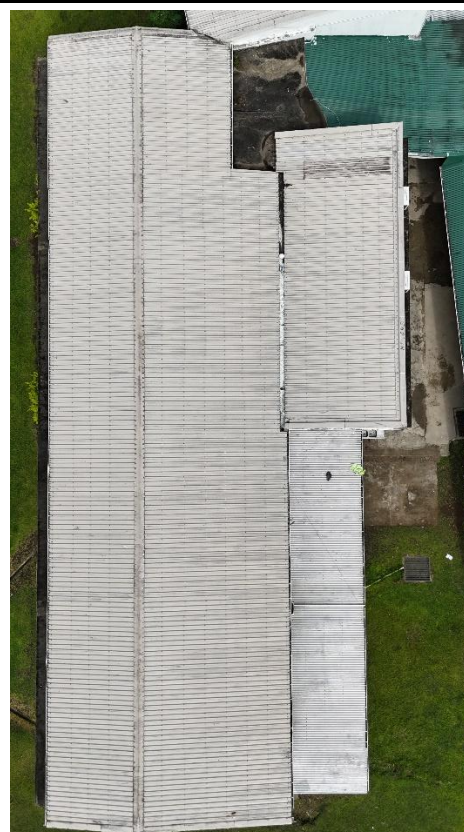
PHOTOGRAPH No. 4: ROOF LINING BUILDING TWO

Roof frame members were not accessible, there was no provision of manhole in this building therefore roof space photograph cannot be provided.

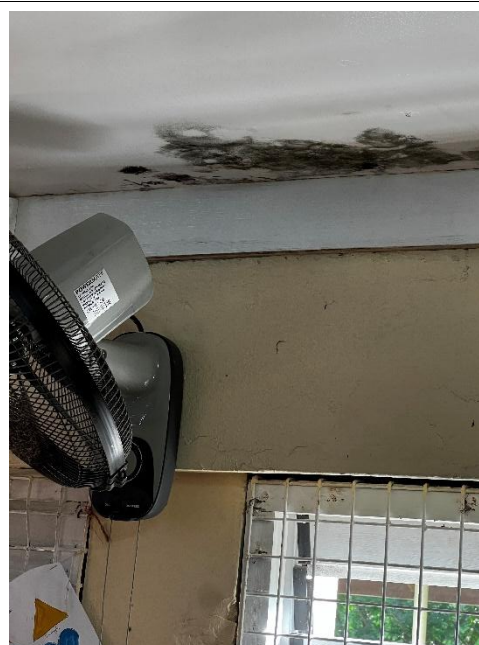
PHOTOGRAPH No. 6: CEILING VIEW AT ECE CLASSROOM

- B2 – ceiling at ECE and staffroom show sign of water leaking through, presumed to be water leak from Kitchen sink (above ECE) and heavy rainfall leak for staff room.

Shown here is the moulding that have dried up during the school visit. This was advised to be leaking during a heavy rainfall.

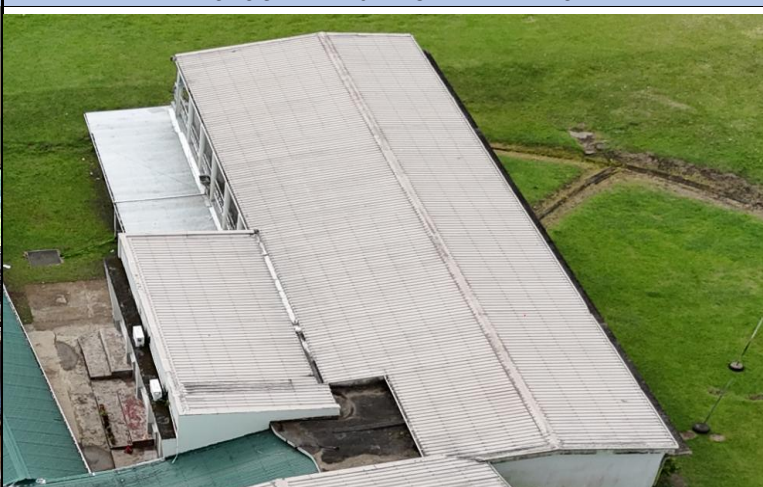
PHOTOGRAPH No. 6: ROOF LINING FOR BUILDING THREE

- B3 – detail investigation is required at concrete ceiling of year 8 room. At the time of inspection, the ceiling showed major cracks on the ceiling. Detail investigation is required to determine recommendation.

1. Concrete ceiling in room 801, show signs of possible cracking. Further investigation is required for this area. the school/ ministry is required to engage a structural engineer.
2. Missing louvre blades
3. Damaged and missing tiles
4. Minor damage to timber walls, inside Year 801s storage room
5. No fire safety equipment installed for this building

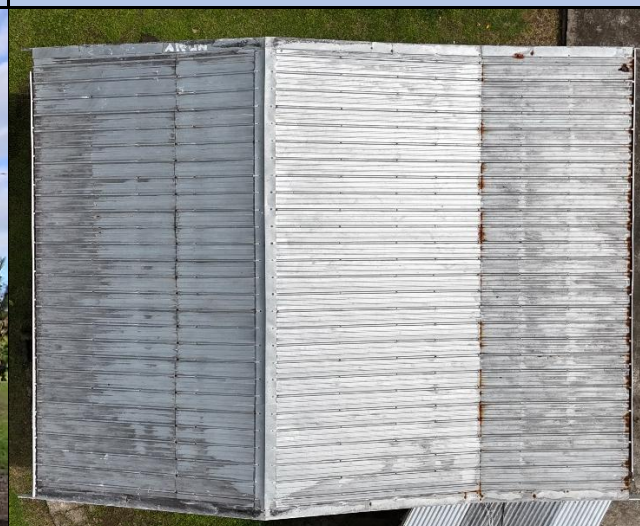
PHOTOGRAPH No. 4: ROOF LINING

- B4 – Roof framing members were undersized and will require upgrading to the current building standard.
- **Windows** – Windows were push out type of glazed window and louvre blade. They were in good condition, some classes had missing louvre blades

1. Existing roof framing are undersized and centred more than 1m apart and also have inadequate fixings or connections.
2. Wall framing was covered with weatherboard and internal ply, this was not inspected.
3. Floor framing, were not inspected due to limited access. However, NRW was able to determine a few floor frame connections which were rusted and of inadequate size.
4. Fire extinguisher were not present in the classroom.
