INFRASTRUCTURE ASSESSMENT AUDIT FOR SUVA – NAUSORI URBAN SCHOOLS

NARERE PRIMARY SCHOOL (REG 2391)

SUMMARY REPORT

PROJECT NUMBER:
 22403058

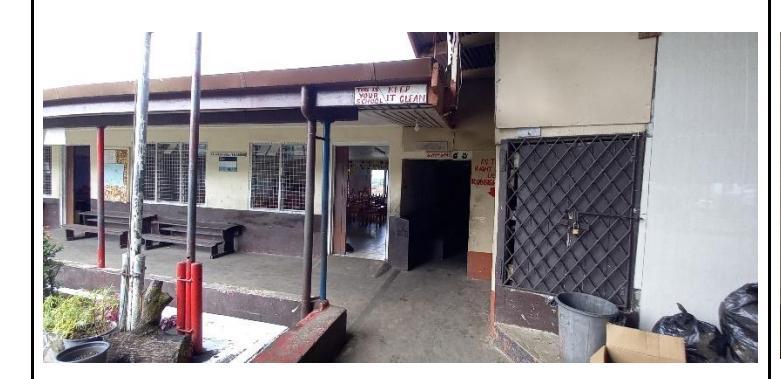
Figure 7: B1 RAMPS

PHOTOGRAPH No. 7: RAMPS

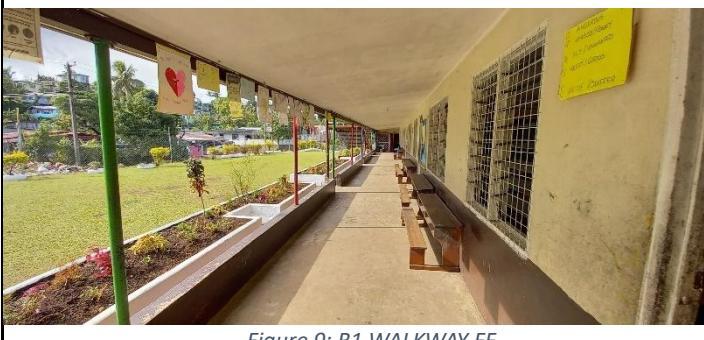
Figure 9: B1 WALKWAY FF

PHOTOGRAPH No. 9: WALKWAY

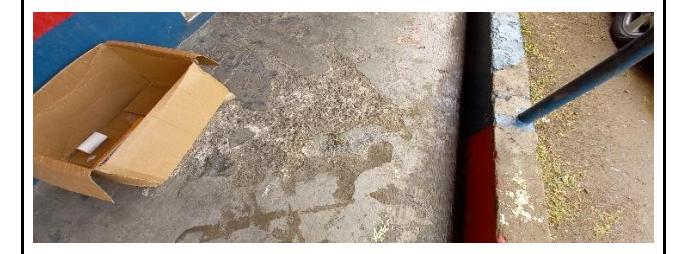
Figure 10: B1 WALKWAY GF

PHOTOGRAPH No. 10: WALKWAY

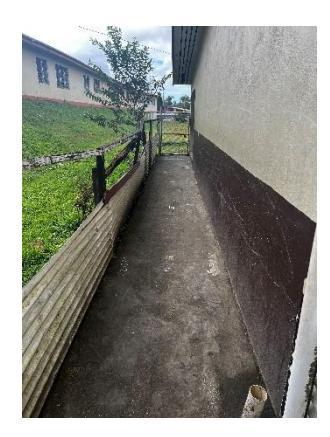
Figure 22: B2 SIDE WALKWAY

PHOTOGRAPH No. 9: WALKWAYS

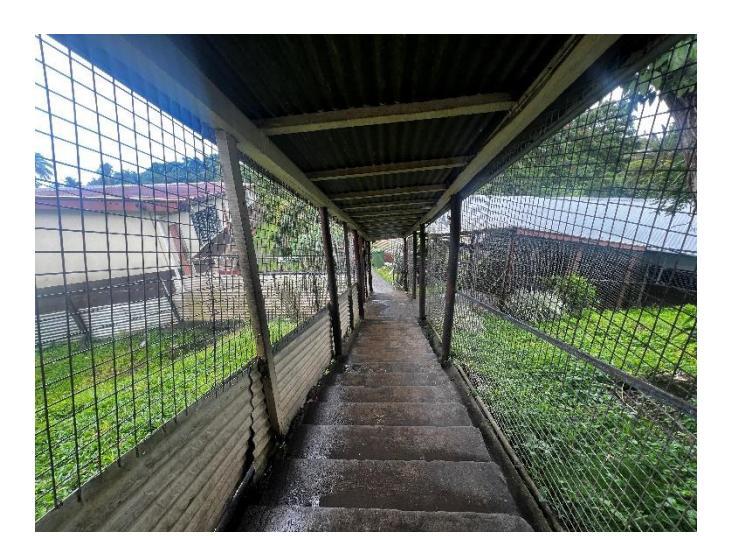
Figure 36: B3 WALKWAY TO B2 AND B3

PHOTOGRAPH No. 11: WALKWAY

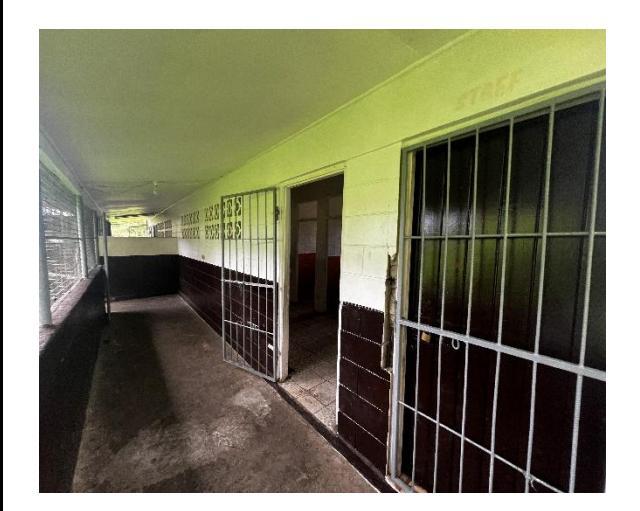
Figure 37: B3 WALKWAY

PHOTOGRAPH No. 12: WALKWAY

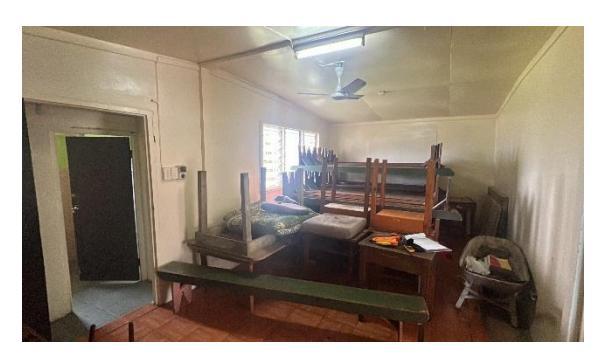
Figure 46: B4 SICK BAY INTERIOR

- There were damaged tiles.
- The sick bay is now used for storage.
- The hired cooking area is only used for functions.
- There are 2 streams for the kindergarten, morning and afternoon sessions with 2 teachers for the morning session and 1 teacher for the afternoon session. Each session consists of 22 students.
- The toilet in the Sick Bay is only utilised if required during a hiring.

PHOTOGRAPH No. 9: INTERIOR

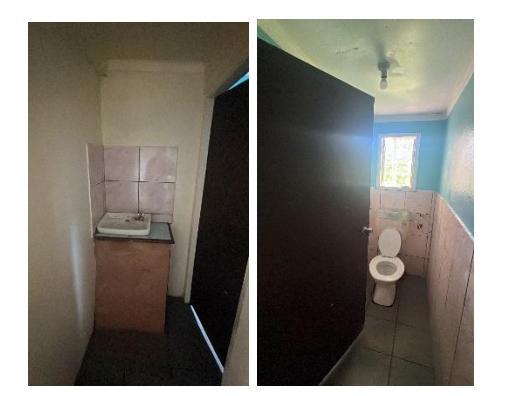
Figure 47: B4 TOILET

PHOTOGRAPH No. 10: TOILET
