INFRASTRUCTURE ASSESSMENT REPORT FOR SUVA-NAUSORI SCHOOLS

FINAL REPORT

PREPARED FOR: MINISTRY OF EDUCATION
January 2025

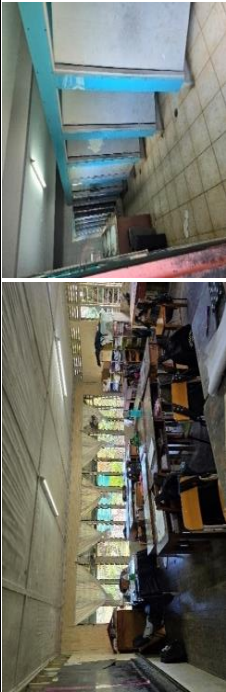
School	Existing Infrastructure	Required infrastructure	Gap between existing and required infrastructure	Evidence
Suva Primary School	Overcrowding: 10/10 classrooms (100%) overcrowded. WASH facilities: 8 Girls cubicles.	18 total classrooms are to be present utilizing the Recommended sizing (1.5m ²) requirement. Girls – 8 cubicles	8 extra classrooms are needed since current 10 classrooms are not sufficient to support the total roll. Additional 1 girls toilet cubicle could be made to cater growing population despite existing being par with the required WASH number.

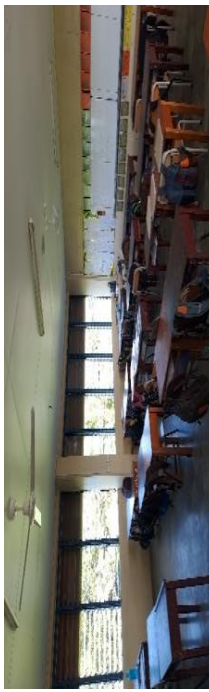
Samabula Primary School	Overcrowding – 7/18 classrooms (38.89%) overcrowded	21 total classrooms are to be present utilizing Recommended sizing (1.5m ²) requirement	3 extra classrooms are needed since current 18 classrooms are not sufficient to support the total roll

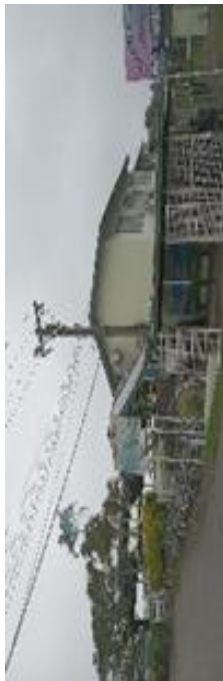
School	Existing Infrastructure	Required infrastructure	Gap between existing and required infrastructure	Evidence
Gospel Primary School	Overcrowding - 12/16 classrooms (75%) overcrowded	22 total classrooms needed under recommended sizing (1.5m ²)	6 extra classrooms are needed since current 16 classrooms are not sufficient to support the total roll

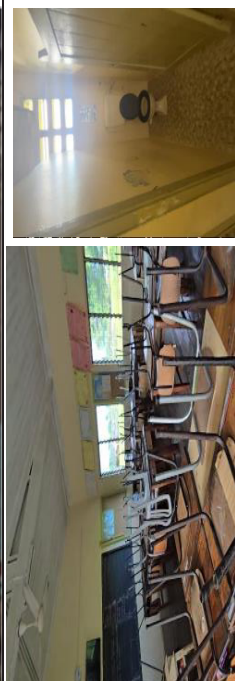
Deenbhandoo Memorial School	Overcrowding: 4/13 classrooms (30.8%) overcrowded. WASH facilities: Boys - 4 cubicles ; 4 Girls cubicles.	17 total classrooms are to be present utilizing Recommended sizing (1.5m ²) requirement. WASH Facilities: Boys – (6 cubicles) Girls – (9 cubicles)	4 extra classrooms are needed since current 13 classrooms are not sufficient to support the total roll. WASH Facilities: Boys : 2 cubicles required. Girls: 5 cubicles required

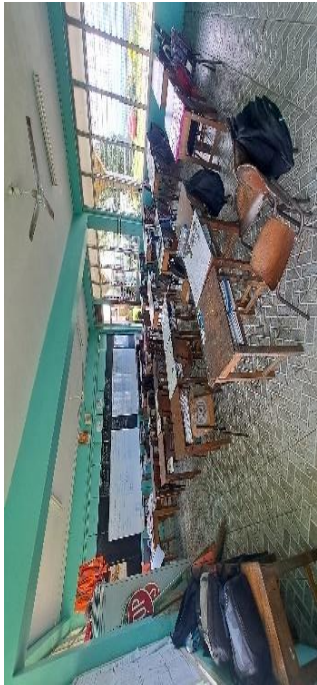
School	Existing Infrastructure	Required infrastructure	Gap between existing and required infrastructure	Evidence
Arya Samaj Primary	Overcrowding – 2/16 classrooms (12.5%) overcrowded	17 total classrooms are to be present utilizing Recommended sizing (1.5m2)	1 extra classroom are needed since current 16 classrooms are not sufficient to support the total roll

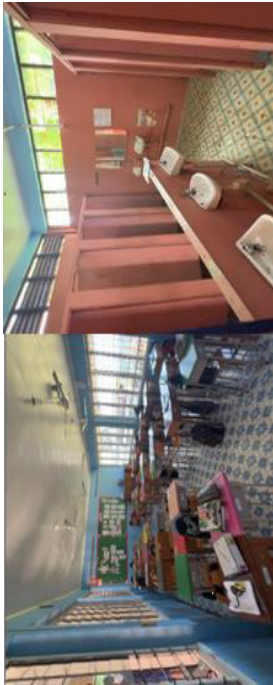
DAV Girls School	WASH Facilities: Girls: 19 cubicles.	WASH Facilities: Girls – (24 cubicles)	WASH Facilities: Girls: 5 cubicles required

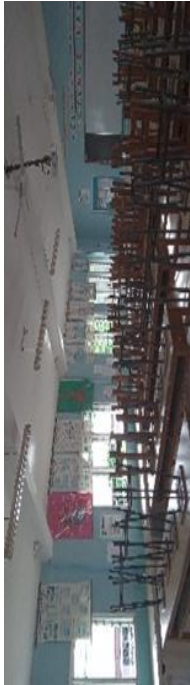
Suva Sangam College	Overcrowding - 1/18	19 total classrooms are to be present utilizing Recommended sizing (1.5m2)	1 extra classroom is needed since current 18 classrooms are not sufficient to support the total roll

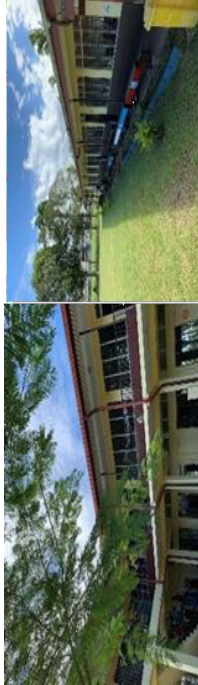
Swami Shardanand Memorial Primary School	Overcrowding - 7/18	22 total classrooms are to be present utilizing Recommended sizing (1.5m2) requirement. Girls: 1 Cubicles required	4 extra classrooms are needed since current 18 classrooms are not sufficient to support the total roll

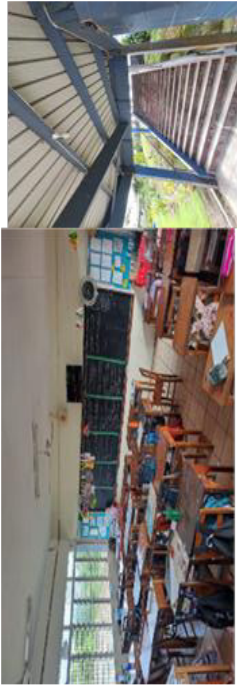
School	Existing Infrastructure	Required infrastructure	Gap between existing and required infrastructure	Evidence
Indira Gandhi Memorial Primary School	Overcrowding - 100% of classrooms were overcrowded, Disability Accessibility - 100% not accessible to disabled people.	Overcrowding - 16 classrooms are required to meet Recommended sizing (1.5m2)s; Disability Accessibility - Ramps, signs, accessible toilets and wider doorways are required to meet compliance.	Overcrowding - 8 classrooms are needed based on Recommended sizing (1.5m2)s; Disability Accessibility - not compliant with FDPF Disability audit tool.

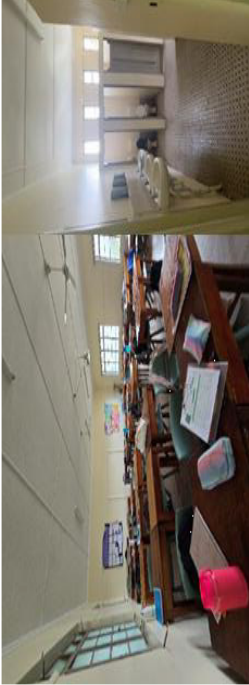
St Josephs Secondary School	Overcrowding: 1/15 classrooms (6.7%) overcrowded.	16 total classrooms are to be present utilizing Recommended sizing (1.5m2) requirement.	1 extra classroom is needed since current 15 classrooms are not sufficient to support the total roll.

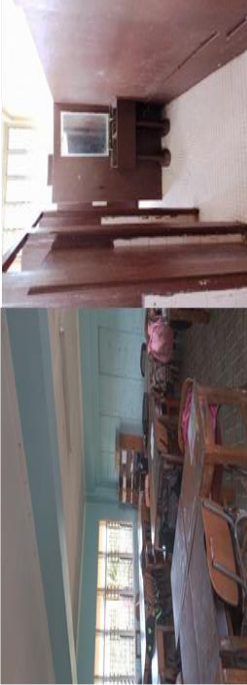
Pt Vishnu Deo Memorial	Overcrowding- 11/14 classrooms (78.5%), WASH cubicles for Boys 4,	21 total classrooms needed under FNBC, WASH cubicles for Boys 6 under FNBC	Extra 7no. Classrooms & new ablution block with boys having 2no. WC, 2no. SHW, 2no.

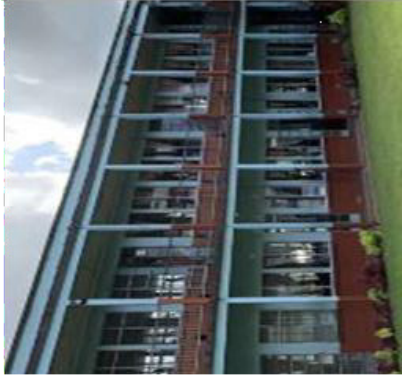
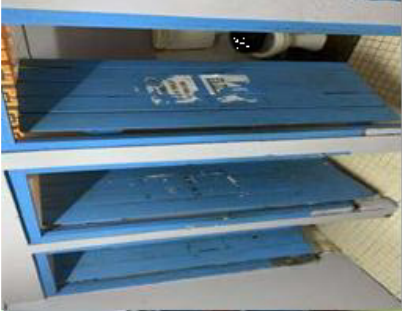
School	Existing Infrastructure	Required infrastructure	Gap between existing and required infrastructure	Evidence
DAV College	total of 23 classroom with total of 843 students with average of 37 student in each classroom. B3 Timber structure building doesn't comply with cyclone standard. School doesn't comply disability access ..	Total of 28 classroom will be need to meet Recommended sizing (1.5m2) and meet the overcrowding issue in school. Provide ramp access in all building.	5 addition classrooms needed to address the overcrowding issue. Provide disability ramp access.

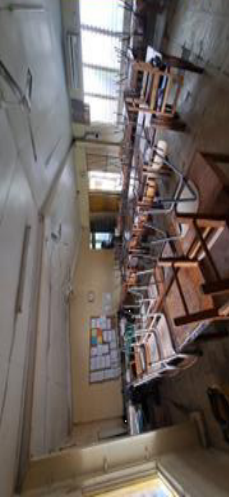
St Marcellin Primary School	Overcrowding – 13/18 (72.2%) of classrooms were overcrowded, Disability Accessibility - 100% not accessible to disabled people.	Overcrowding - 24 classrooms are required to meet Recommended sizing (1.5m2); Disability Accessibility - Ramps, signs, accessible toilets and wider doorways are required to meet compliance.	Overcrowding - 6classrooms are needed based on Recommended sizing (1.5m2); Disability Accessibility - not compliant with FDFP Disability audit tool.

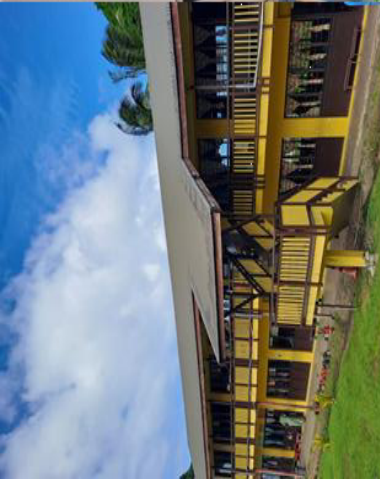
Annesley Infant School	Disability Accessibility - 100% not accessible to disabled people, Disaster Resilience - 100% not resilient.	Disaster Resilience - roof cladding and roofing nails are rusted and there weren't any permanent mesh shutters on the windows. For cyclone certification these will need to be amended, Disability Accessibility - Ramps, signs, accessible toilets and wider doorways are required to meet compliance.	Disaster Resilience - rusting of roof cladding, roofing nails and permanent cyclone mesh shutters contradicts to the cyclone certification requirement requiring replacement, Disability Accessibility - not compliant with FDFP Disability audit tool.

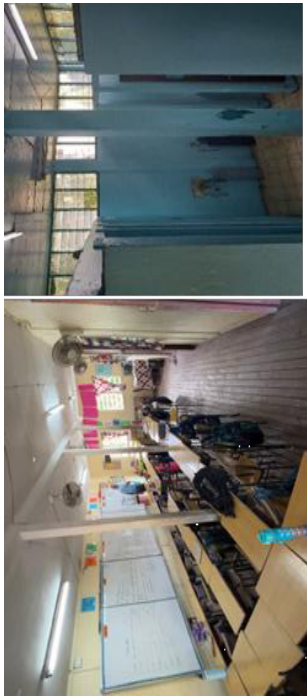
School	Existing Infrastructure	Required infrastructure	Gap between existing and required infrastructure	Evidence
Holy Trinity Anglican Primary School	Overcrowding: 17/18 classrooms (94.4%) overcrowded.	25 total classrooms are to be present utilizing Recommended sizing (1.5m2) requirement.	7 extra classrooms are needed since current 18 classrooms are not sufficient to support the total roll.

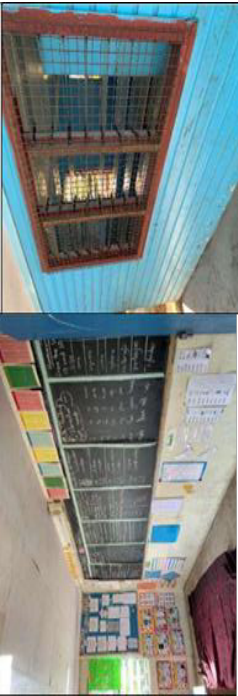
John Wesley Primary School	The school has 16/16 overcrowded classrooms, limited disability features, and rusted cladding.	RECOMMENDED SIZING (1.5M2)1990 standards for structural safety, additional classrooms, proper washroom ratios, and accessibility are required.	The school needs 8 extra classrooms, six additional washroom cubicles for girls, cyclone upgrades, and ramps.

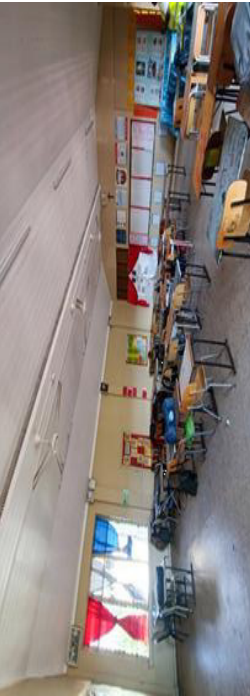
Marist Brothers High School	Overcrowding - 14/20 classrooms (70%) overcrowded	26 total classrooms are to be present utilizing Recommended sizing (1.5m2) requirement	6 extra classrooms are needed since current 20 classrooms are not sufficient to support the total roll

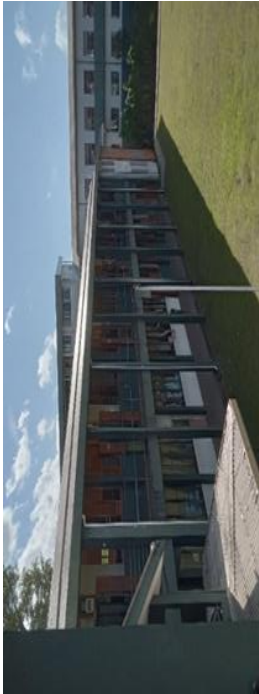
School	Existing Infrastructure	Required infrastructure	Gap between existing and required infrastructure	Evidence
MGM High School	Overcrowding - 17/27 classrooms (62.9%) overcrowded	32 total classrooms are to be present utilizing Recommended sizing (1.5m2) requirement	5 extra classrooms are needed since current 27 classrooms are not sufficient to support the total roll

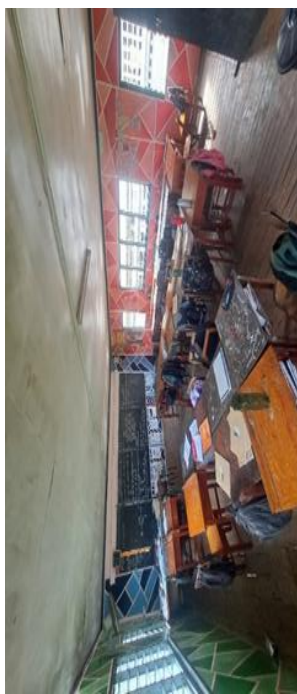
Nabua Primary School	Structure - the timber structures used as classrooms were in poor condition and displayed weak structural integrity like damaged timber walls and floors with the floor framing deteriorating.	<ul style="list-style-type: none"> - Structural Integrity – Columns, slabs, beams, rafters, purlins sizes to follow FNBC1990. - General upkeep –routine checkup as per MOE policies with major defects requiring immediate intervention.' 	Structures need to be renovated and require timely maintenance and repair works of all structures.

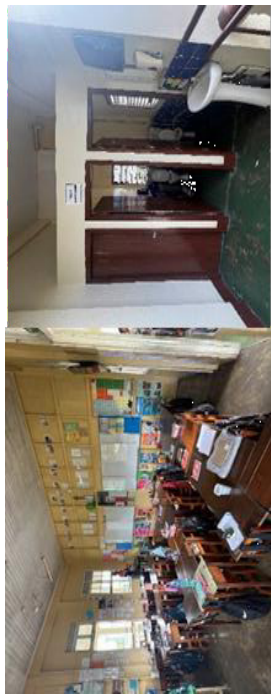
St Annes Primary School	Overcrowding - 8/8 classrooms (100%) overcrowded / WASH Facilities - 10 current cubicles not compliant	16 total classrooms are to be present utilizing Recommended sizing (1.5m2) requirement / 15 total cubicles are to be present as per FNBC 1990 1:20 student to toilet ratio	8 extra classrooms are needed since current 8 classrooms are not sufficient to support the total roll / 5 extra cubicles are needed as the current 10 are not sufficient for the total roll

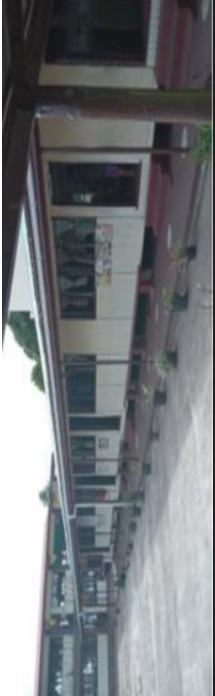
Dudley Intermediate School	Overcrowding: 12/12 classrooms (100%) overcrowded.	15 total classrooms are to be present utilizing Recommended sizing (1.5m2) requirement.	3 extra classrooms are needed since current 12 classrooms are not sufficient to support the total roll.

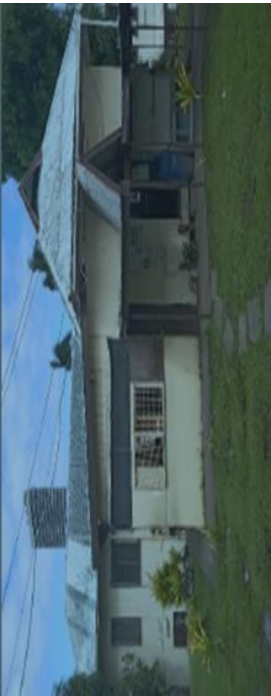
Dudley High School	Overcrowding: 18/26 classrooms (69.2%) overcrowded.	32 total classrooms are to be present utilizing Recommended sizing (1.5m2) requirement.	6 extra classrooms are needed since current 26 classrooms are not sufficient to support the total roll.

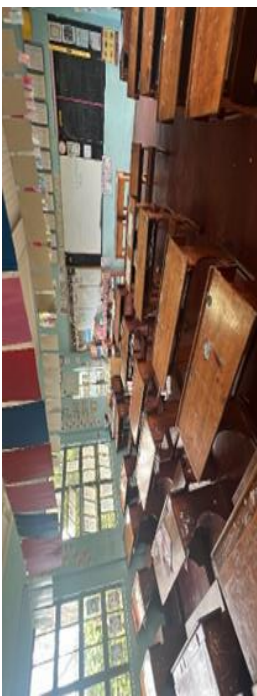
Nehru Primary School	Overcrowding: 17/17 classrooms (100%) overcrowded. Girls: 12	25 total classrooms are to be present utilizing Recommended sizing (1.5m2) requirement. Girls: 13 total WASH Cubicles are needed	8 extra classrooms are needed since current 17 classrooms are not sufficient to support the total roll. Girls: 1

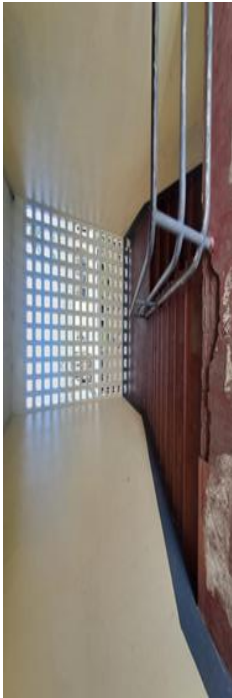
School	Existing Infrastructure	Required infrastructure	Gap between existing and required infrastructure	Evidence
Nabua Secondary School	Disability Accessibility - 100% not accessible to disabled people.	Disability Accessibility - Ramps, signs, accessible toilets and wider doorways are required to meet compliance.	Disability Accessibility - not compliant with FDPF Disability audit tool.

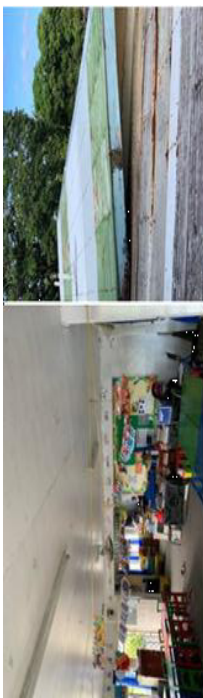
St Agnes Primary School	The school has 10/18 overcrowded classrooms, and incomplete disability features.	RECOMMENDED SIZING (1.5M2)1990 standards for structural integrity, adequate classroom size, proper washroom ratios, and accessibility features.	6 extra classrooms, five additional cubicles for girls, cyclone upgrades, and ramps are required.

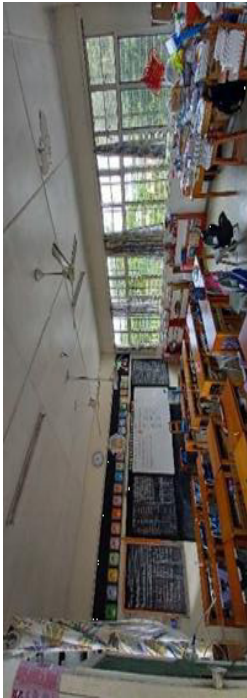
Yat Sen Primary School	Disability Accessibility - 100% not accessible to disabled people.	Disability Accessibility - Ramps, signs, accessible toilets and wider doorways are required to meet compliance.	Disability Accessibility - not compliant with FDPF Disability audit tool.

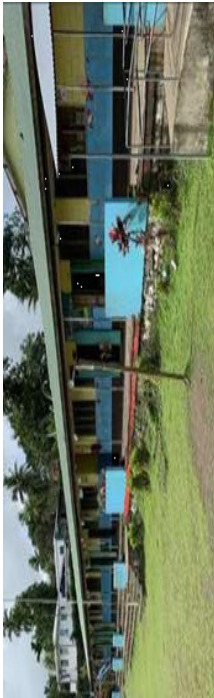
Assemblies of God Primary	Overall, 25 classrooms available with total of 1095 students with average of 44 students in each classroom	Build additional 5 classrooms to occupancy to have 1.5m²	total of 40 classroom need to meet Recommended sizing (1.5m2) to address overcrowding in school.

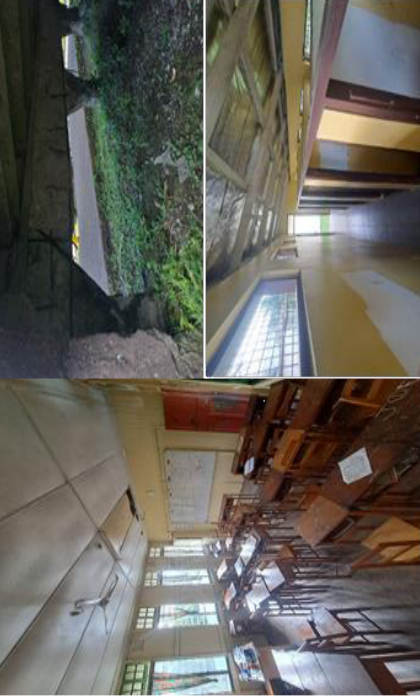
Suva Methodist Primary School	Overcrowding – 15/21 (71.4%) of classrooms were overcrowded, Disability Accessibility - 100% not accessible to disabled people. Disaster Resilience - 90% not resilient.	Overcrowding - 23 classrooms are required to meet Recommended sizing (1.5m2); Disability Accessibility - Ramps, signs, accessible toilets and wider doorways are required to meet compliance. Disaster Resilience - Structural Integrity such as columns, slabs, beams, rafters and purlin sizes to follow FNBC 1990.	Overcrowding - 2 classrooms are needed based on Recommended sizing (1.5m2); Disability Accessibility - not compliant with FDFP Disability audit tool; Disaster Resilience - the architectural fractures and structural cracks visible are required maintenance.

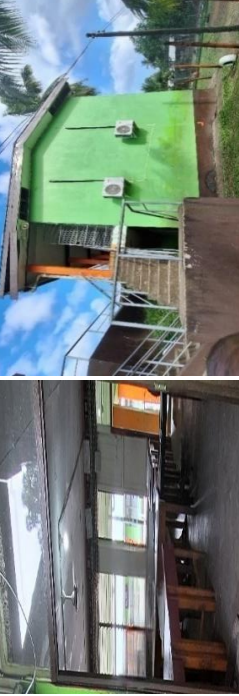
Assemblies of God High School	Overcrowding - 13/17 classrooms (76.5%) / Disability - No accessible facility	22 total classrooms needed under RECOMMENDED SIZING (1.5M2)/ Doorways, walkway, railings, ramps etc needed as per Fiji Disabled People's Federation Access Audit Tool	5 extra classrooms are needed since current 24 classrooms are not sufficient to support the total roll / No compliance to Disability Audit Tool.

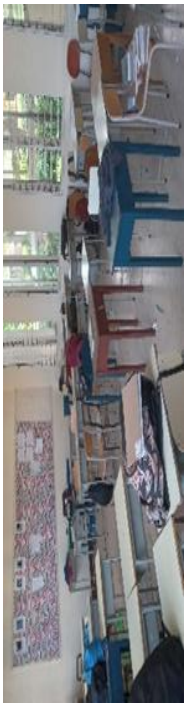
School	Existing Infrastructure	Required infrastructure	Gap between existing and required infrastructure	Evidence
Suva Grammar School	Overcrowding - 22/28	34 total classrooms are to be present utilizing Recommended sizing (1.5m2) requirement	6 extra classrooms are needed since current 28 classrooms are not sufficient to support the total roll

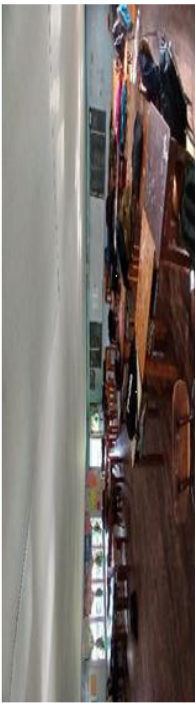
Draiba Primary School	Overcrowding - 6/21 classroom (28.6%) overcrowded	24 total classrooms are to be present utilizing Recommended sizing (1.5m2) requirement	3 extra classrooms are needed since current 20 classroom are not sufficient to support the total roll

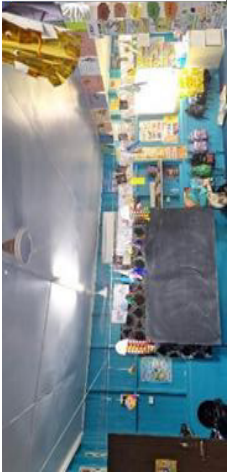
Suva Muslim Primary School	Overcrowding - 4/25 Girls: 13 Cubicles present	26 total classrooms are to be present utilizing Recommended sizing (1.5m2) requirement. Girls: 16 Cubicles total required	1 extra classroom are needed since current 25 classroom are not sufficient to support the total roll. Girls: 3 Cubicles required

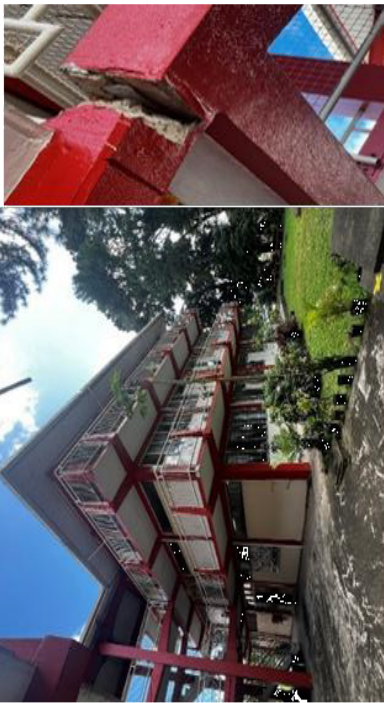
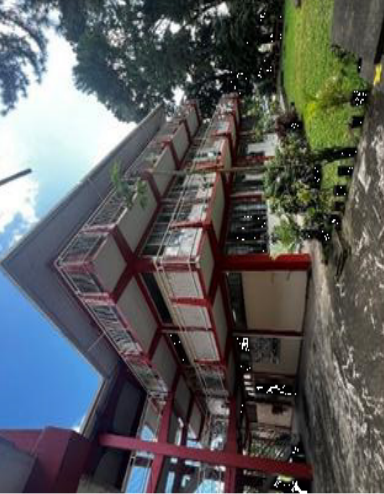
Yat Sen Secondary School	Structural integrity and disaster resilience - 15%	Structural does not comply to FNBC 1990 as there is a severely deteriorated structural member (B1 beam) that may compromise the structural integrity of the building	Immediate Structural analysis required for structural element (beam at B2)

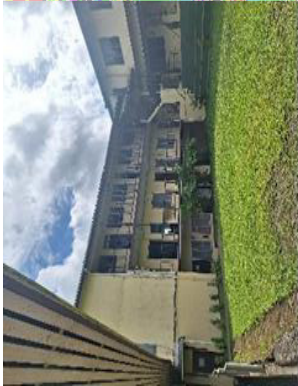
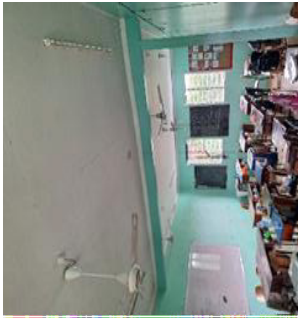
School	Existing Infrastructure	Required infrastructure	Gap between existing and required infrastructure	Evidence
Suva Muslim College	Overcrowding - 4/18	20 total classrooms are to be present utilizing Recommended sizing (1.5m2) requirement.	2 extra classrooms are needed since current 18 classroom are not sufficient to support the total roll

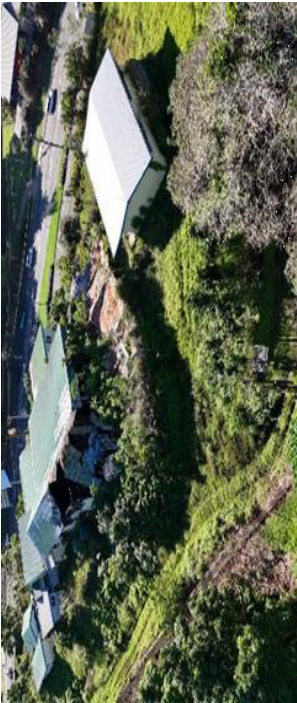
Vatuwaqa Primary School	Structures are all damaged due to a fire outbreak in building labelled B2 and majority of the structures require attention.	<ul style="list-style-type: none"> - Structural Integrity – Columns, slabs, beams, rafters, purlins sizes to follow RECOMMENDED SIZING (1.5M2)1990. - General upkeep –routine checkup as per MOE policies with major defects requiring immediate intervention. 	Structures requires demolition of the damaged and unstable structures and rebuilding to the required standards and building codes.

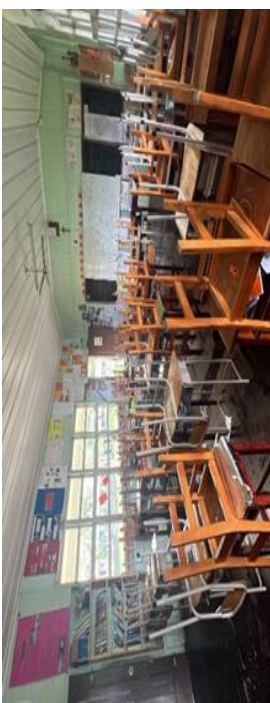
Stella Maris School	Overcrowding: 7/8 classrooms (87.5%) overcrowded.	15 total classrooms are to be present utilizing 2m ² Recommended sizing (1.5m2) requirement.	7 extra classrooms are needed since current 8 classrooms are not sufficient to support the total roll.

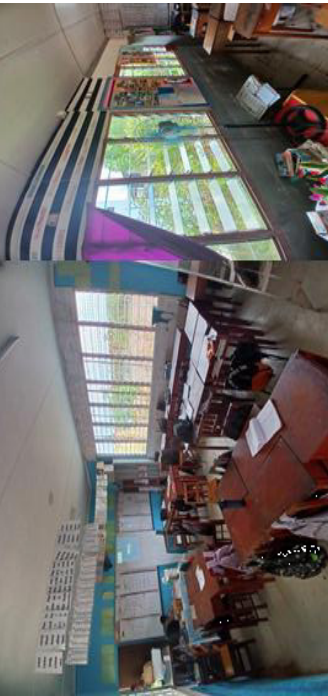
St John Bosco	Overcrowding – 10/21 (47.6%) of classrooms were overcrowded, Disaster Resilience - 90% not resilient.	Overcrowding - 26 classrooms are required to meet Recommended sizing (1.5m ²); Disaster Resilience - roof cladding and roofing nails are rusted and there weren't any permanent mesh shutters on the windows. For cyclone certification these will need to be amended	Overcrowding - 5 classrooms are needed based on Recommended sizing (1.5m ²); Disaster Resilience - rusting of roof cladding, roofing nails and permanent cyclone mesh shutters contradicts to the cyclone certification requirement requiring replacement.

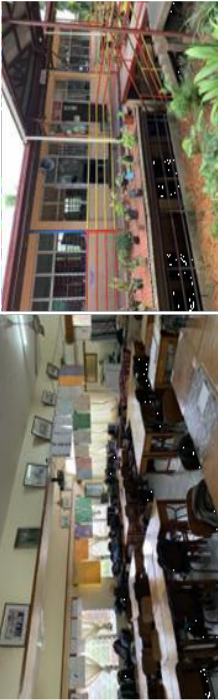
School	Existing Infrastructure	Required infrastructure	Gap between existing and required infrastructure	Evidence
Jagindar Primary School	The school has 21/24 overcrowded classrooms, inadequate washroom cubicles with 4 boys and 8 girls toilet cubicles, and disability features.	RECOMMENDED SIZING (1.5M2) requires 31 total classrooms, 9 boys and 19 girls toilet cubicles, and accessibility were to be present under FNBC 1990.	The school needs 7 extra classrooms, 5 additional washroom cubicles for boys, 11 for girls, and ramps.

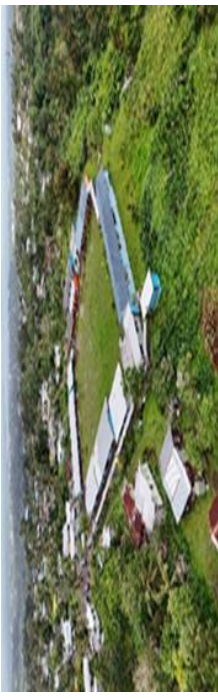
Jeremiah Raibeau College	Overcrowding - 3/5 classrooms (60%) overcrowded	8 total classrooms are to be present utilizing Recommended sizing (1.5m2) requirement	3 extra classrooms are needed since current 5 classrooms are not sufficient to support the total roll

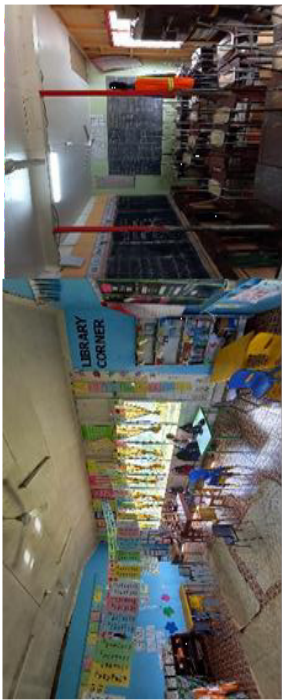
Tacirua Primary School	Overcrowding - 8/16 Girls WASH: 6 Cubicles present	21 total classrooms are to be present utilizing Recommended sizing (1.5m2) requirement. Girls: 10 Cubicles required	5 extra classrooms are needed since current 16 classrooms are not sufficient to support the total roll. Girls WASH: 4 extra Cubicles required

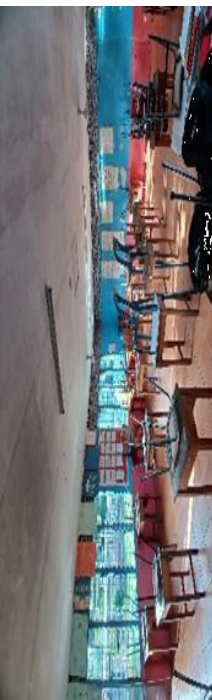
Dr. Ram Lakhani Memorial	Overcrowding - 6/11 classroom (54.55%) overcrowded	17 total classrooms are to be present utilizing Recommended sizing (1.5m2) requirement	6 extra classrooms are needed since current 11 classroom are not sufficient to support the total roll

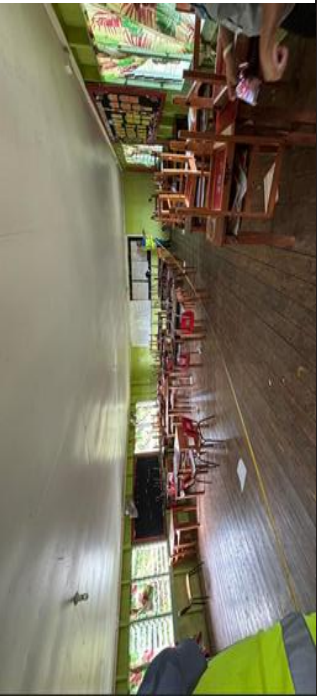
School	Existing Infrastructure	Required infrastructure	Gap between existing and required infrastructure	Evidence
Newtown Christian Primary School	Structure - classroom doors deteriorated, classroom lighting inadequate, limited fire fighting equipment.	Protection of doorway Type C construction requirement under FNBC, requirements for artificial lighting under FNBC, Requirements for fire fighting equipment under FNBC.	all classroom doors to be replaced with quality solid core frame, new light frames required for classrooms, new fire hose reels with separate water supply & fire extinguishers to be provided.

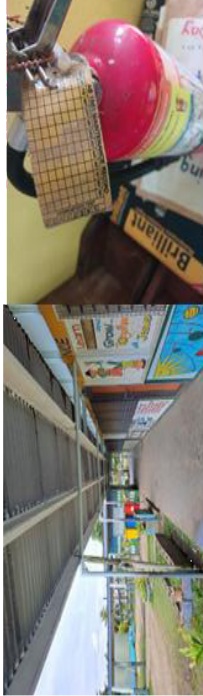
Bishop Kempthorne Memorial	Disability Access and Fire	Upgrade Infrastructure to include disability access. Fire Safety Compliance	construct ramps, provide space, etc, or disability. Upgrade all fire fighting equipment and obtain NFA Compliance

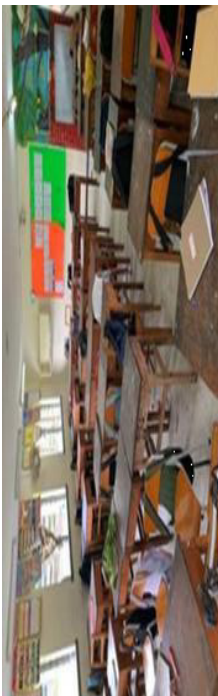
Delainamasi Govt School	The school has 12/26 overcrowded classrooms and inadequate washroom facilities – Girls WASH: 16 Cubicles present	Recommended Sizing (1.5m ²) requires 30 total classrooms to be present while FNBC 1990 standards requires for structural safety, Girls WASH: 19 Cubicles required, and accessibility are required.	The school needs 4 extra classrooms, 3 additional girls' cubicles and ramps.

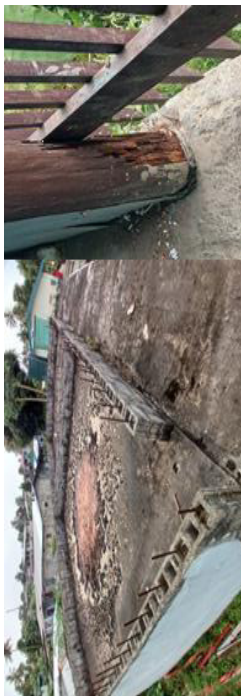
Basden College	Existing infrastructure in bad condition and No Fire compliance	Upgrade Infrastructure to minimum standards. Fire Safety Compliance	Engage Engineer for structural assessment and rehabilitation. Upgrade all fire fighting equipment and obtain NFA Compliance

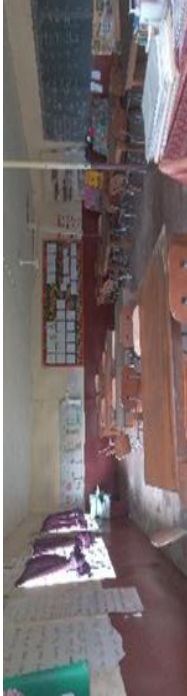
School	Existing Infrastructure	Required infrastructure	Gap between existing and required infrastructure	Evidence
Narere Primary School	Overcrowding – 3/13	16 total classrooms are to be present utilizing Recommended sizing (1.5m2) requirement	3 extra classrooms are needed since current 13 classrooms are not sufficient to support the total roll

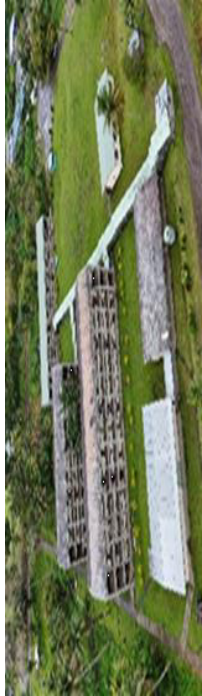
Nasinu Secondary School	Overcrowding – 17/19 classrooms (84%) overcrowded	24 total classrooms are to be present utilizing Recommended sizing (1.5m2) requirement	5 extra classrooms are needed since current 19 classrooms are not sufficient to support the total roll

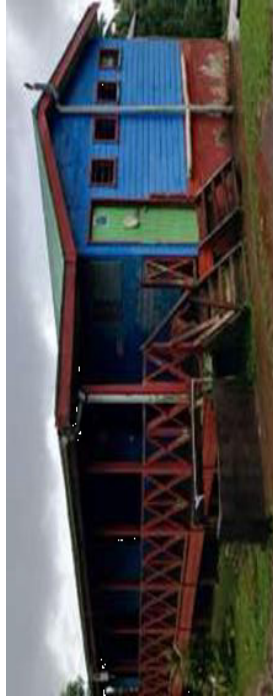
Kalabu Fijian Primary School	Total of 12/16 overcrowded classroom with total of 655 students with average of 42 student in each classroom. B2 Timber structure building doesn't comply with cyclone standard.	total 22 classroom need to meet Recommended sizing (1.5m2). Upgrade work required on B2 to meet cyclone standard.	additional 6 classroom need to meet Recommended sizing (1.5m2) to address overcrowding in school and upgrade works on B2 Timber structure to meet cyclone standards

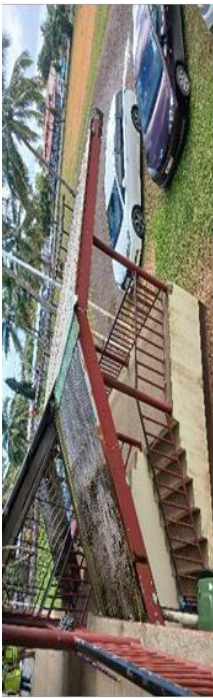
Ahmadiyya Muslim College	<p>Disability Accessibility - 100% not accessible to disabled people.</p> <p>Disaster Resilience - 90% not resilient.</p> <p>Condition of Infrastructure - 80% structural integrity failure.</p>	<p>Disaster Resilience - roof cladding and roofing nails are rusted and there weren't any permanent mesh shutters on the windows. For cyclone certification these will need to be amended,</p> <p>Disability Accessibility - Ramps, signs, accessible toilets and wider doorways are required to meet compliance.</p> <p>Condition of Infrastructure - building structure require more intervention to improve structural integrity and condition.</p>	<p>Disaster Resilience - rusting of roof cladding, roofing nails and permanent cyclone mesh shutters contradicts to the cyclone certification requirement requiring replacement,</p> <p>Disability Accessibility - not compliant with FDFP Disability audit tool.</p> <p>Condition of Infrastructure - building structure require more intervention to improve structural integrity and condition.</p>

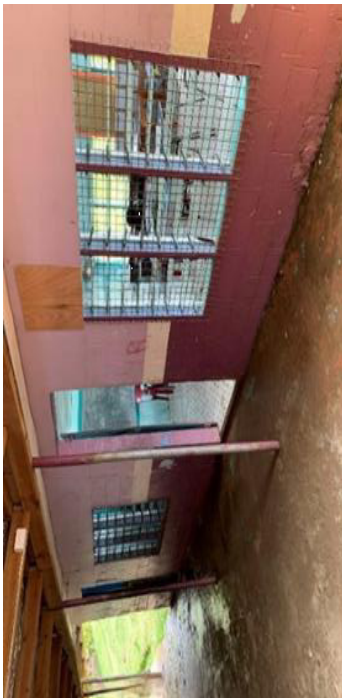
School	Existing Infrastructure	Required infrastructure	Gap between existing and required infrastructure	Evidence
Kalabu Secondary School	Disaster resilience - rusted roof cladding and roofing elements, absence of cyclone shutters.	Disaster Resilience - roof cladding and roofing nails are rusted and there weren't any permanent mesh shutters on the windows. For cyclone certification these will need to be amended,	Disaster Resilience - rusting of roof cladding, roofing nails and permanent cyclone mesh shutters contradicts to the cyclone certification requirement requiring replacement,

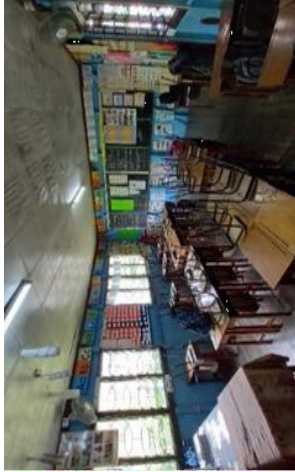
William Cross Primary	Overcrowding: 7/8 classrooms (87.5%) overcrowded. WASH Facilities: Girls: 6 cubicles.	15 total classrooms are to be present utilizing Recommended sizing (1.5m2) requirement. WASH Facilities: Girls – (7 cubicles)	7 extra classrooms are needed since current 8 classrooms are not sufficient to support the total roll. WASH Facilities: Girls: 1 cubicles required

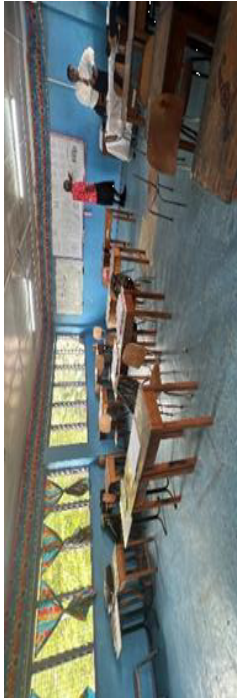
William Cross College	Overcrowding: 4/10 classrooms (40%) overcrowded. WASH Facilities: Girls: 6 cubicles.	12 total classrooms are to be present utilizing Recommended sizing (1.5m2) requirement. WASH Facilities: Girls – 8 cubicles	2 extra classrooms are needed since current 10 classrooms are not sufficient to support the total roll. WASH Facilities: Girls: 2 cubicles required

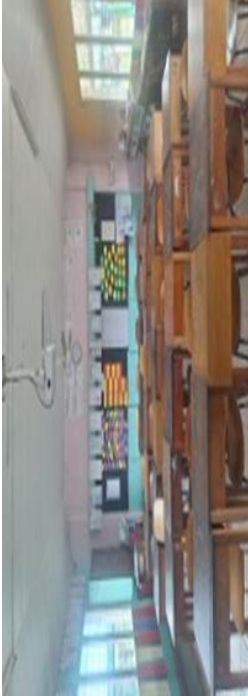
Nasinu Muslim Primary School	The school has 5/24 overcrowded classrooms.	RECOMMENDED SIZING (1.5M2) for 26 total classrooms and FNBC1990 standards for structural safety, proper washroom ratios, and accessibility are required.	The school needs 2 extra classrooms, and cyclone upgrades.

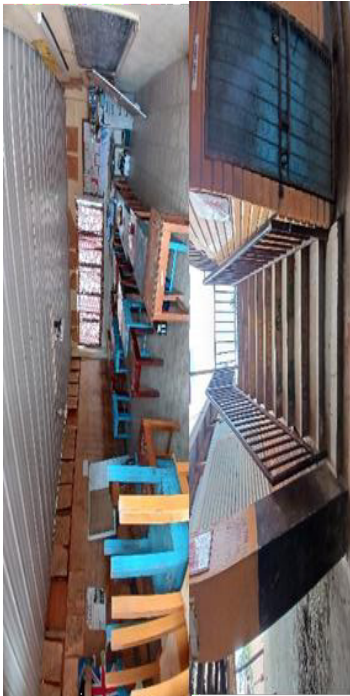
School	Existing Infrastructure	Required infrastructure	Gap between existing and required infrastructure	Evidence
Davulevu Methodist Primary	Overcrowding – 20/21 (95.24%) of classrooms were overcrowded, Disability Accessibility - 80% not accessible to disabled people.	Overcrowding - 28 classrooms are required to meet Recommended sizing (1.5m2); Disability Accessibility - Ramps, signs, accessible toilets and wider doorways are required to meet compliance.	Overcrowding – 7 classrooms are needed based on Recommended sizing (1.5m2); Disability Accessibility - not compliant with FDPF Disability audit tool.

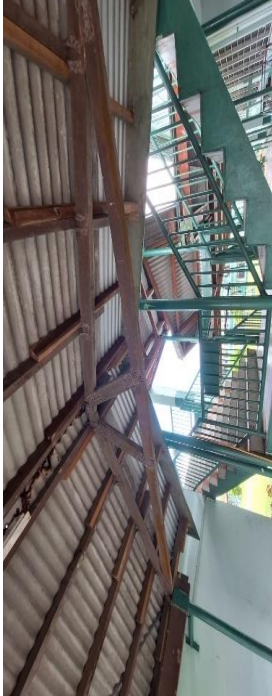
Nasinu Muslim High School	Multiple floor levels without ramps, walkways having different heights, WASH facilities and classroom doors not accommodating for wheelchair users	Disability Accessibility - Ramps, signs, accessible toilets and wider doorways are required to meet compliance.	Disability Accessibility - not compliant with FDPF Disability audit tool

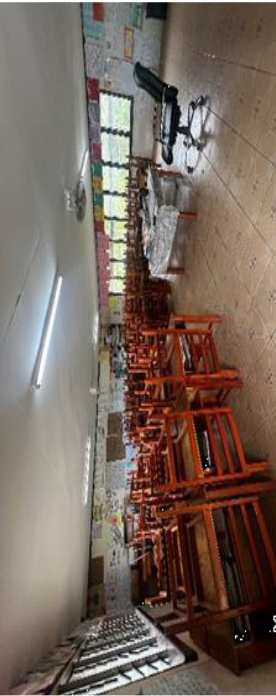
School	Existing Infrastructure	Required infrastructure	Gap between existing and required infrastructure	Evidence
Wainibuku Hut Primary School	Overcrowding: 5/8 classrooms (62.5%) overcrowded. WASH Facilities: Girls: 4 cubicles.	13 total classrooms are to be present utilizing Recommended sizing (1.5m ²) requirement. WASH Facilities: Girls – 7 cubicles	5 extra classrooms are needed since current 8 classrooms are not sufficient to support the total roll. WASH Facilities: Girls: 3 extra toilet cubicles

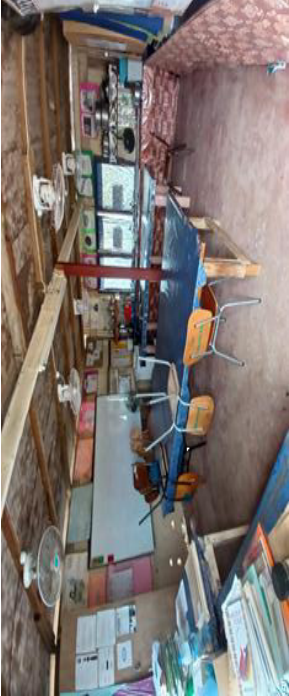
Davulevu Methodist High School	Overcrowding – ¼ (25%) of classrooms were overcrowded. Disability Accessibility – 100% not accessible to disabled people.	Overcrowding - 5 classrooms are required to meet Recommended sizing (1.5m ²); Disability Accessibility - Ramps, signs, accessible toilets and wider doorways are required to meet compliance.	Overcrowding – 1 extra classroom is needed based on Recommended sizing (1.5m ²); Disability Accessibility - not compliant with FDFP Disability audit tool.

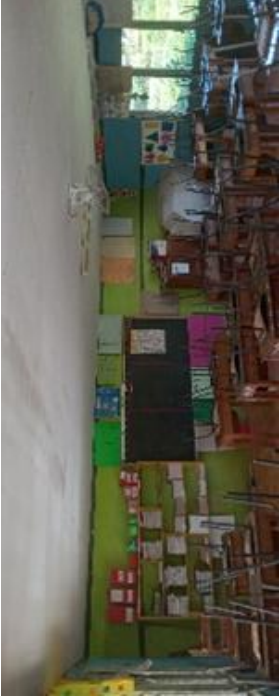
Dilkusha Boys Primary	Overcrowding - 10/24	27 total classrooms are to be present utilizing Recommended sizing (1.5m ²) requirement	3 extra classrooms are needed since current 24 classrooms are not sufficient to support the total roll

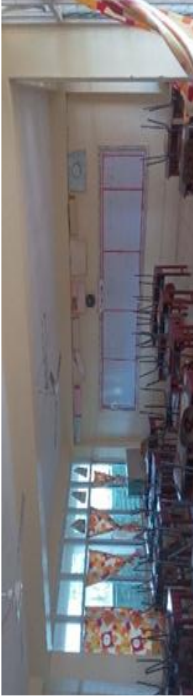
Bhawani Dayal Primary	The school has structural defects, 16/24 overcrowded classrooms	Recommended Sizing (1.5m ²) requires 30 additional classrooms while FNBC 1990 standards requires for structural safety, and accessibility are required.	6 extra classrooms are needed since current 24 classrooms are not sufficient to support the total roll

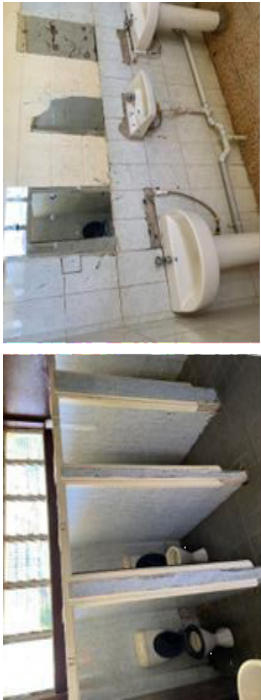
School	Existing Infrastructure	Required infrastructure	Gap between existing and required infrastructure	Evidence
Nakasi High School	The school has structural defects, 5/9 overcrowded classrooms and 8 girls washroom facilities	Recommended sizing (1.5m ²) requires 12 total present classrooms while FNBC 1990 standards requires for structural safety, 8 total present girls WASH facilities, and accessibility are required.	The school needs 3 extra classrooms, cyclone and structural upgrades, ramps, and clear pathways. Some consideration could be taken to add extra girl's toilet cubicles since its exactly par with the requirement in order to cater for growing population.

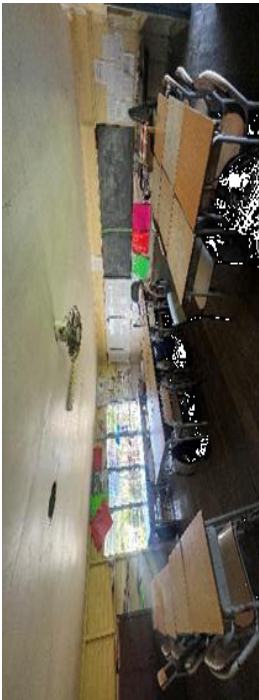
Bainivalu Primary School	Overcrowding: 16/16 classrooms (100%) overcrowded. WASH Facilities: Boys: 4 cubicles. Girls: 8 cubicles.	25 total classrooms are to be present utilizing Recommended sizing (1.5m ²) requirement. WASH Facilities: Boys - 4 cubicles. Girls - 8 cubicles	9 extra classrooms are needed since current 16 classrooms are not sufficient to support the total roll. WASH Facilities: To cater for growing student population, some consideration of building 1 extra cubicles for boys and girls' toilets is needed since existing is in par with the required number of cubicles.

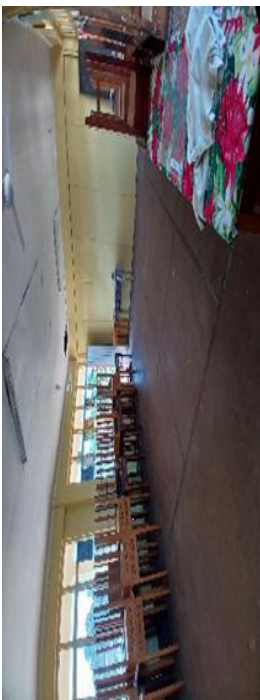
Saraswati College	Girls WASH Facilities: 7 cubicles	FNBC 1990 requires current girls WASH Facilities: 7 cubicles	since existing number of girls toilet cubicles is in par with requirement, additional 1 toilet cubicle could be made to cater for growing population.

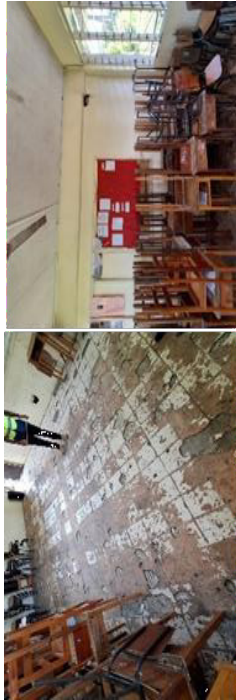
Lelean Memorial School	Overcrowding – 23/27 classrooms. Girls WASH Facilities: 17 cubicles. WASH facilities in very poor condition with broken structures and unhygienic.	37 total classrooms are to be present utilizing Recommended sizing (1.5m ²) requirement. Girls -20 cubicles required. WASH to be equipped with up-to-date facilities with regular maintenance.	10 extra classrooms are needed since current 27 classroom are not sufficient to support the total roll. Girls WASH Facilities: 3 extra cubicles required. WASH does not meet the requirement requiring immediate intervention and upgrading works.

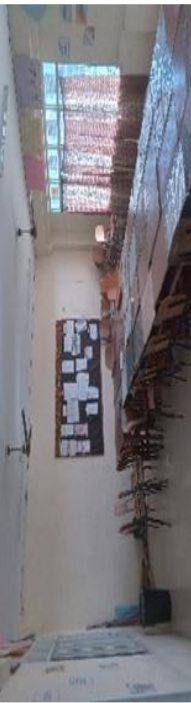
School	Existing Infrastructure	Required infrastructure	Gap between existing and required infrastructure	Evidence
Bhawani Dayal Arya College	Overcrowding - 10/24	26 total classrooms are to be present utilizing Recommended sizing (1.5m2) requirement	2 extra classrooms are needed since current 24 classrooms are not sufficient to support the total roll

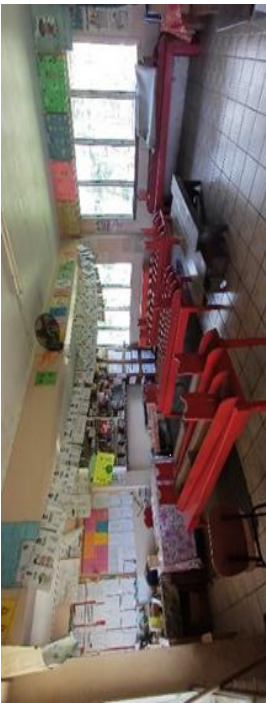
Rambisessar Primary School	Overcrowding: 7/16 classrooms (43.75%) overcrowded. WASH Facilities: Boys: 3 cubicles.	19 total classrooms are to be present utilizing Recommended sizing (1.5m2) requirement. WASH Facilities: Boys - 4 cubicles	3 extra classrooms are needed since current 16 classrooms are not sufficient to support the total roll. WASH Facilities: Boys: 1 extra cubicle required

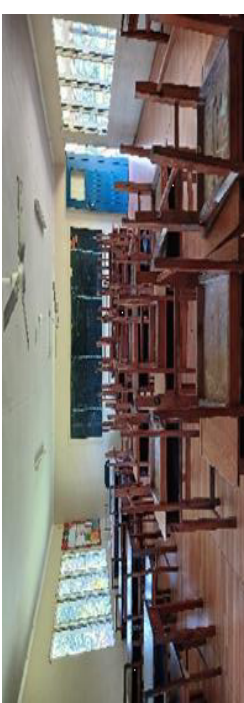
Saraswati Primary School	No Disability Accessibility	Upgrade Infrastructure to include disability access and compliance with Engineering Standards	construct ramps, provide space, etc, or disability. Upgrade Infrastructure to

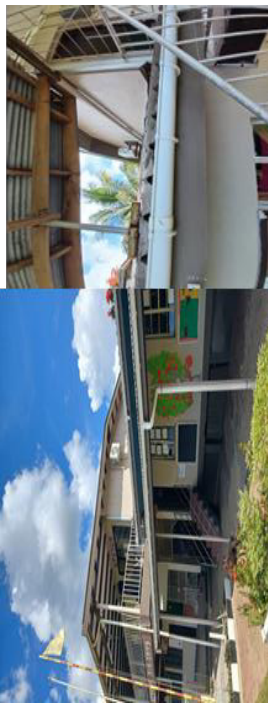
Nakaikogo Sanatan Dharam School	Disability Access and No Engineered Certificate	Upgrade Infrastructure to include disability access and compliance with Engineering Standards	construct ramps, provide space, etc, or disability. Upgrade Infrastructure to

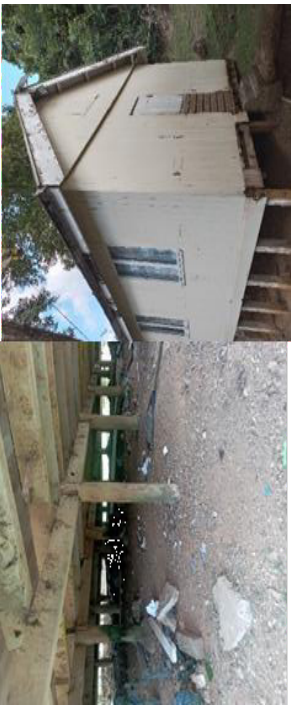
School	Existing Infrastructure	Required infrastructure	Gap between existing and required infrastructure	Evidence
Adi Cakobau School	Disaster resilience - 3no. old timber structures used as classrooms have deteriorated. Almost all timber structures require upgrading works.	Structure Integrity to comply requirements under FNBC.	Demo & rebuild 3no. old timber structures. Upgrade tie down connections for the rest of the 8no. timber structures.

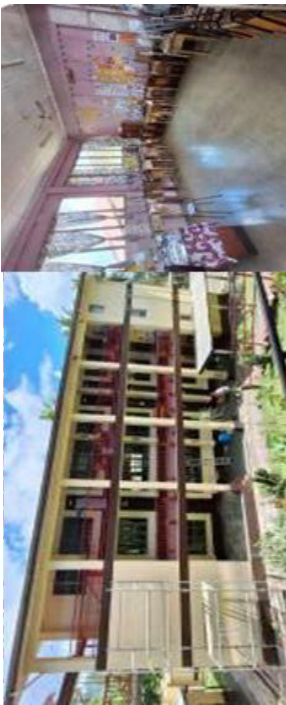
Dilkusha Girls Primary	No disability ramp access provides in all buildings. Total of 6/24 overcrowded classrooms with 857 students average of 36 students in each classroom.	30 total classrooms needed under Recommended sizing (1.5m2). Provide disability ramp access in all buildings	6 additional classroom is needed to meet Recommended sizing (1.5m2) to address overcrowding issue in school. Provide ramp access in all building.
