INFRASTRUCTURE ASSESSMENT AUDIT FOR SUVA – NAUSORI URBAN SCHOOLS

DR. RAM LARKHAN MEMORIAL PRIMARY SCHOOL (REG 2384)

SUMMARY REPORT

SITE INSPECTION REPORT

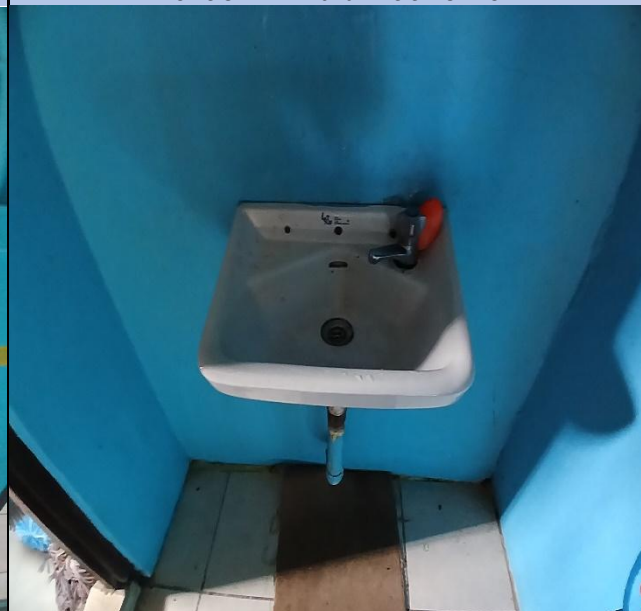
PHOTOGRAPH NO 7 - TOILETS

- The cubicle doors were damaged.
- Some toilet seat pans were missing.
- Rust was found on the door hinges and steel connectors of the PVC pipe outlets in the toilet system.
- The floor and walls had damaged and missing tiles.
