INFRASTRUCTURE ASSESSMENT AUDIT FOR SUVA – NAUSORI URBAN SCHOOLS

AOG PRIMARY (2335)

SUMMARY REPORT

ASSEMBLIES OF GOD PRIMARY SCHOOL (REG 2335) SITE INSPECTION REPORT

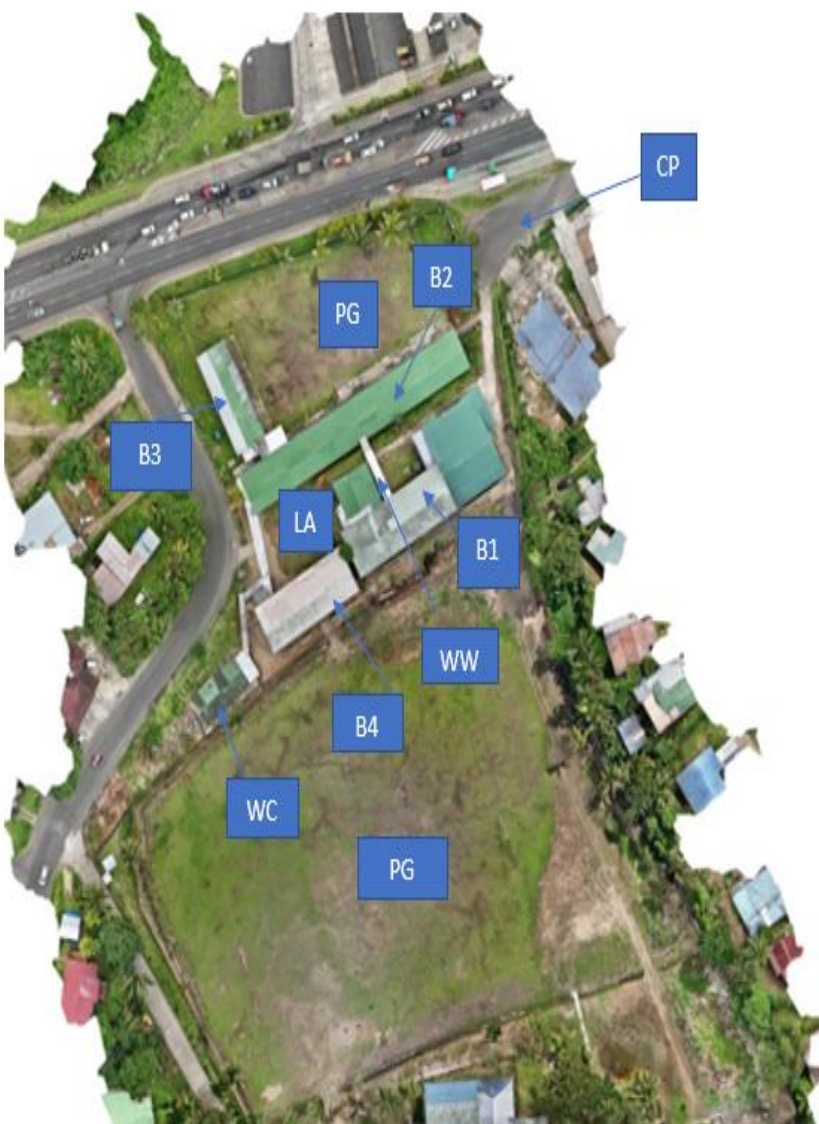
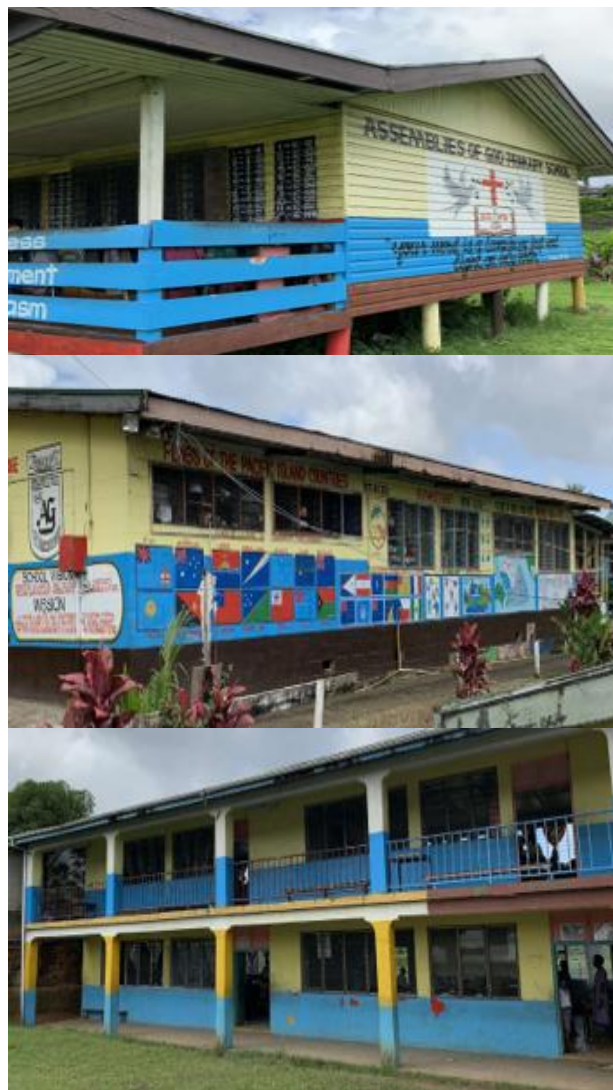
School Inspection Summary	
School name:	AOG PRIMARY SCHOOL
Overall condition state:	POOR
Key recommendations:	
- Overcrowding – 13 new classrooms required based on FNBC standards - Overcrowding – 5 new classrooms required based on recommended sizing (1.5m ²) - Accessibility –All buildings require accessibility ramps, accessible doorways - Disaster resilience – Windows to include cyclone shutters and roof cladding fastened with Cyclone roofing screws.	
Comments:	
Major defects were noted as follows: <ul style="list-style-type: none"> Damaged ceiling Cracks on walls Missing ramps (All buildings) Inadequate stairway width. (All buildings) Girls' toilet cubicles in poor condition. Dented and dislodged handrails. Roof cladding, gutter and roofing nails. 	
Aerial view of school	General view of school
