INFRASTRUCTURE ASSESSMENT AUDIT FOR SUVA – NAUSORI URBAN SCHOOL

PT. VISHNU DEO MEMORIAL PRIMARY SCHOOL (2379) SUMMARY REPORT

PT. VISHNU DEO MEMORIAL PRIMARY SCHOOL (2379) SITE INSPECTION REPORT

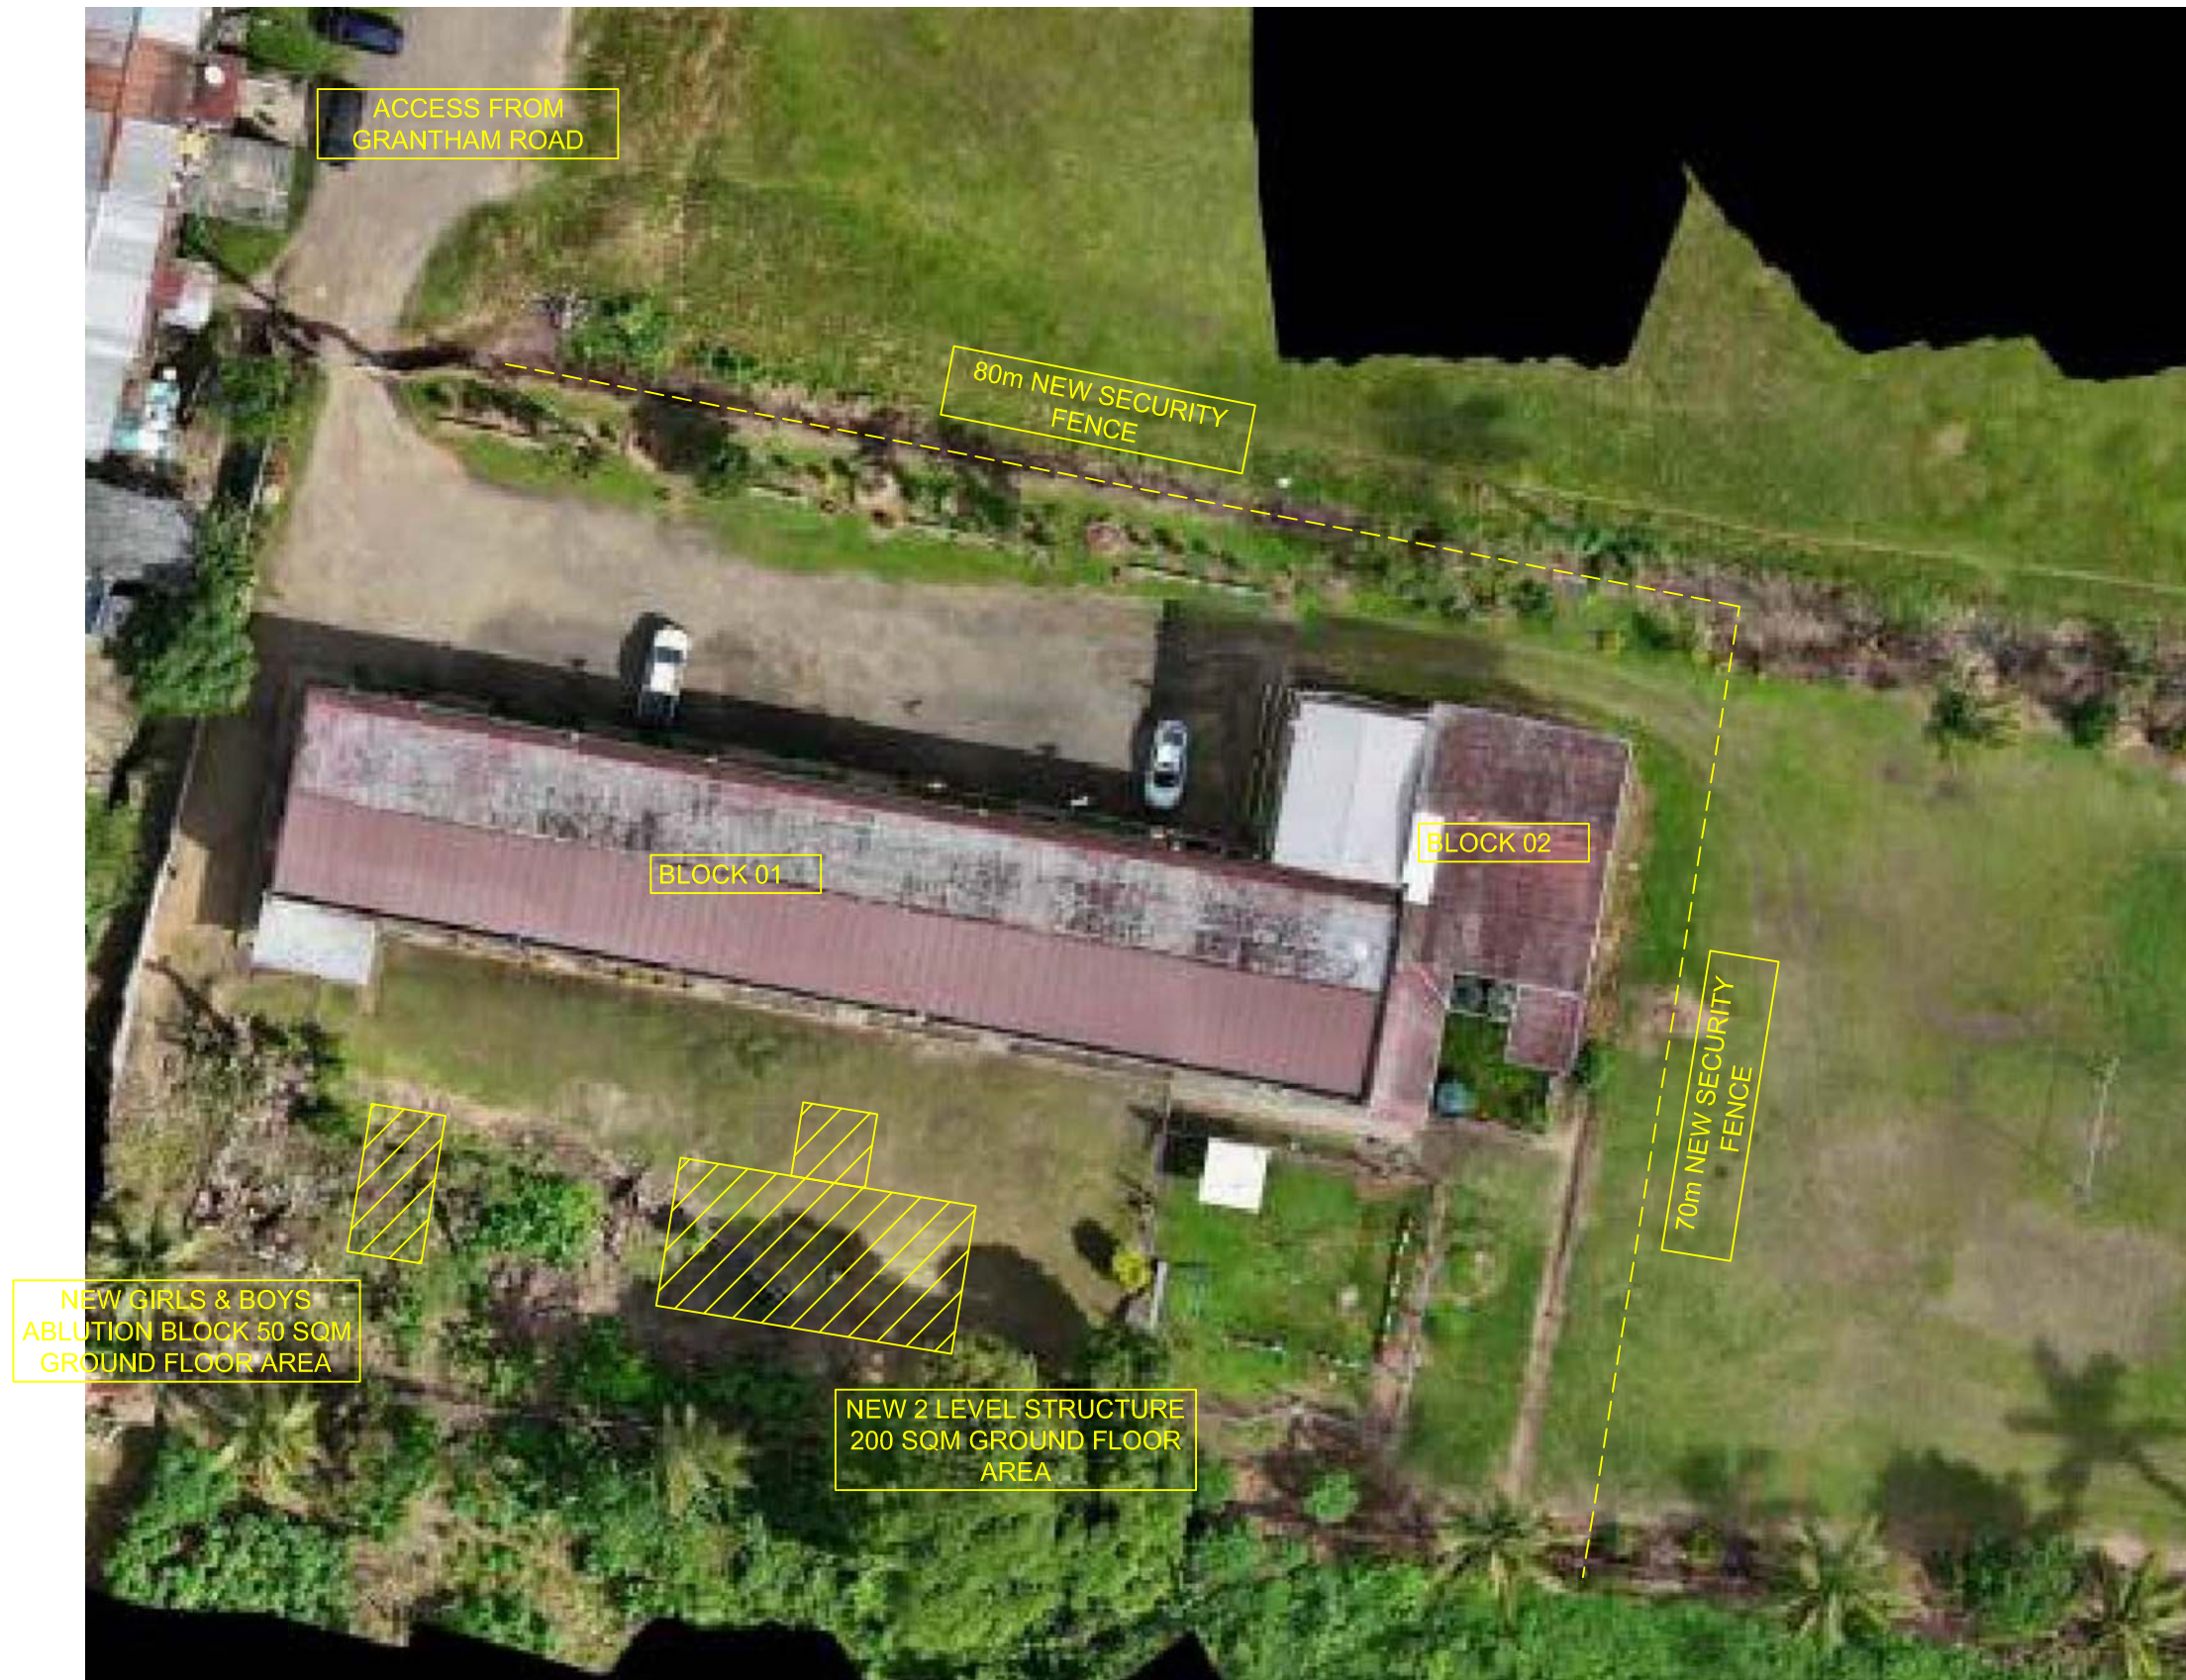
BLOCK 01
EXISTING TWO LEVEL STRUCTURE,
GROUND FLOOR HAVE CANTEEN, GRADES 101,
102, 201, 301, 401, 501
FIRST FLOOR HAVE GRADES 502, 601, 602, 701,
702, 801.

BLOCK 02
EXISTING TWO LEVEL STRUCTURE,
GROUND FLOOR HAVE ECE ROOM, MALE
STAFF TOILET, FEMALE STAFF TOILET, GIRLS
TOILET & BOYS TOILET.
FIRST FLOOR HAVE ADMIN OFFICE, STAFF
TOILET, CULTURE ROOM, GRADES 302, 802.
