INFRASTRUCTURE ASSESSMENT AUDIT FOR SUVA – NAUSORI URBAN SCHOOLS

DEENBHANDHOO MEMORIAL SCHOOL (REG 2306)

SUMMARY REPORT

SITE INSPECTION REPORT

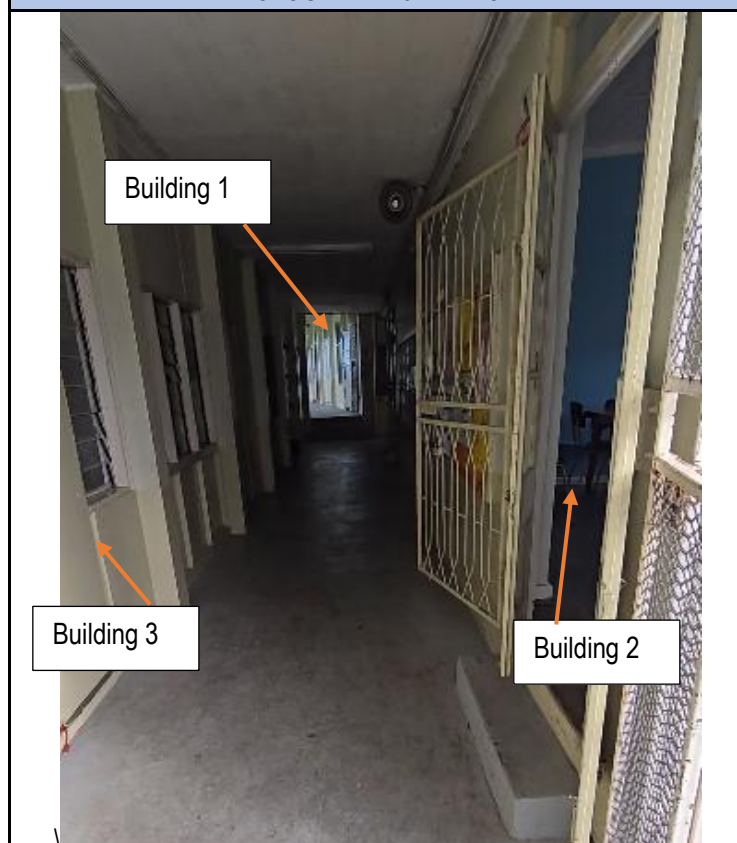
PHOTOGRAPH No. 3: BACK – The rear end of building 2 is connected to Building 3 and supports the walkway that connects building 3 to building 1

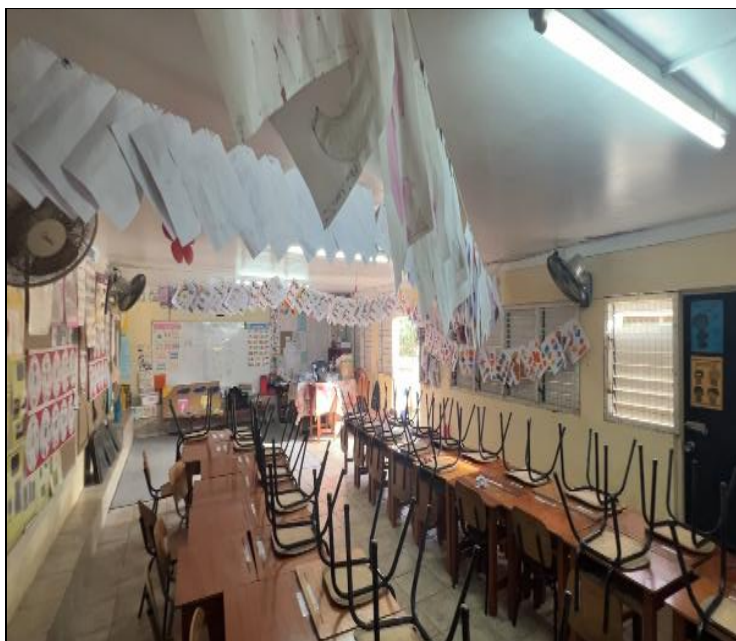
PHOTOGRAPH No. 5: INTERIOR VIEW.

- B2 – ceiling at ECE and staffroom show sign of water leaking through, presumed to be water leak from Kitchen sink (above ECE) and heavy rainfall leak for staff room.

Shown here is the kindergarten room. This takes up the whole floor space at ground floor. Top floor includes, school office Principal's office and staff room.

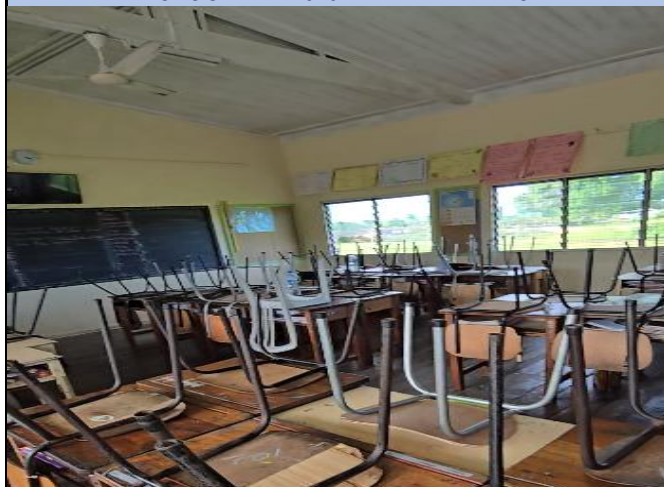
PHOTOGRAPH No. 5: INTERIOR VIEW.

- B3 – detail investigation is required at concrete ceiling of year 8 room. At the time of inspection, the ceiling showed major cracks on the ceiling. Detail investigation is required to determine recommendation.

Shown here is Room 701, this is one of the rooms located on the top floor, which also includes, Room 301, library, computer lab

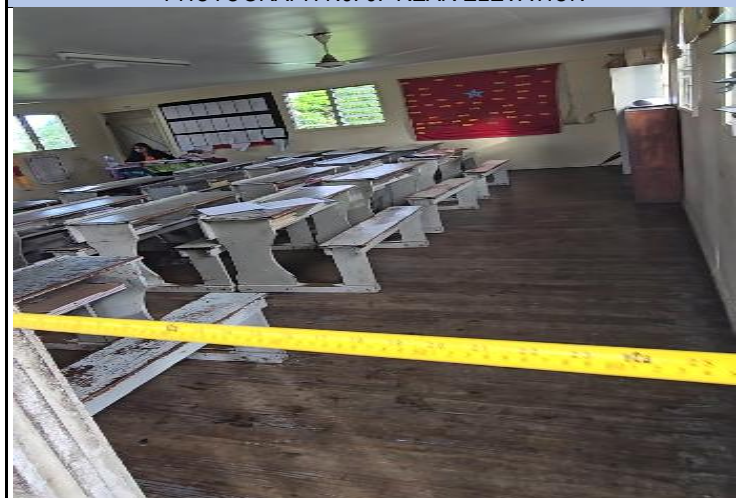
PHOTOGRAPH No. 5: INTERIOR VIEW.

- B4 –Floor frame and floor finishing were in good condition; however, floor framing was observed to be undersized with inadequate connections in accordance with current building standards. Foundation were 150/200mm timber posts on mass concrete foundation, integrity of the foundation could not be determined.

Shown here is Room 202, this is a stand-alone building and is in front of the principal's residence.
