INFRASTRUCTURE ASSESSMENT AUDIT FOR SUVA – NAUSORI URBAN SCHOOL

CHRISTIAN MISSION FELLOWSHIP PRIMARY SCHOOL (9862) SUMMARY REPORT

CHRISTIAN MISSION FELLOWSHIP PRIMARY SCHOOL (9862) SITE INSPECTION REPORT

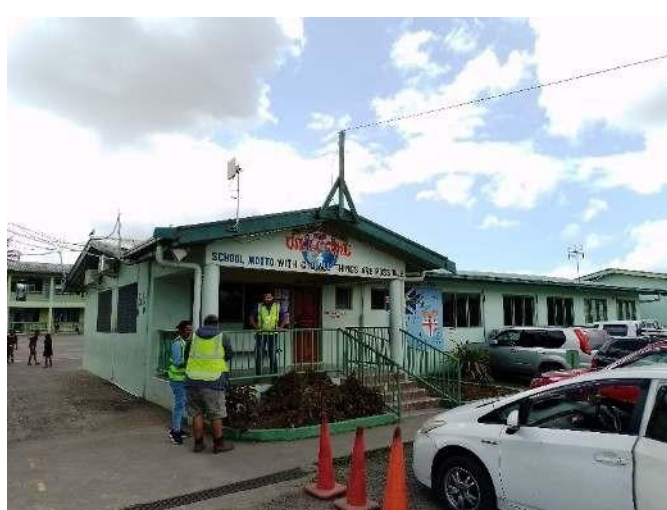
01. FRONT VIEW & ENTRY ACCESS TO ADMIN OFFICE.

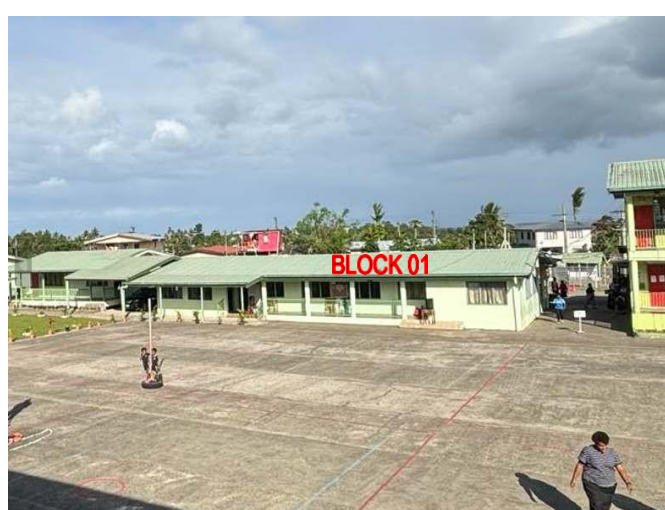
02. SHELTERED WALKWAY, CORRIDOR TO HARD COURT.

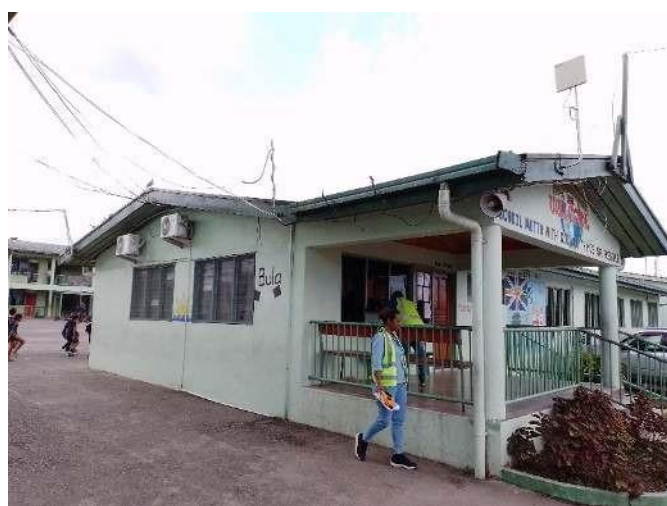
03. PA SYSTEM, AIR CON UNITS, METAL RAILING.

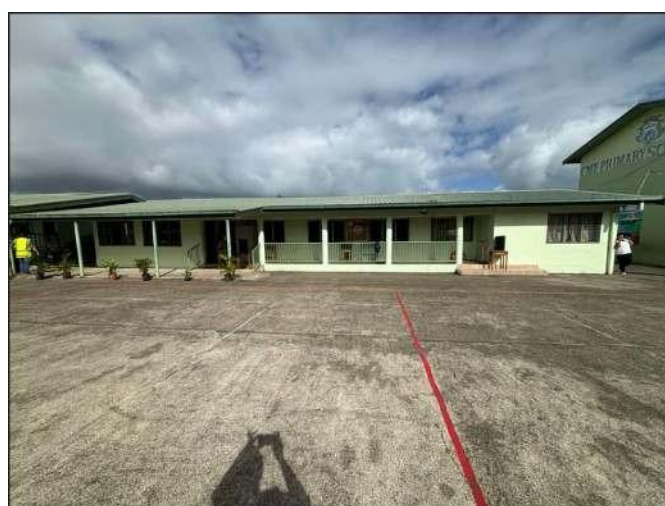
04. ACCESS TO HOS OFFICE & BACK EXIT.

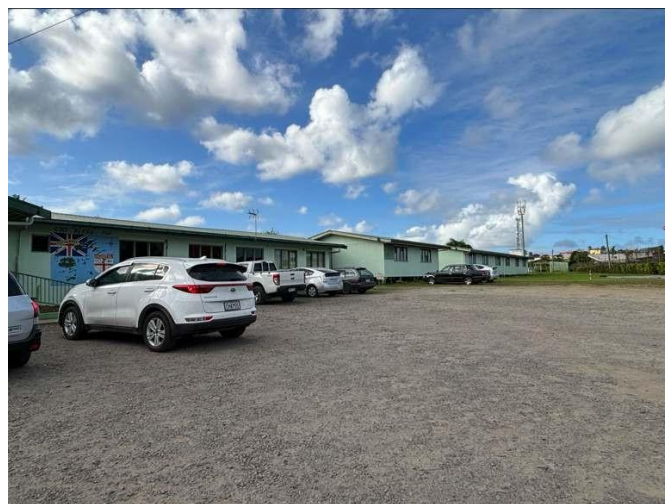
06. CARPARK FOR TEACHERS & PICK UP POINT.

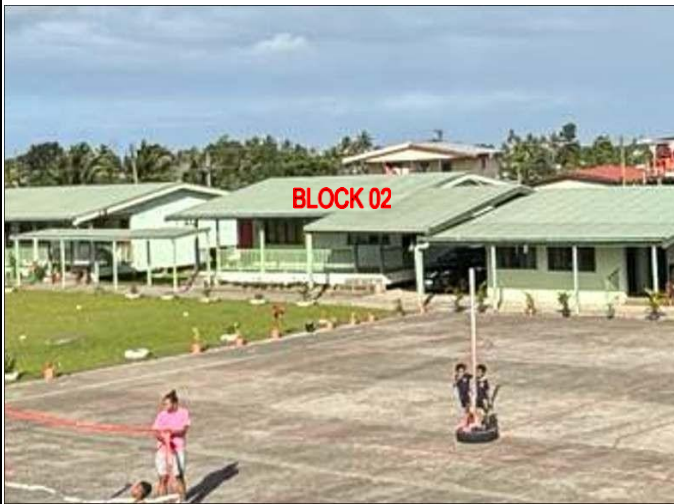
01. SHELTERED WALKWAY LINKS TO EVERY BLOCK.

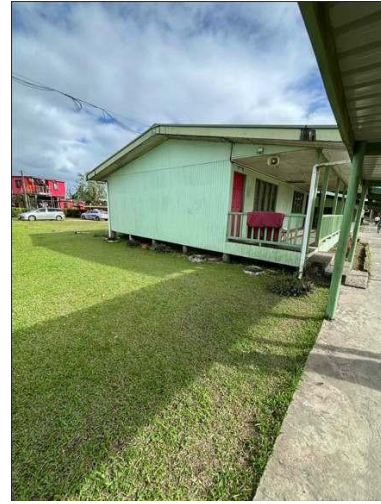
02. SIDE VIEW, STORMWATER DRAINAGE.

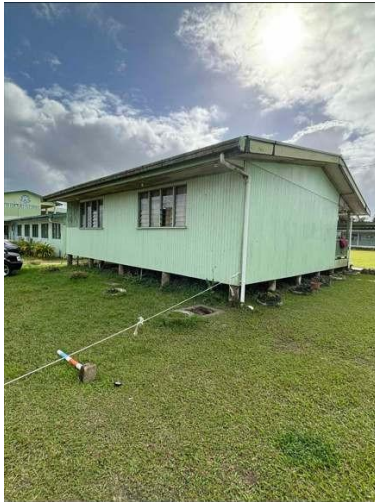
03. BACK VIEW, FLOOR RAISED ABOVE GL.

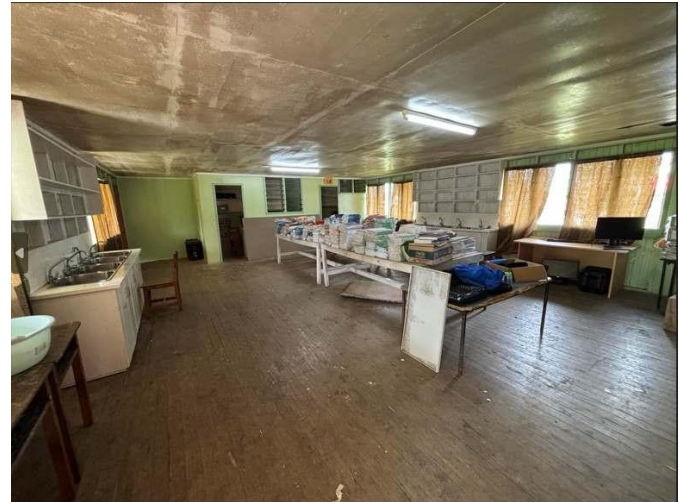
04. BARE SURFACE FLOOR, OPEN SPACE CONCEPT.

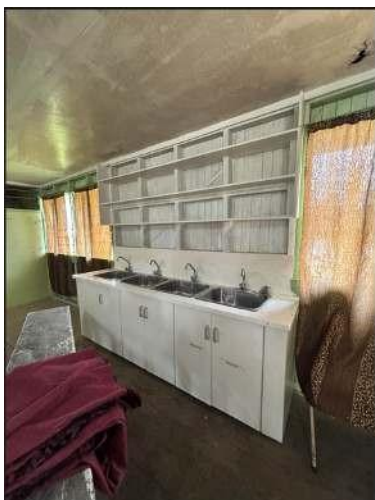
05. HAND BASINS ON BOTH SIDE WALLS.

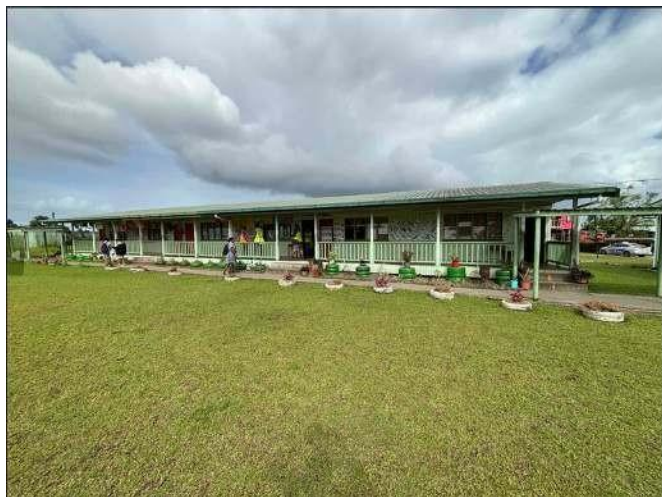
01. FRONT VIEW ACCESS INTO ROOMS, CORRIDOR RAILING

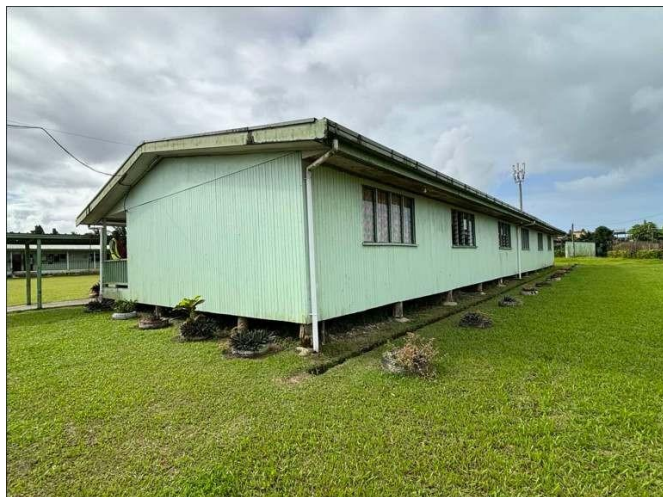
02. BACK VIEW, FLOOR RAISED ABOVE GL.

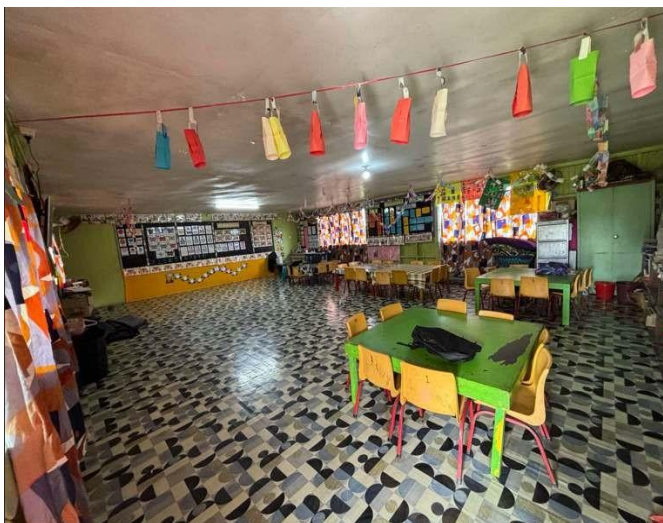
04. ECE 02 ROOM FLOOR CARPET, CEILING FANS, FEW LIGHTS.

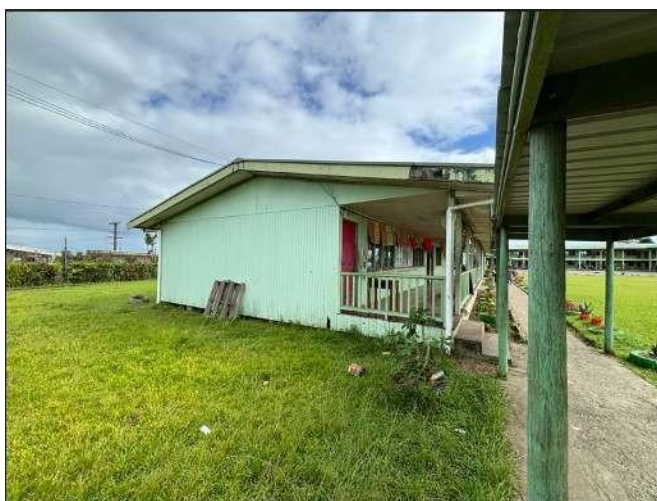
05. SIDE VIEW, STORMWATER DRAINAGE.

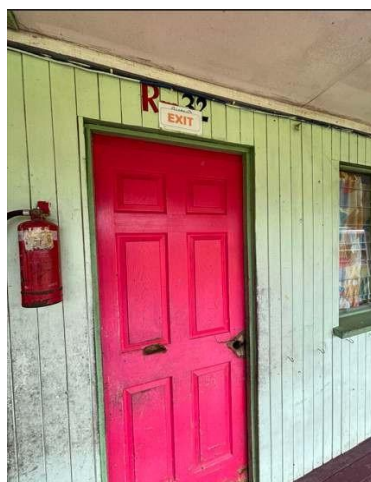
06. ACCESS DOOR TYPICAL FOR EACH ROOM.

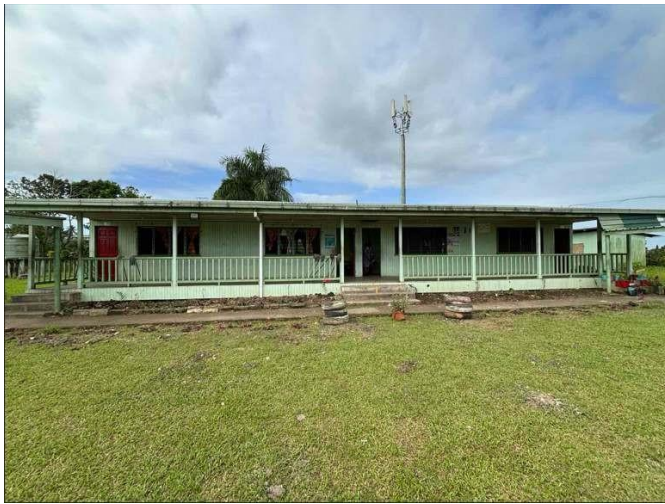
01. FRONT VIEW ACCESS INTO ROOMS, CORRIDOR RAILING

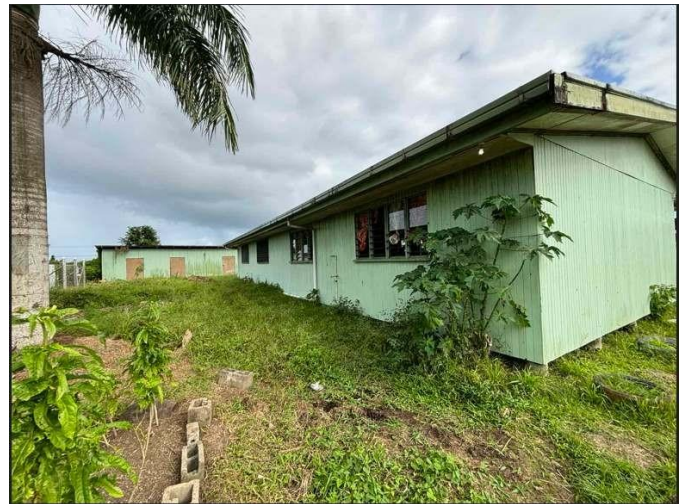
02. BACK VIEW, FLOOR RAISED ABOVE GL.

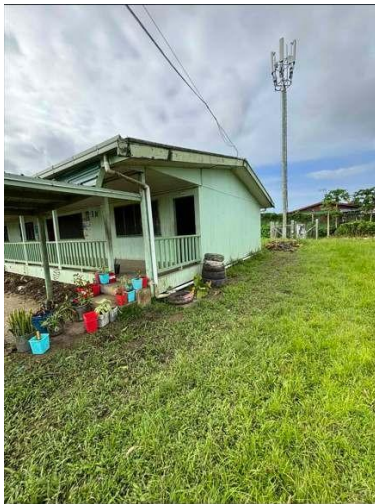
03. SIDE VIEW, STORMWATER DRAINAGE.

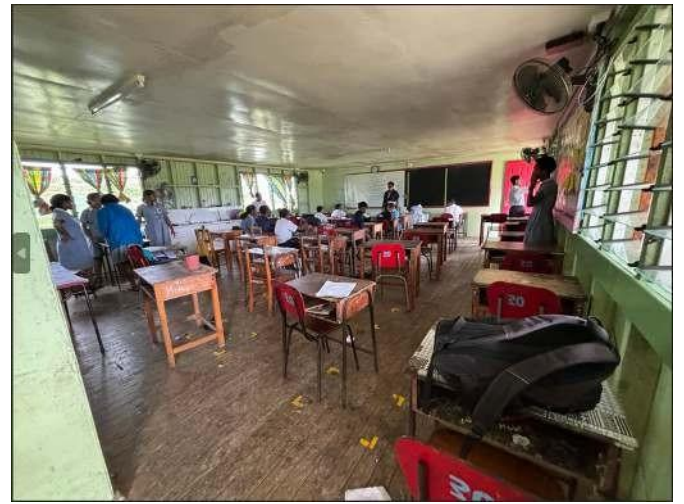
04. BARE SURFACE FLOOR, CEILING FANS, FEW LIGHTS.

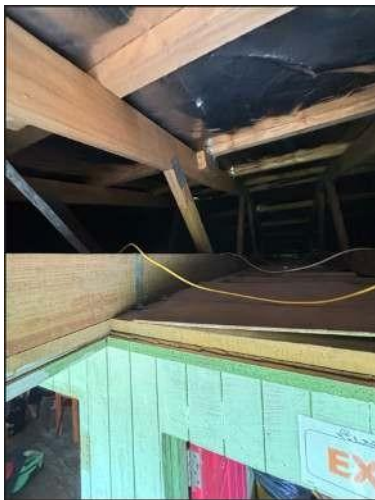
05. TIMBER TRUSS SYSTEM.

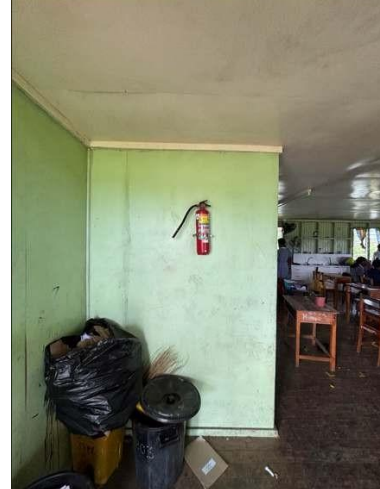
06. FIRE EXTINGUISHER IN EACH ROOM.

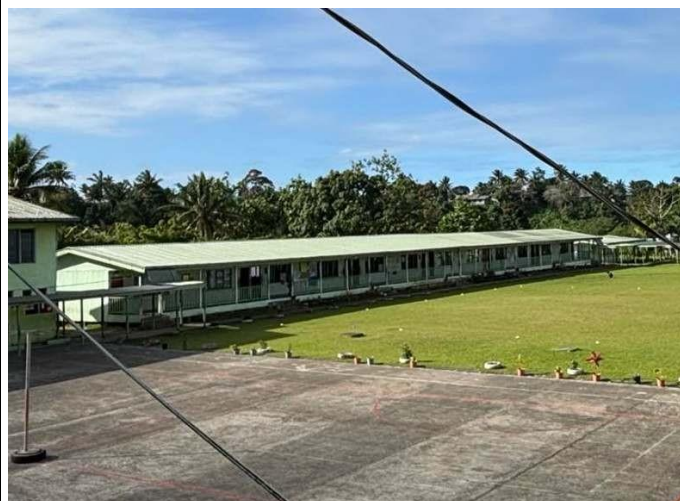
01. SHELTERED WALKWAY TO BLOCK.

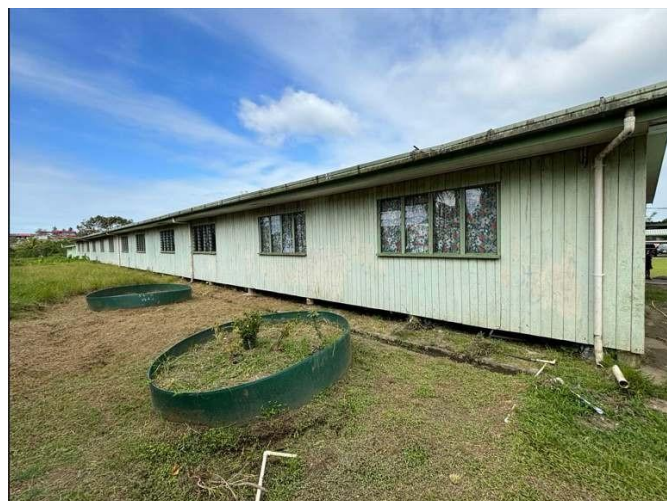
02. BACK VIEW, FLOOR RAISED ABOVE GL.

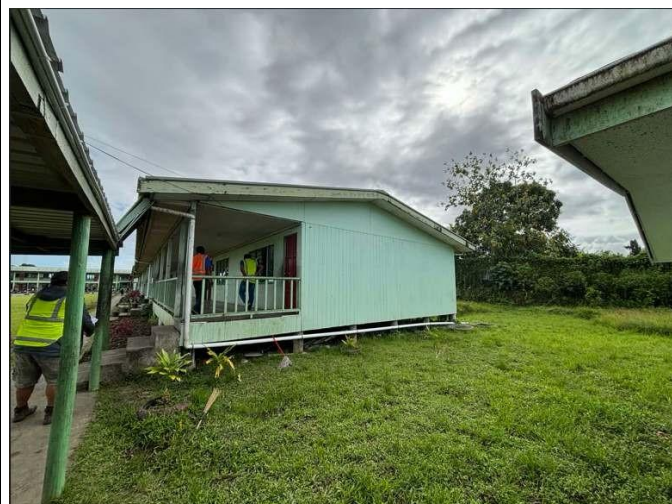
03. SIDE VIEW, STORMWATER DRAINAGE.

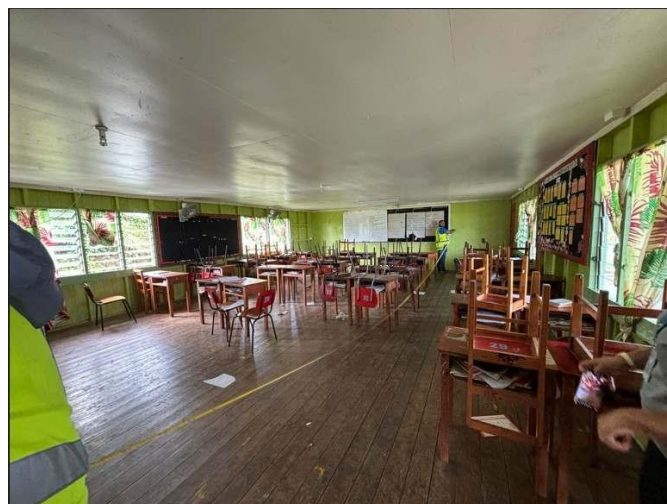
04. YEAR 801 BARE SURFACE FLOOR, CEILING FANS, FEW LIGHTS.

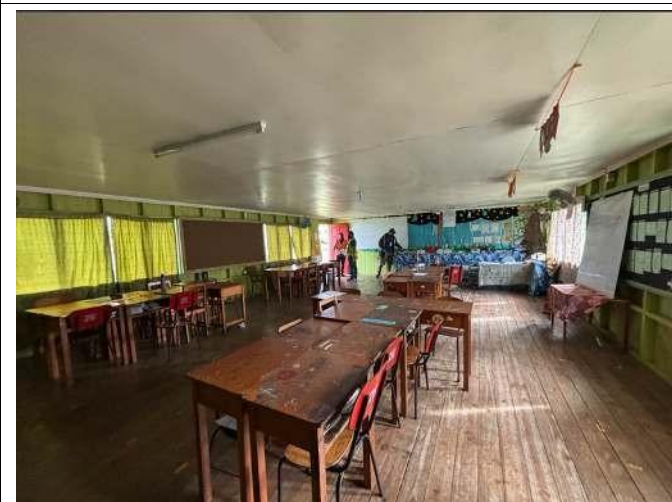
05. YEAR 704 BARE SURFACE FLOOR, CEILING FANS, FEW LIGHTS.

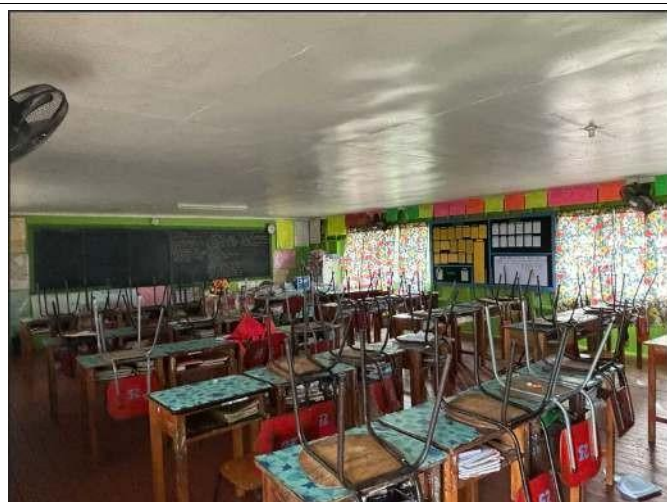
06. YEAR 603 BARE SURFACE FLOOR, CEILING FANS, FEW LIGHTS.

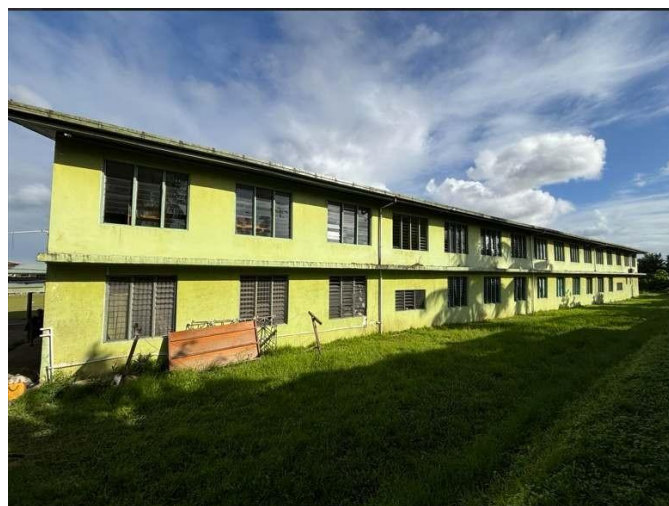
01. BACK VIEW, STORMWATER DRAINAGE.

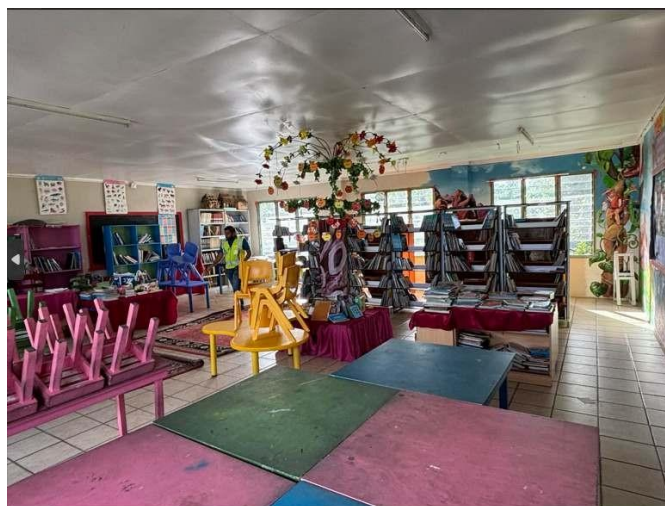
02. LIBRARY ROOM - TILED FLOOR, ADEQUATE LIGHTS, SPACE.

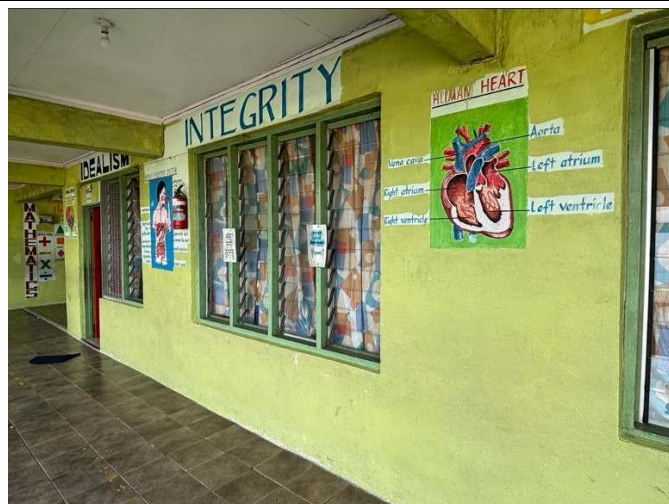
03. CORRIDOR WITH STAIRWELL BOTH ENDS.

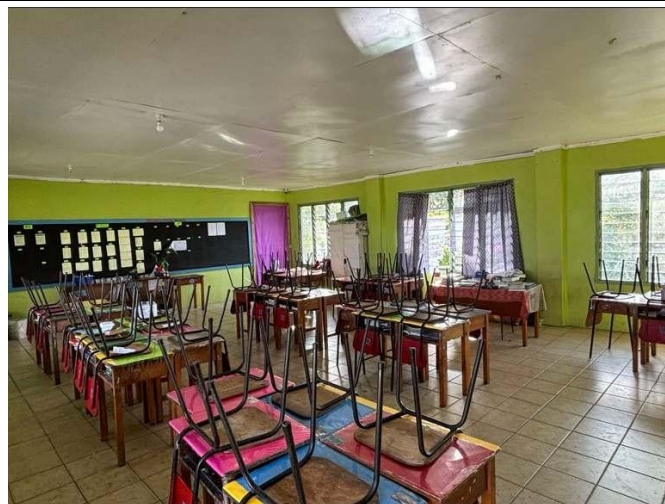
04. YEAR 602 - TILED FLOOR, CEILING U/S ROOF FRAME.

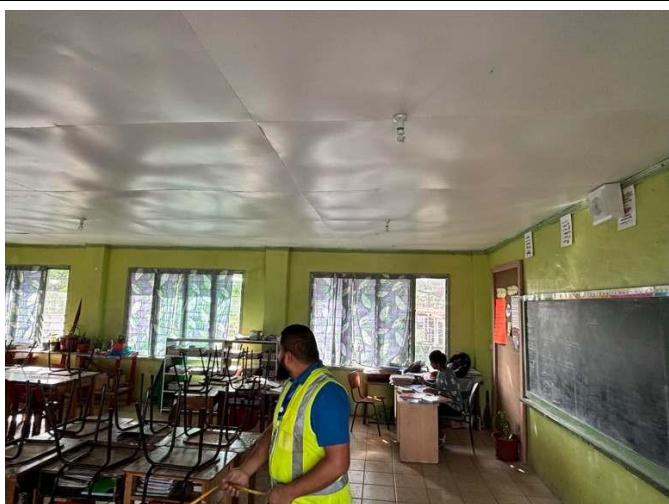
05. YEAR 503 - PA SYSTEM TO ALL ROOMS.

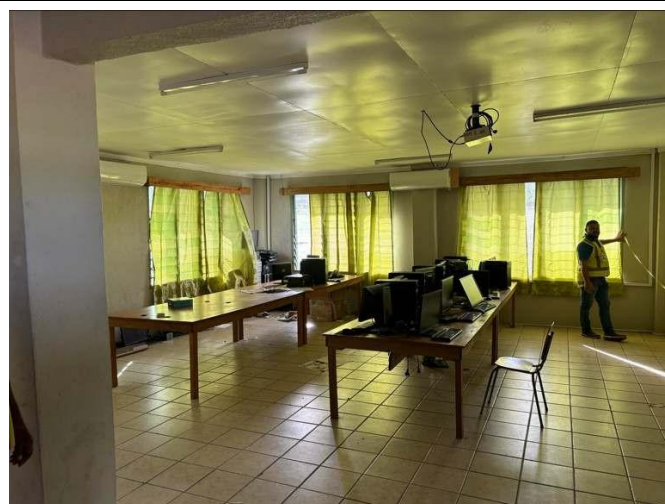
06. COMPUTER LAB WELL VENTILATED & LIGHTS.

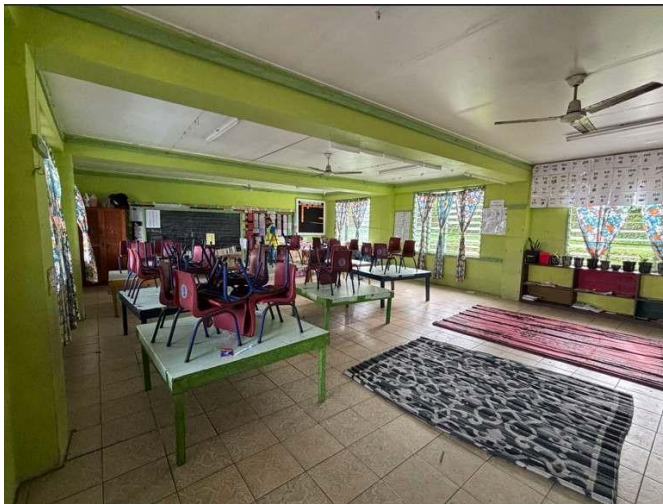
01. YEAR 103 - RIGID FRAME BEAMS & COLUMNS.

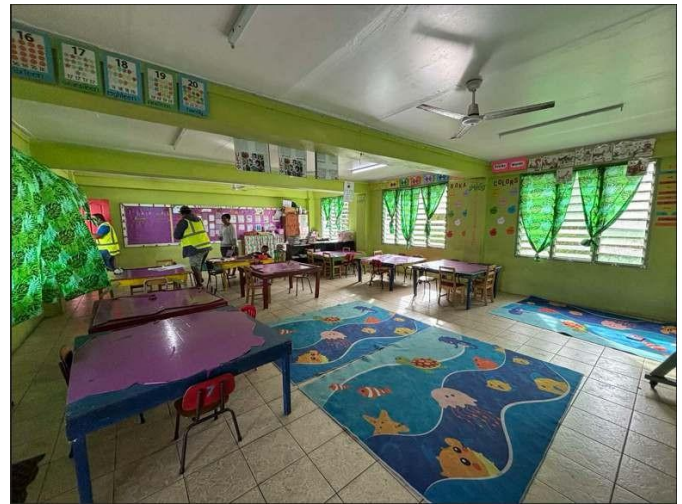
02. YEAR 101 - TILED FLOOR, ADEQUATE LIGHTS, SPACE.

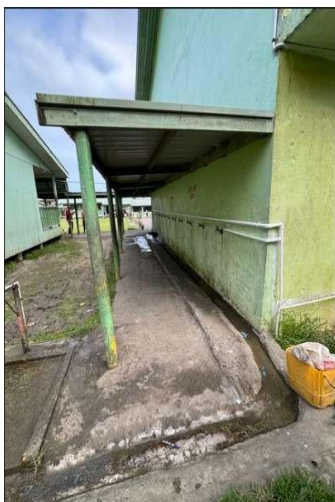
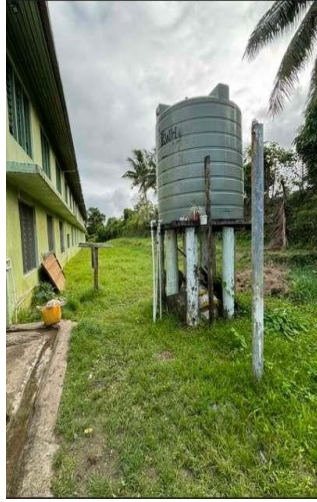
03. TAPS ON SIDE WALL & WATER TANK SUPPLY.

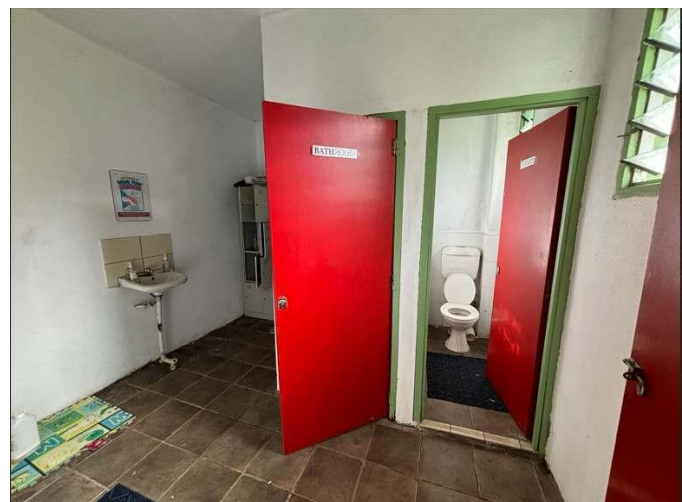
04. SICK BAY TOILET, SHOWER, TAP, TILED FLOOR.

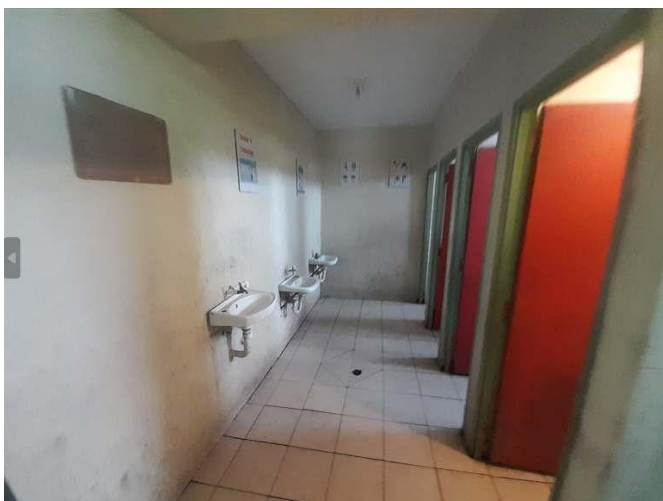
05. BOYS TOILET HAND BASINS,CUBICLES, FLOOR GRATING.

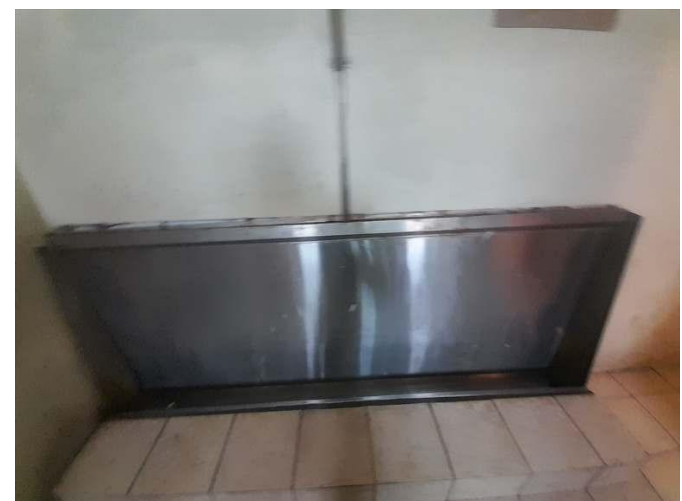
06. BOYS TOILET SSS URINAL.

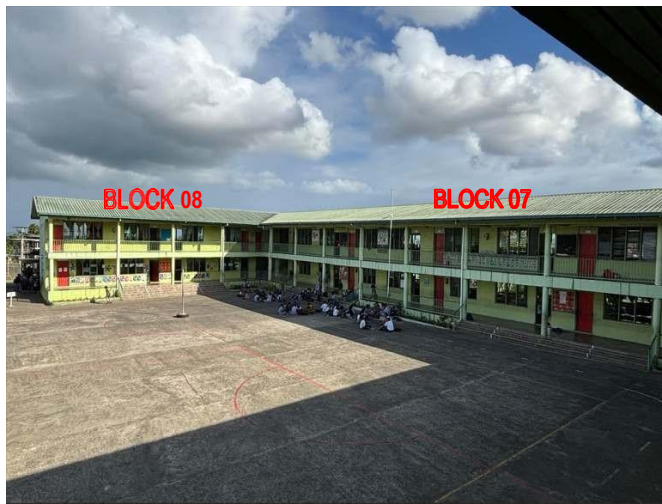
01. ADJOINING CORRIDORS FOR TWO BLOCKS.

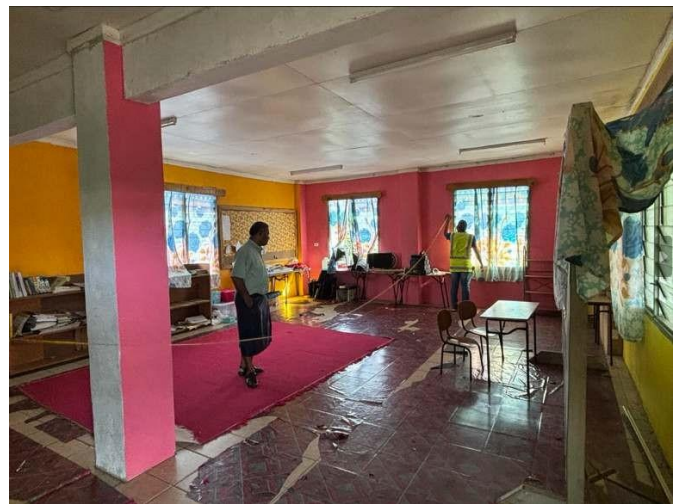
02. LANGUAGE ROOM – RIGID FRAME BEAMS & COLUMNS.

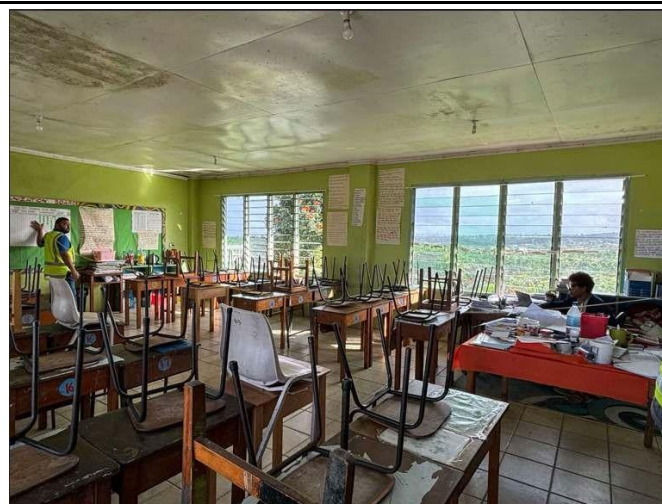
05. YEAR 501 CEILING U/S ROOF FRAME.

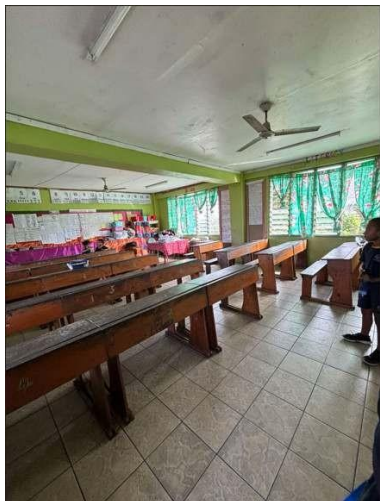
01. YEAR 301 - TILED FLOOR, CEILING FAN, LIGHTS.

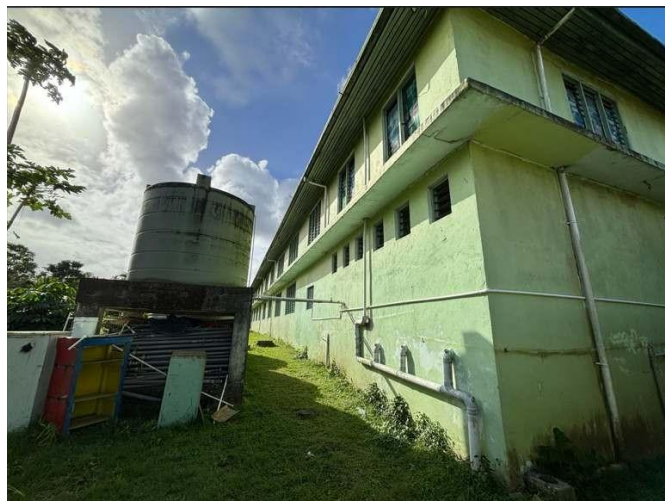
02. WATER TANK SUPPLY CORNER OF BLOCK 07.

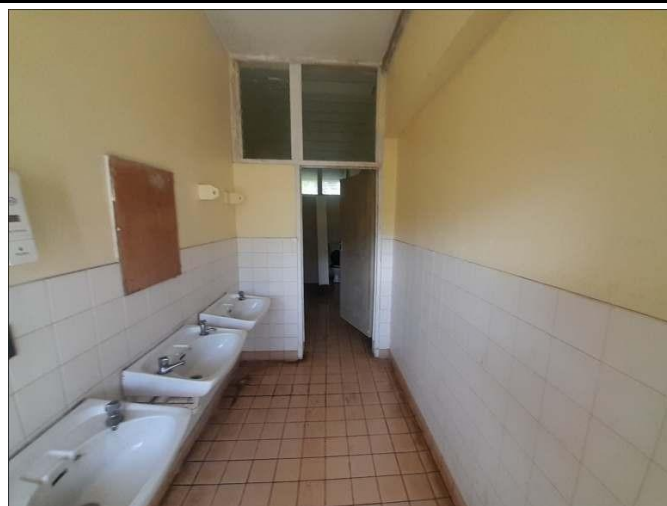
03. BOYS TOILET HAND BASINS, TILED FLOOR & WALL.

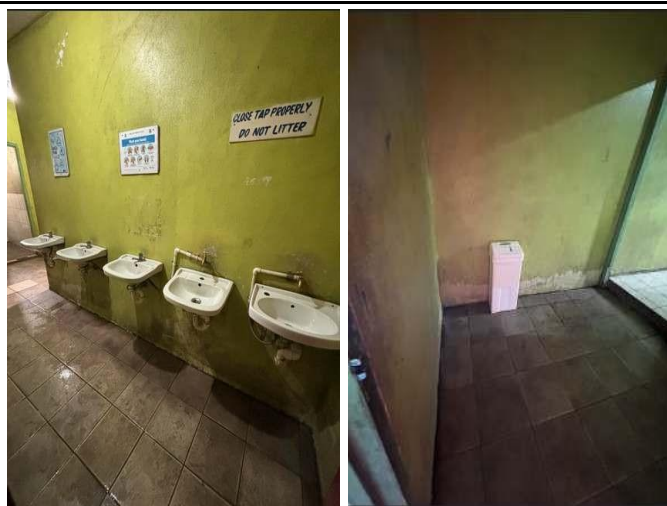
05. GIRLS TOILET HAND BASINS, SAN BIN, FLOOR GRATING.

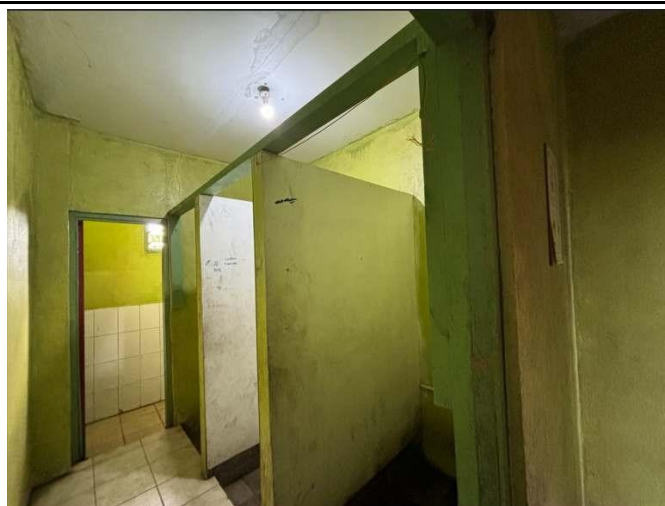
06. GIRLS TOILET SHOWER CUBICLES.

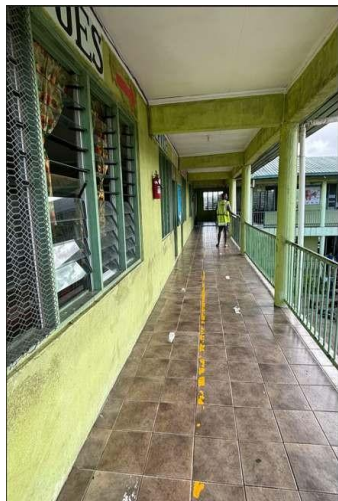
01. CLASSROOM EXIT INTO CORRIDOR.

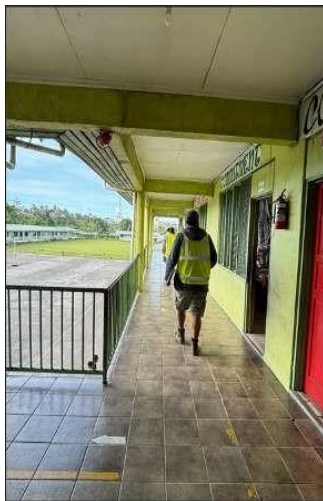
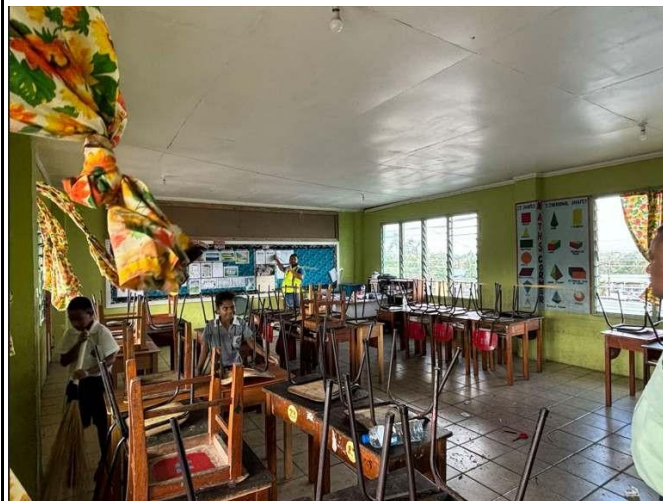
02. YEAR 401 TILED FLOOR, BULB LIGHT.

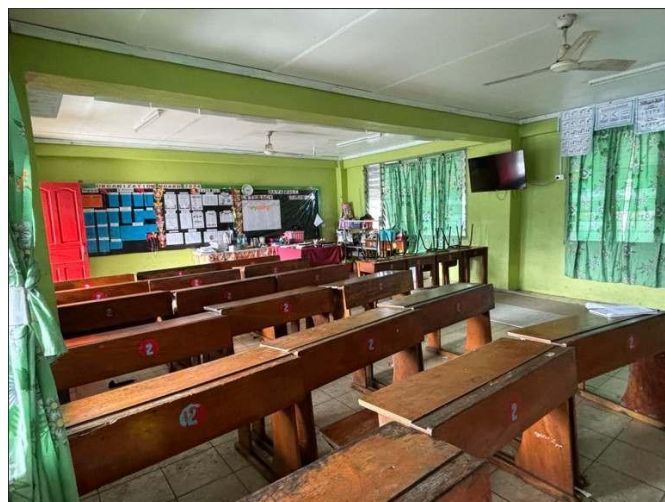
03. YEAR 302 TILED FLOOR, CEILING FAN, LIGHTS.

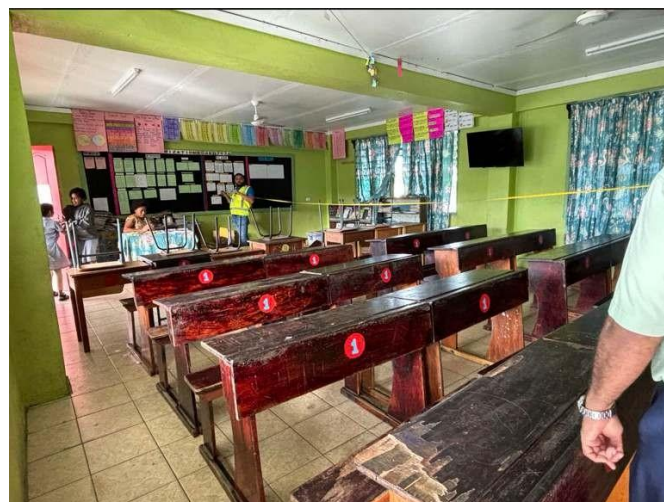
04. YEAR 303 TILED FLOOR, CEILING FAN, LIGHTS.

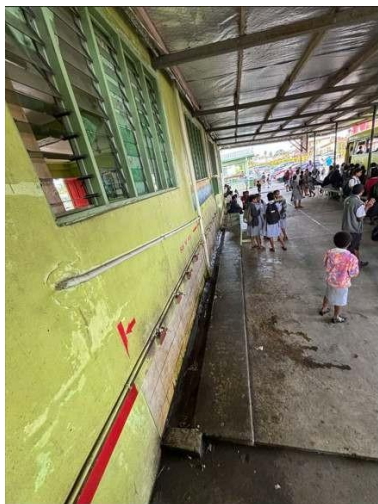
05. TAPS BACK OF BLOCK 08.

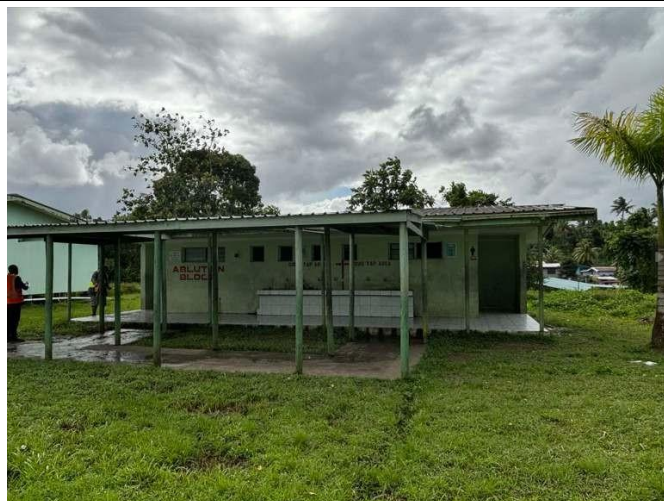
01. SHELTERED WALKWAY TO ABLUTION BLOCK.

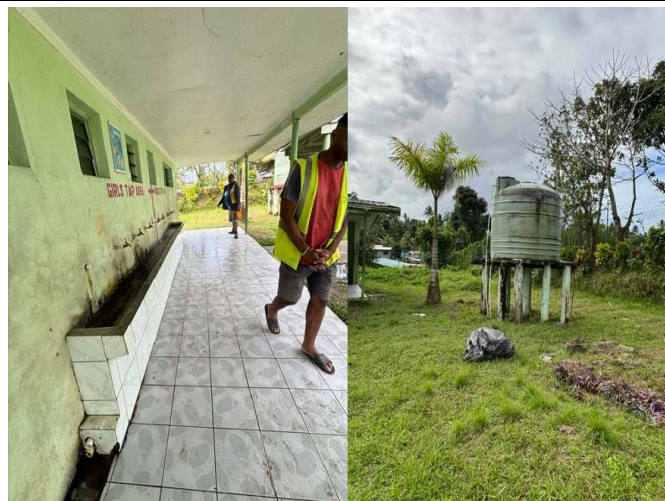
02. GENERAL USE TAPS & WATER TANK SUPPLY.

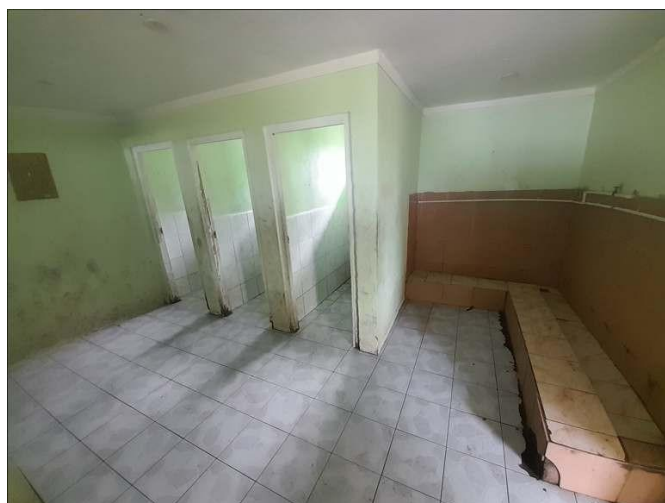
04. BOYS WC CUBICLES, URINAL, TILED FLOOR.

Recommendations <ul style="list-style-type: none">● Replace all deteriorated cubicle doors & joinery with new lock system.● Replace clear louvre blade glass with opaque type window blades for privacy.● Block 09 walls, floor, ceiling to receive good wash and new paint.

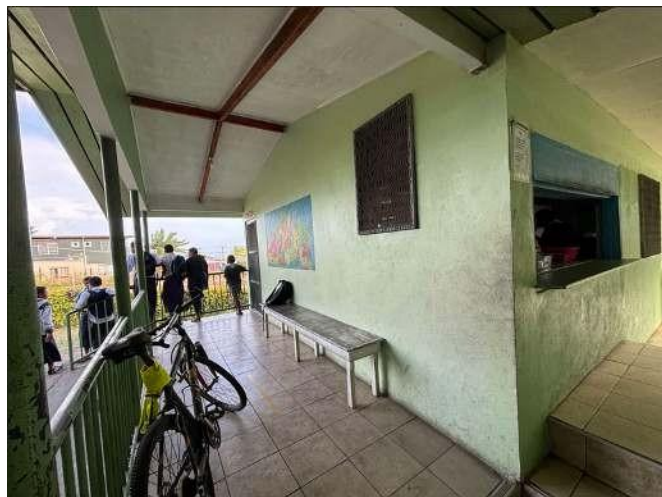
01. SERVING COUNTER, ACCESS DOOR TO CANTEEN KITCHEN
